**Geological investigation of heavy rainfall induced
landslide incidences at Bastari and Naulra village of
Pithoragarh District of Uttarakhand**

A report

**Disaster Mitigation and Management Centre
Department of Disaster Management
Uttarakhand Secretariat
Dehradun- 248 001**

**Investigations around Didihat region in
Pithoragarh district aftermath of landslide
disaster of 1st July, 2016**

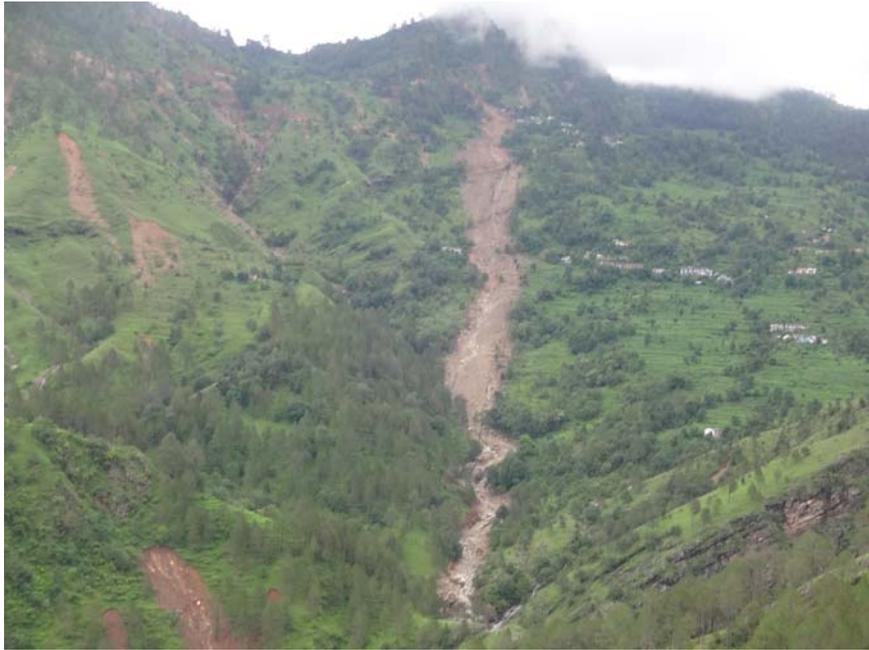
the pace of erosion along the nala. Rapidly running water and gravity driven movement induced by lubricating action of ground water thus driven the debris down slope at fast pace. The west flowing seasonal stream is observed to have overrun the cultivated lands and a partially damaged house (at right flank of landside) in the Urma village (Fig. 4).

Fig. 3: View of Bastari debris flow (camera looking east).

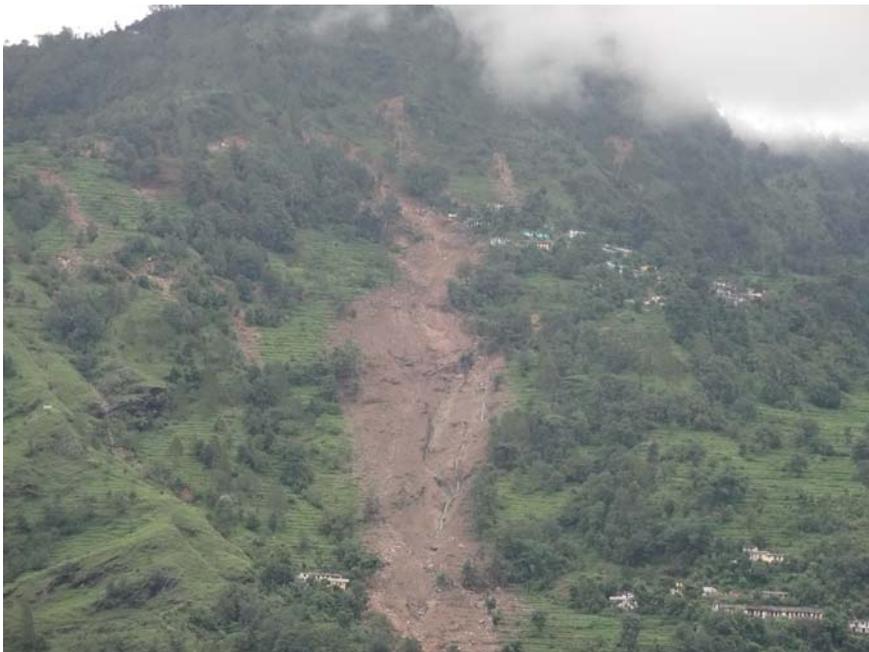
Fig. 4: Close up view of Bastari landslide.

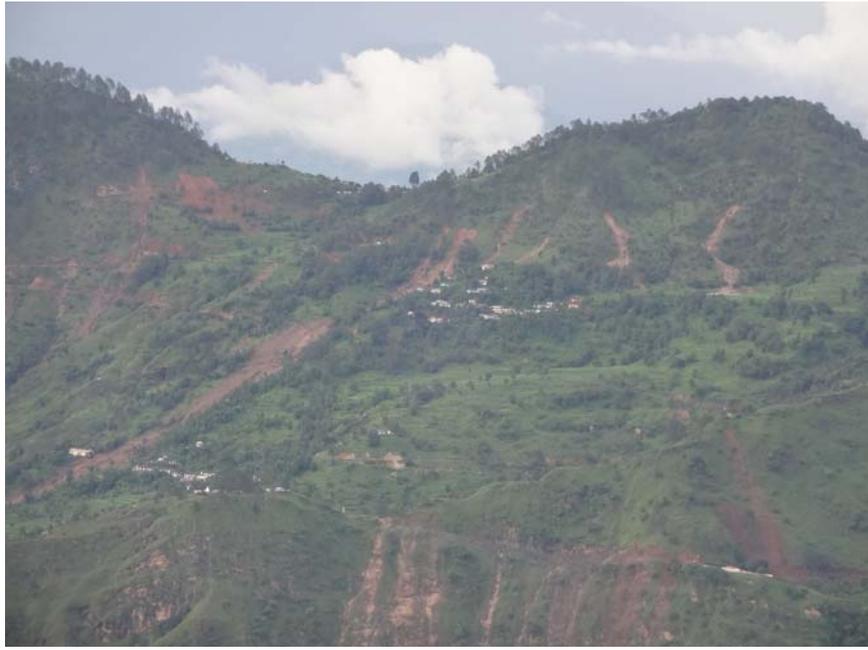
Besides major landslide several landslide scars are also observed on the uphill side to Bastari village (Fig. 5). Activation of these have the potential of posing danger to the village. Geologically, the area is deduced to be in a critical state of equilibrium and the following mitigation measures are suggested:

Fig.5: Landslide scars developed after heavy rainfall around Bastari village.

2. For the treatment of landslide scars developed on uphill side of Bastari village it is recommended that suitably designed wire mesh gabion walls be put in place in steps. The remaining portion of village is required to be treated appropriately, particularly on the left flank of Bastari landslide.

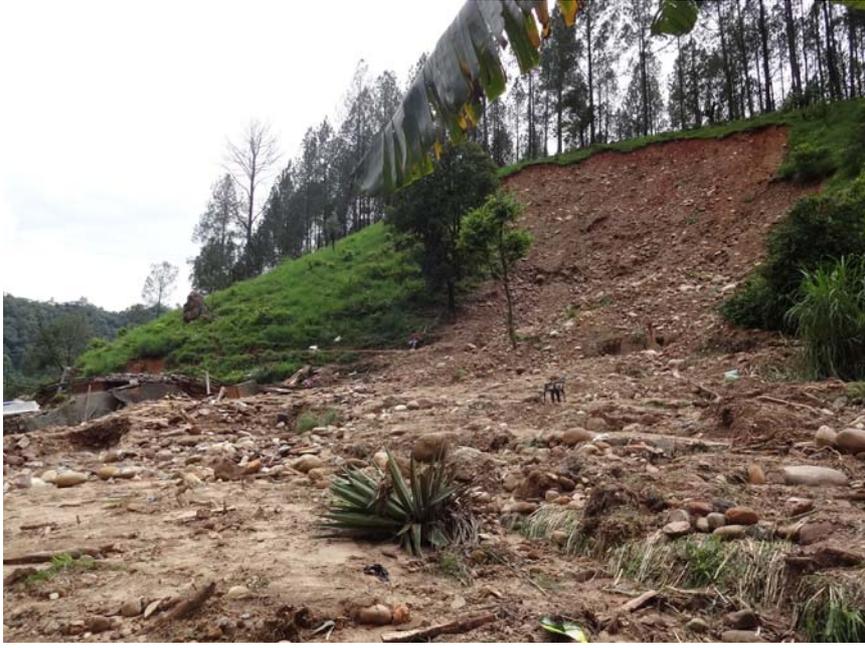
The landslide debris that descended down from the area upslope of the village is observed to have overrun both agricultural fields and houses (Fig. 7 and 8). The thickness of the debris accumulated in the area is observed to be around 3.0 meters. This overburden material is observed to comprise of river borne material consisting of dark brown to reddish, fine grained silty-sandy matrix with rounded boulders and pebbles.

Fig. 7: Debris flow on slope made up of RBM at Kumalgaon near Naulra village (camera looking west).

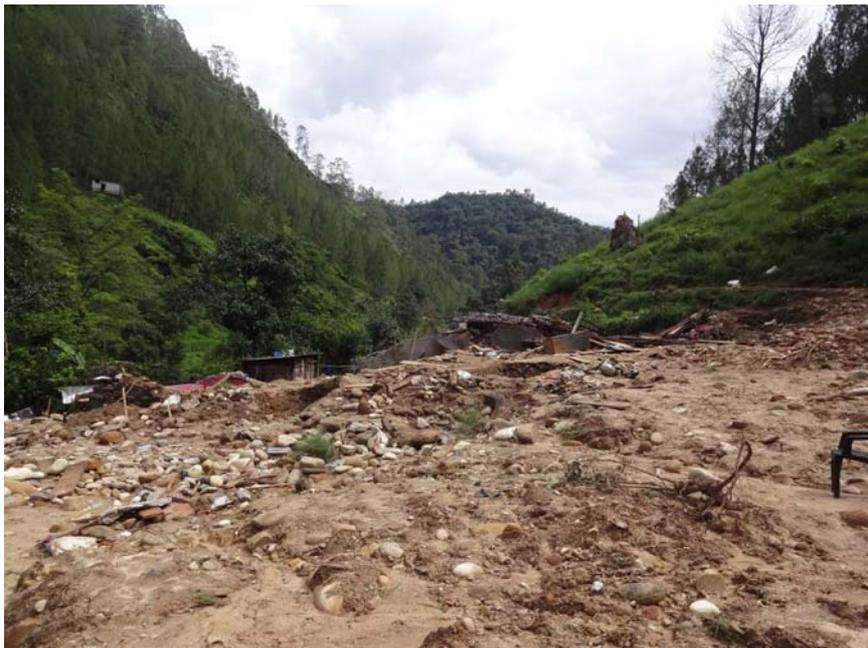
Fig. 8: Devastation around Kumalgaon village.

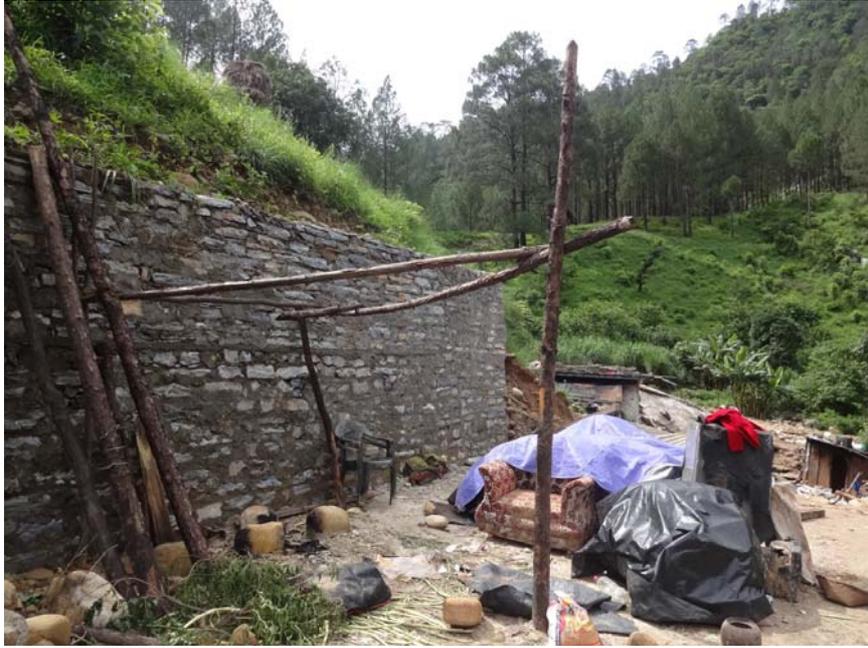
Fig. 9: Photograph depicts excavation and treatment (retaining wall) of the slope for construction on right flank of Naulra slide.

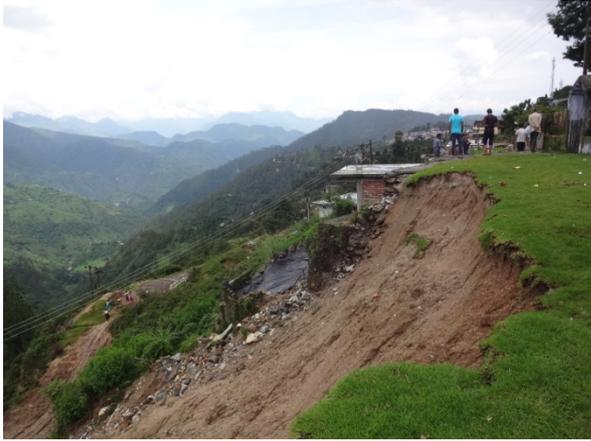
Fig. 2. Slope failure at Deendayal Park.

Reconnaissance geological-geotechnical assessment: The debris slide is observed to have occurred on the northeastern slope below Deendayal Park. The inclination of failure slope is observed to be 40° . The width of the failure slope is about 50 meters along Didihat-Pamsiyari road section and height of the crown is about 110 meters. The landslide debris that descended down from the Deendayal Park is observed to have accumulated on a newly constructed Pamsiyari road and along the drain. This overburden material is observed to comprise of hill wash and debris consisting of brown to reddish brown, coarse-grained sandy matrix with fragments of granitic gneisses. 10 - 15 cm wide NW-SE trending cracks are observed in front of house on the right flank of the slide. Together with this retaining wall below the house is observed to have bulged.

Heavy rainfall is deduced to be the main triggering factor for the debris slide. Steep slope together with the presence of thick cover of debris with valley side dipping strata are some other contributing factors for the slope failure.

Suggested measures: The hill slope around Deendayal Park is deduced to be highly susceptible to failure, particularly in the event of heavy or prolonged rainfall. The residents are therefore advised to keep safe distance from the vulnerable slope and vacate the area, especially during heavy or prolonged rainfall.

It is recommended that appropriately designed retaining structures of suitable height with firm foundation are required to be erected from Pamsiyari road level for checking slope failure. Appropriate measures are required for checking infiltration of rainwater. For the treatment of house situated at the right flank pre-constructed bulged retaining wall should be demolished and it needs to be reconstructed properly. At left flank of the slide, suitably designed masonry wall should be provided below the house together with proposed retaining

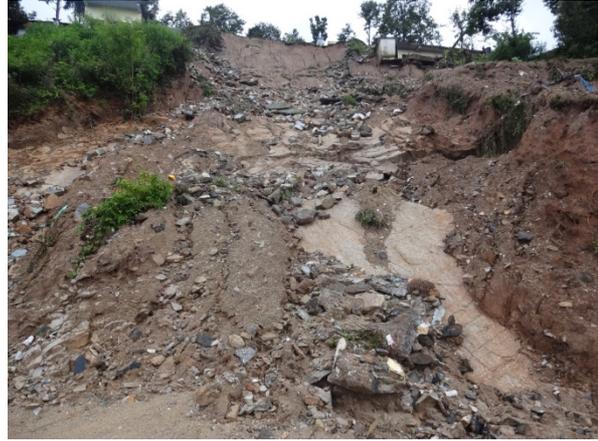
Fig. 3. Broad view of Deendayal Park landslide.

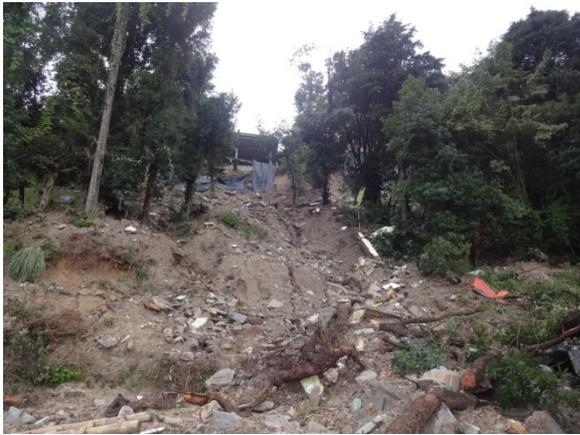
Fig. 4. Slope failure at Lotpatta village.

Reconnaissance geological-geotechnical assessment: The debris slide is observed to have occurred on the northeastern slope of Lotpatta village. The inclination of failure slope is observed to be 50° - 55° . The width of the failure slope is about 50 meters along the footpath and height of the crown is about 100 meters. Four more landslide scars are also observed around the major landslide. Descending down through the cultivated land the landslide debris is observed to have accumulated upslope of the footpath (Fig. 4 and 5). This overburden material is observed to comprise of hill wash and debris consisting of brown to reddish brown, coarse-grained sandy matrix with fragments of granitic gneisses.

Heavy rainfall is deduced to be the main triggering factor for the landslide. Steep slope, excavation and overloading on debris slope, poor drainage network, construction on cultivated land and gully erosion are some other contributing factors for the slope failure.

It is recommended that suitably designed wire mesh gabion walls be put in place in three steps from upslope to footpath and uphill side check dams needs to be given in certain interval. For the slope treatment below the houses situated at the crown part, suitably designed masonry walls should be provided below the houses.

Appropriate measures are required for checking infiltration of rainwater. It is also strongly recommended that construction of any sort should not be allowed around Lotpatta slide zone. For the protection against landslide scars buttress walls needs to be given.

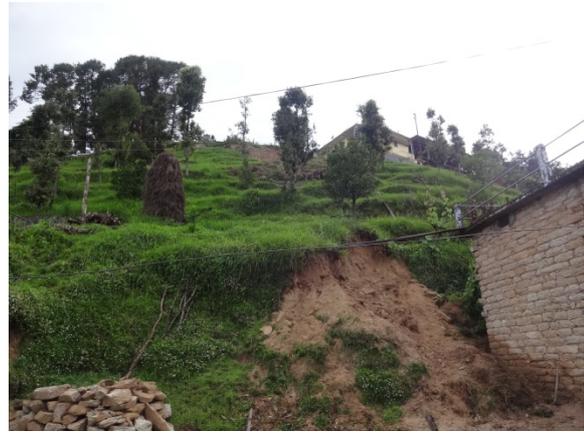
Fig. 5. Landslide scar at Lotpatta village.

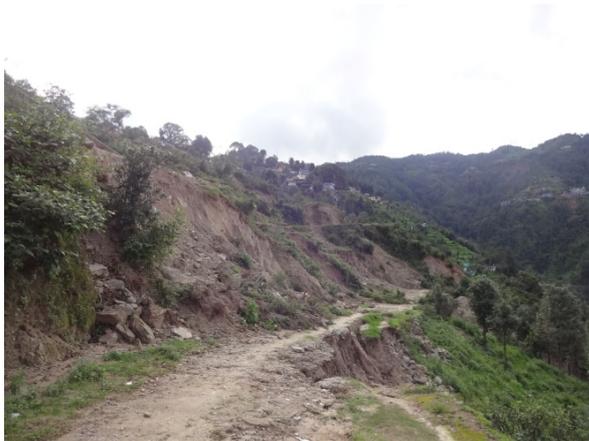
Fig. 6. Broad view of Pamsiyari road landslide.

Reconnaissance geological-geotechnical assessment: The bouldery debris slide is observed to have occurred on the northeastern slope. The inclination of failure slope is observed to be 40° . The width of the failure slope is about 200 meters along the Pamsiyari road section and height of the crown is about 350 meters. The bouldery debris landslide took place from uphill side of the newly constructed road and is observed to have accumulated on the road as also on the down hill side (Fig. 6 and 7). This overburden material is observed to comprise of hill

Heavy rainfall is deduced to be the main triggering factor for the debris slide. Moderate to steep slope together with the presence of thick cover of debris dominated with boulders and road cutting are some other contributing factors for the slope failure.

Suggested measures: It is recommended that suitably designed wire mesh gabion walls be put in place together with road side drain.

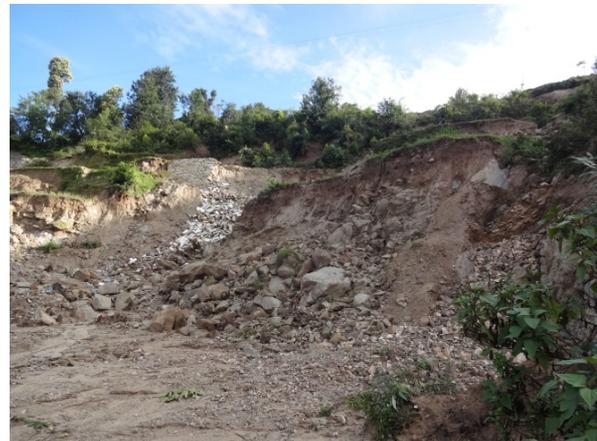
Fig. 7. Close-up view of landslide.

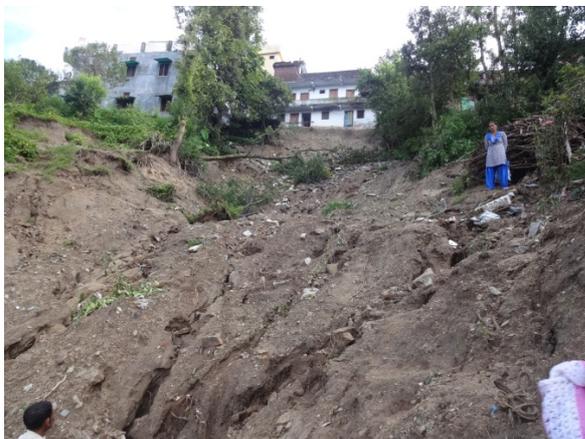
Reconnaissance geological-geotechnical assessment: The debris slide is observed to have occurred on the northeastern slope of Dhmiyakhan. The inclination of failure slope is observed to be $30^\circ - 35^\circ$. The width of the failure slope is about 30 meters along the footpath and height of the crown is about 60 meters. The landslide debris is observed to have accumulated along the seasonal drain going across the footpath and entered a house (Fig. 8 and 9). This overburden material is observed to be comprised of hill wash and debris consisting of brown, coarse-grained silty-sandy matrix with fragments of granitic gneisses.

Fig. 8. Slope failure at Dhmiyakhan.

Heavy rainfall is deduced to be the main triggering factor for the landslide. Overloading on thick cover of soil, encroachment along seasonal drain and gully erosion are some other contributing factors for the slope failure.

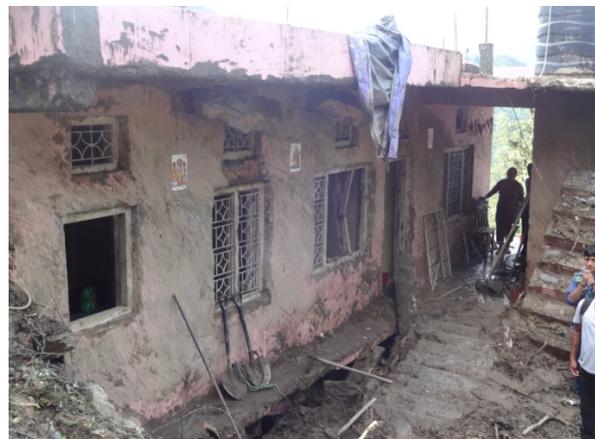
Fig. 9. Severely damaged house due to landslide.

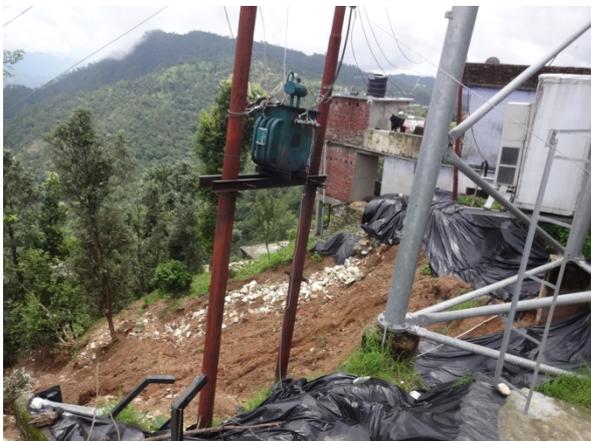
Reconnaissance geological-geotechnical assessment: Debris slide took place due to have rainfall from the northeasterly slope of the area (Figs. 10 and 11). The inclination of failure slope is observed to be $45^\circ - 50^\circ$. The width of the failure slope is about 30 meters below the mobile tower and height of the crown about 50 meters.

Fig. 10. View of damaged part of an electricity pole and a mobile tower due to landslide.

The shallow hill wash together with debris that descended down along a gully from the area upslope is observed to have overrun ultimately into the northeasterly flowing drain going across the Didihat – Dunakot road. This overburden material is observed to comprise of hill wash and debris consisting of brown to grayish brown, fine-grained silty-sandy matrix with fragments of rock. Foundation portion of an electricity pole and a mobile tower are also damaged by this incidence (Fig. 10).

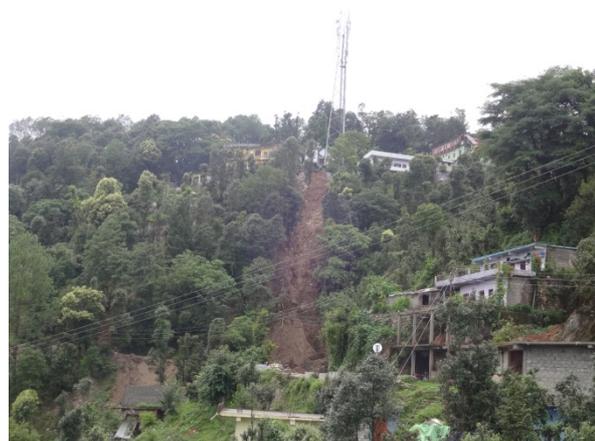
Fig. 11. Bird eye view of mobile tower landslide.

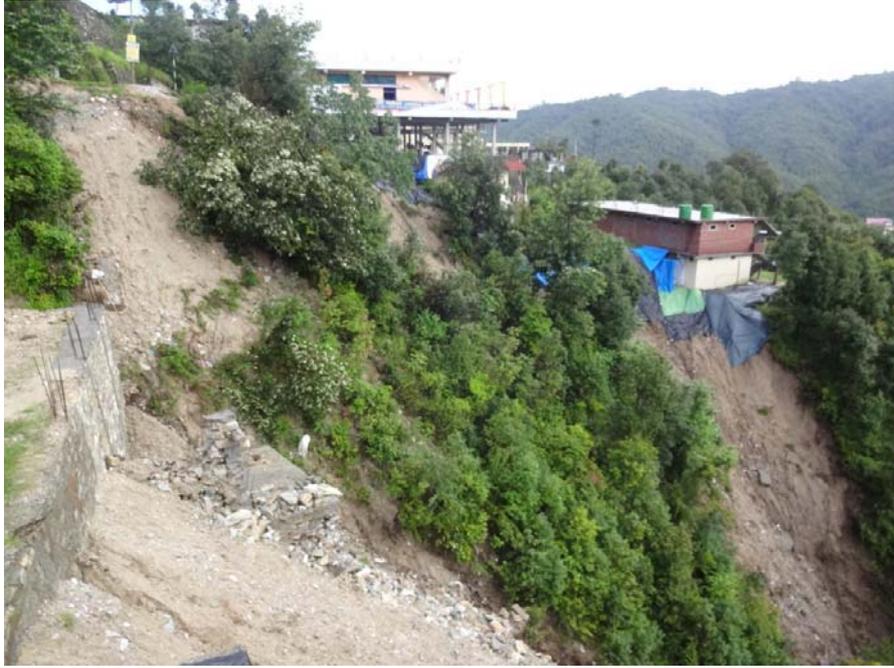
The debris slide is observed to have occurred on the western slope due to heavy rainfall. The inclination of failure slope is observed to be 50°. The width of the failure slope is about 60 meters and height of the crown is about 50 meters. The debris slide took place from the downhill side of Didihat – Pithoragarh road and is observed to have accumulated along the nala below the slide (Fig. 12). This overburden material is observed to comprise of hill wash and debris consisting of brown to grayish brown, coarse grained silty - sandy matrix with fragments of granitic gneiss.

Heavy rainfall is deduced to be the main triggering factor for the debris slide. Steep slope together with the presence of thick cover of debris and toe erosion by seasonal stream are some other considerable causative factors for the landslide.

Fig. 12. Landslide near Milan Restaurant, GIC Ward.

Suggested measures: It is recommended that appropriately designed toe protection wall of suitable height be erected in two steps from seasonal stream and after these benches be provided with modification of slope. Suitably designed masonry walls should be provided to support the failure below the buildings.

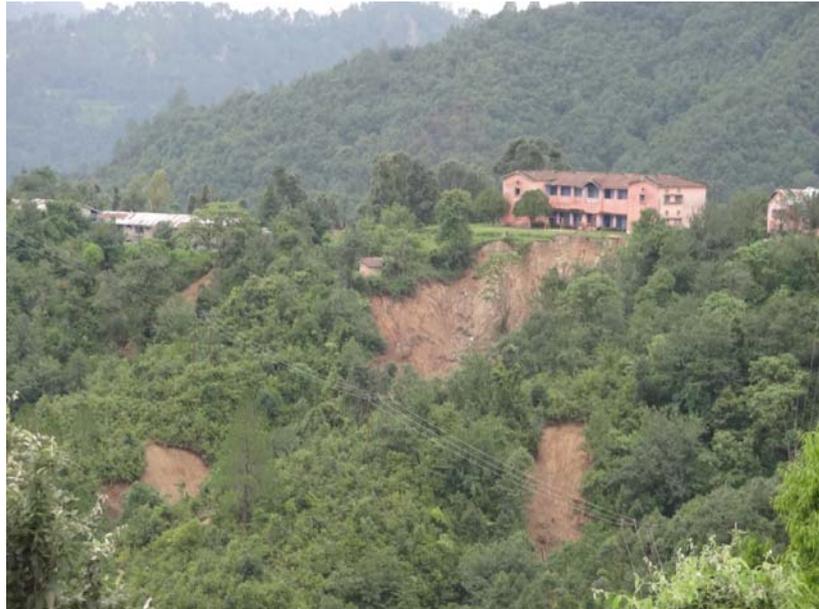
Reconnaissance geological-geotechnical assessment: The area under present investigation is observed to be occupied by thick overburden material with dense vegetation cover. The landslide zone is observed to have moderate to steep slope. Rock exposures are not observed near the landslide zone. The debris slide is observed to have occurred on the northern slope due to heavy rainfall. The inclination of failure slope is observed to be 40° . The width of the failure slope is about 80 meters and height of the crown is about 60 meters. This overburden material is observed to comprise of hill wash and debris consisting of brown to reddish brown, medium grained silty - sandy matrix with fragments of granitic gneiss.

Heavy rainfall is deduced to be the main triggering factor for the debris slide. Steep slope together with the presence of thick cover of debris and gulley erosion are some other causative factors for the landslide.

Fig. 13. Landslide near DIET, Didihat.

Suggested measures: It is recommended that appropriately designed retaining structures of suitable height be erected in two steps to protect the toe of the slide. In between crown and proposed retaining structures, check dams be constructed using in-situ material at a certain intervals. Plantation of broad leafed plants and shrubs is recommended for ensuring protection against gully erosion.

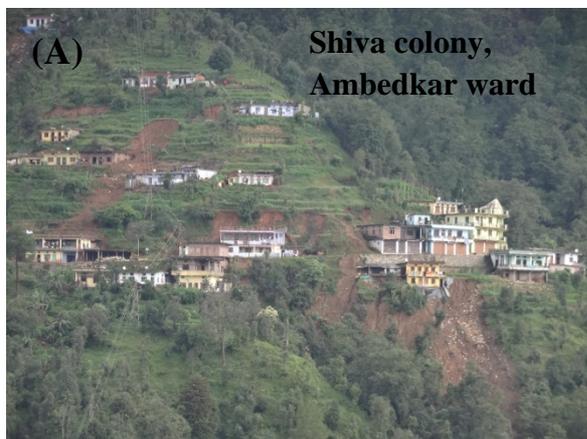
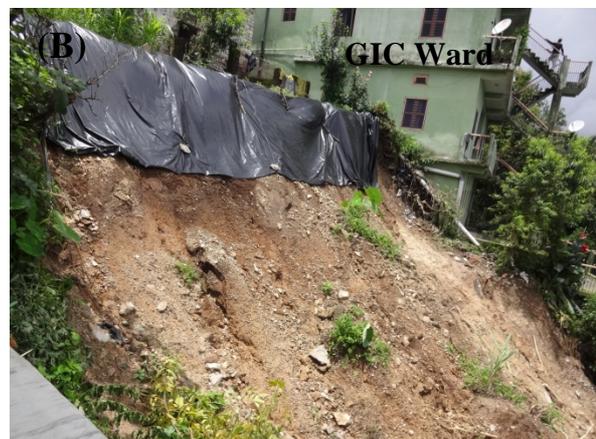
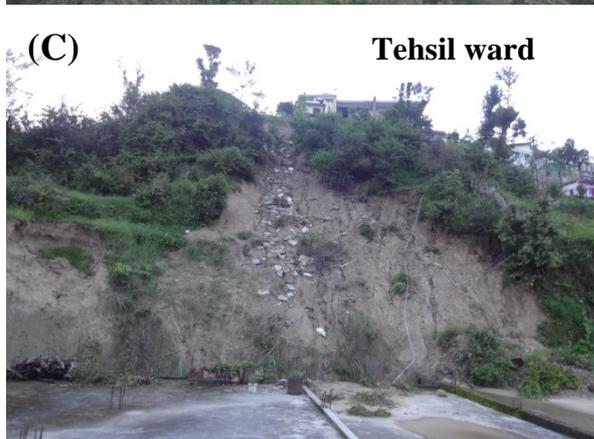
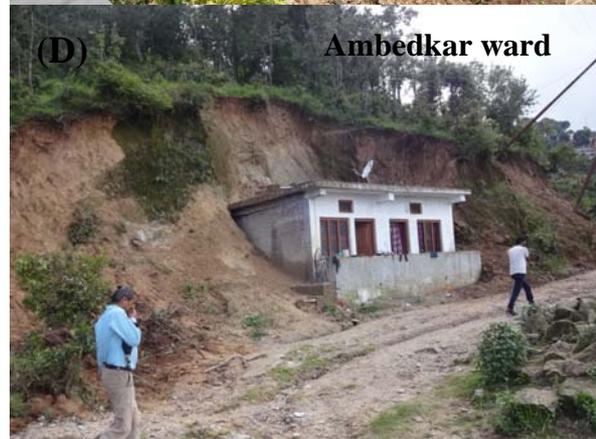
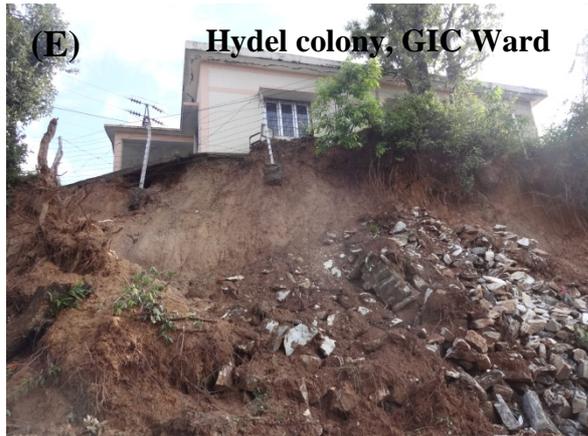
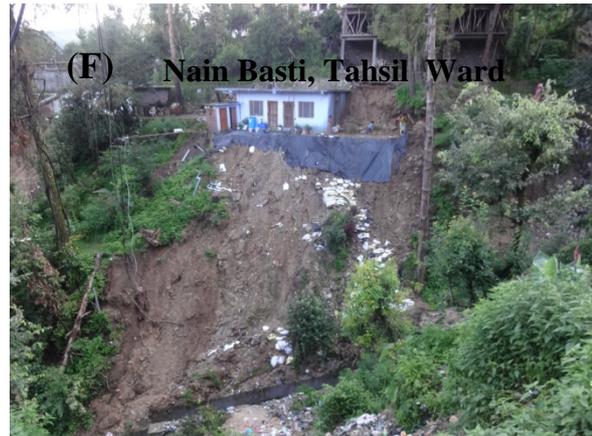
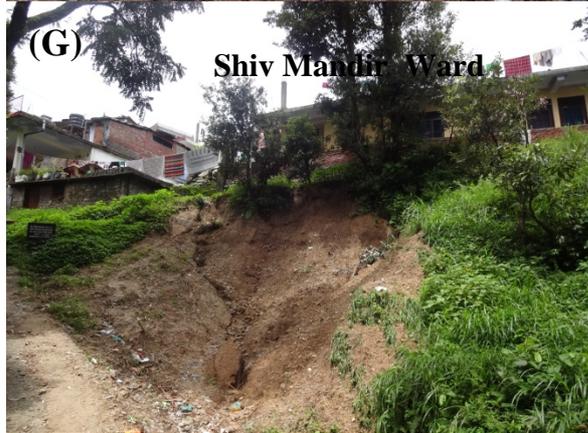
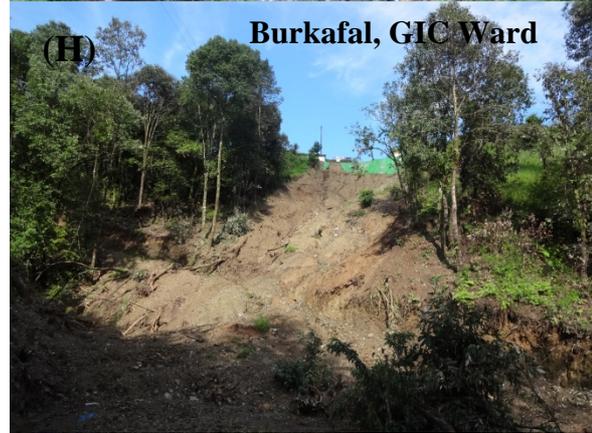
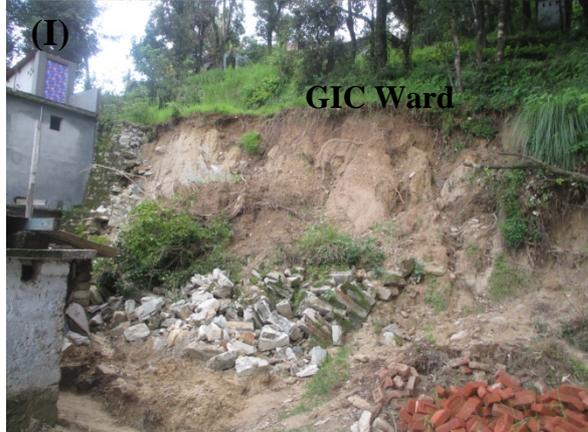
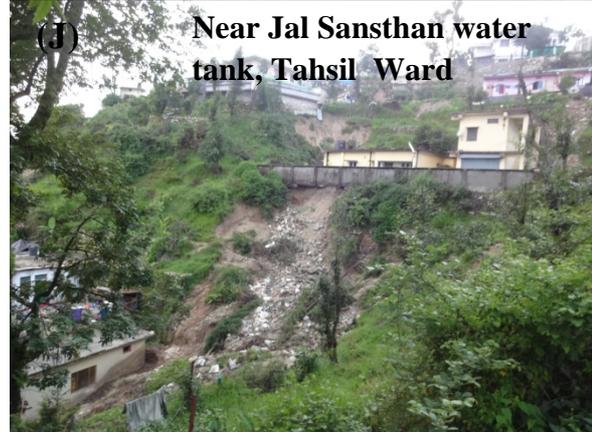
Fig. 14 A, B, C, D, E, F, G, H, I and J are from different locations of Didihat town but scenario is almost same in all the region, though the area was devastated by heavy rainfall of 31st June 2016, but most of the region common things responsible for the slope failure are construction on moderate to steep slope made up off overburden material or old landslide debris, excavation of slope, absence of proper drainage network. Besides, encroachment along the drain is observed at several locations and most of the places buildings have been constructed close vicinity to hill slope even 2 meter minimal gap is avoided between hill slope and buildings. Due to this reason most of the places debris laden water either entered into the rooms or flowing through the roof.

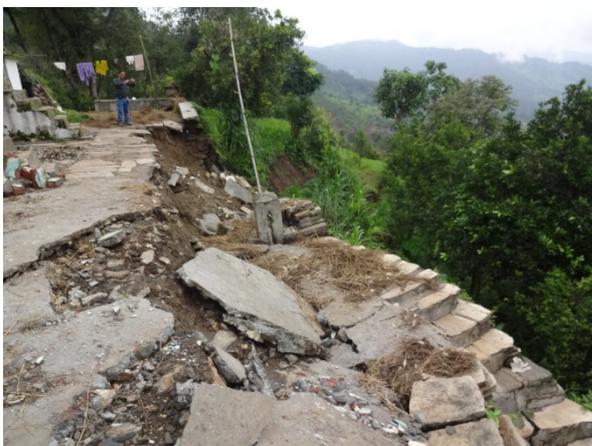
Heavy rainfall is deduced to be the main triggering factor for the slope failure. Dip slope, loose soil, avoidance of Guls (water drains) in between cultivated land due to migration of local people to city / town areas are some other contributing factors for the slope failure around Sunakot (Devel) area.

Fig. 15. Slope failure in front of house at Sunakot.

Suggested measures: Severely damaged portion of the house should be demolished and rebuild with proper foundation. For the protection against landslide along footpath suitably designed wire mesh gabion wall be put in place in steps along the footpath. If guls (water drains) could be maintained by the locals, development of cracks on cultivated land could be reduced.

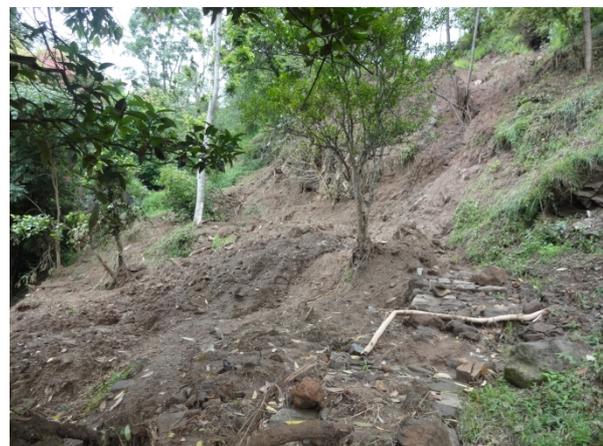
Fig. 16. Landslide along the footpath of village.

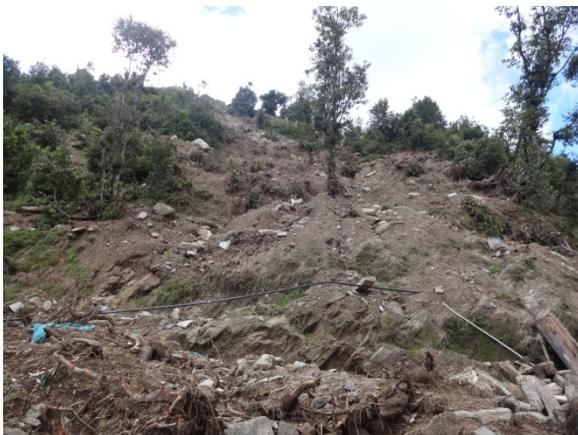
Fig. 17. Slope failure at Nonpapon village.

Heavy rainfall is deduced to be the main triggering factor for the landslide. Steep slope together with thick cover of debris and road cutting on crown portion are some other contributing factors for the slope failure.

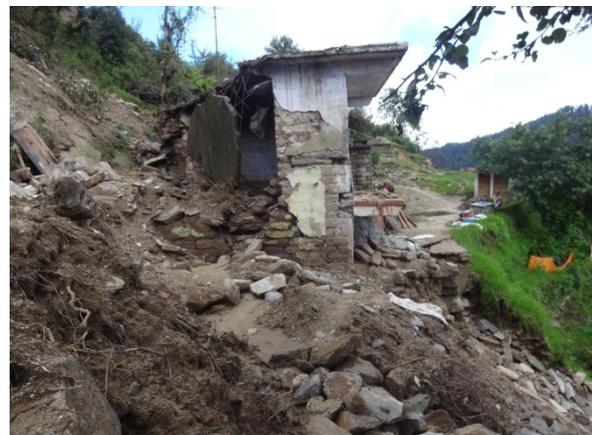
Fig. 18. Damaged house at Nonpapon village.

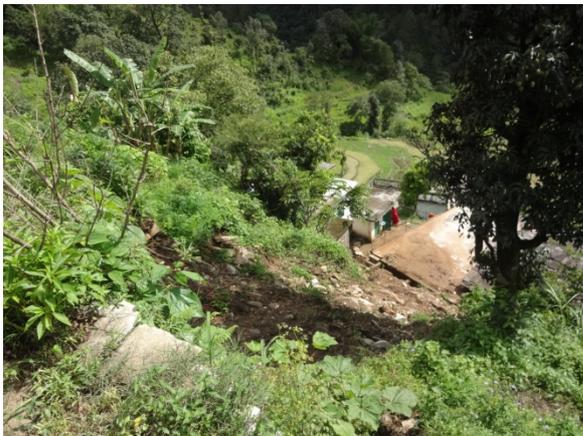
Fig. 19. Slope failure at Bagjivilla village.

Reconnaissance geological-geotechnical assessment: The area is affected by the debris flow at several locations and on the uphill side of the village one major landslide is observed. Debris flow is observed to have occurred on the southwestern slope of Bagjivilla village (Figs. 19 and 20). The inclination of failure slope is observed to be 60° - 65° . Width of the failure slope is about 30 meters and height of the crown is about 50 meters. Shallow landslide debris that descended down from the area upslope of the villages is observed to have overrun both cultivated fields and a house. A cemented gul (water drain) located at crown portion of the landslide is observed to be damaged due to landslide. On the downhill side of the house in

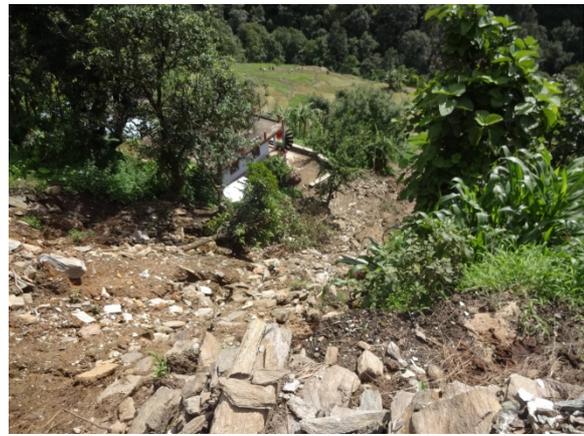
Fig. 20. Debris flow uphill side of a house.

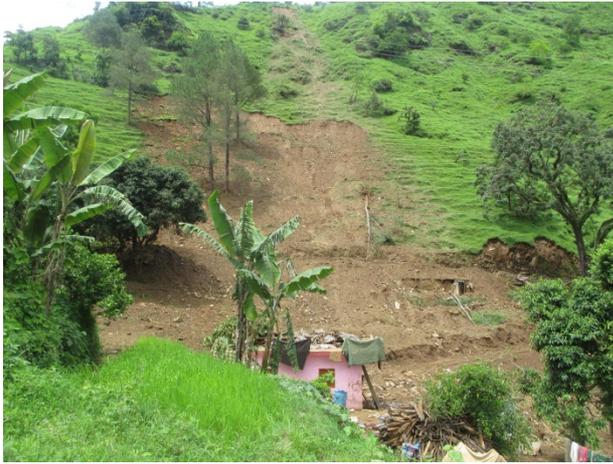
Reconnaissance geological-geotechnical assessment: Rock exposures of metabasics and phyllites belonging to Lesser Himalaya are observed along the road section as also to the upslope of the village. The foliation planes are generally observed to be well-developed and dip at angles of around 35° towards northeast. The joint sets are observed to have steep and almost vertical disposition. These are observed to be SSW dipping and NE-SW striking respectively (55°/ 240° and 90°/ 60°). The debris slide is observed to have occurred on the southern slope of E-W trending ridge. The inclination of failure slope is observed to be more than 50°. The width of the failure slope is about 40 meters along the cultivated fields and height of the crown from cultivated fields is about 35 meters.

Fig. 21. Photograph showing slope failure at Patherkot Malla.

The shallow landslide debris that descended down from the area upslope of the village is observed to have overrun both agricultural fields and a house (Figs. 21 and 22). The thickness of the debris accumulated in the house is observed to be 0.5 to 1.0 meters. This overburden material is observed to comprise of hill wash and debris consisting of gray to grayish brown, fine grained silty matrix with fragments of metabasics and phyllites.

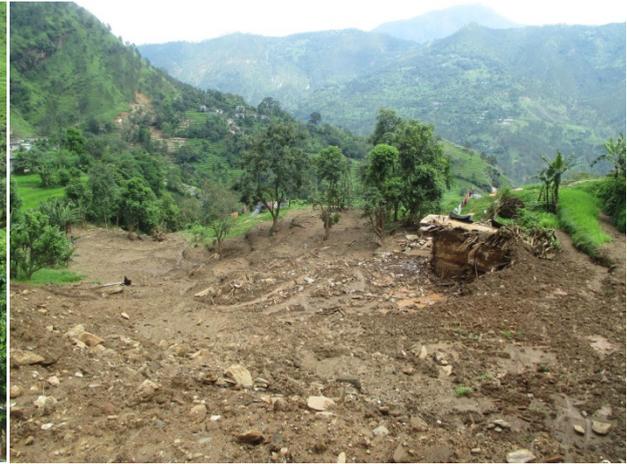
Fig. 22. View of the house and a number of agricultural land damaged by water saturated debris in Patherkot Malla.

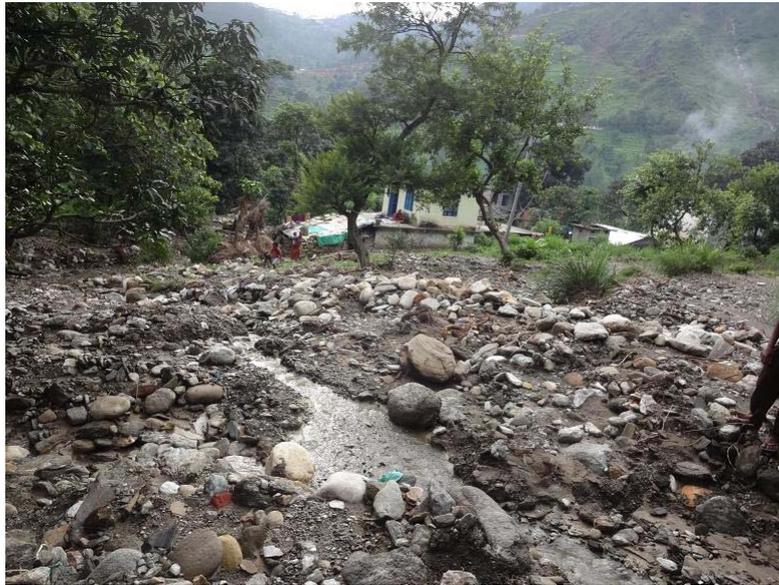
Fig. 23. Photograph depicts high sediment laden discharge by Liparti nala.

Patet village is observed to be affected by stream erosion that is deduced to contribute to the instability of the area. On 30th June, 2016, the Liparti nala reportedly diverted towards the village on its right flank. Due to this, total 09 houses and a number of agricultural fields were covered with water saturated debris. The thickness of the debris accumulated in the houses is observed to be around 0.5 to 1.0 meters (Fig. 23).

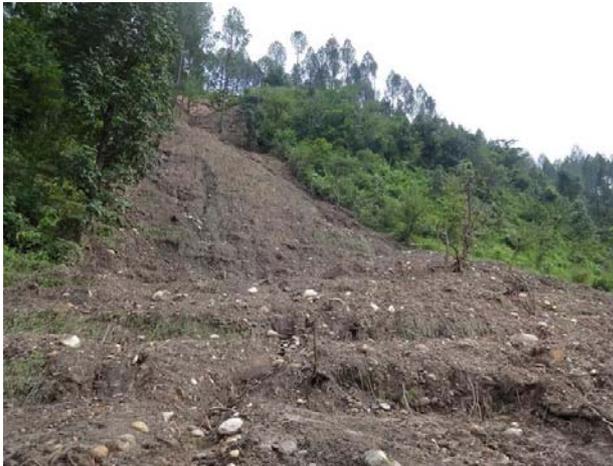
Fig. 24. Photograph depicting debris flow.

Hill wash materials together with bouldery debris flow are observed to have occurred on the northwestern slope of NE-SW trending ridge. The inclination of failure slope is observed to be 50° . The width of the failure slope is about 40 m along the cultivated fields and height of the crown from cultivated fields is about 30 meters.

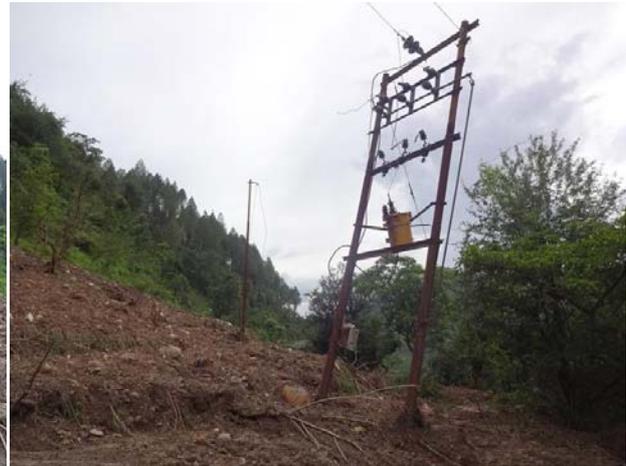
Fig. 25. View of an electricity line was damaged and disconnected by debris flow.

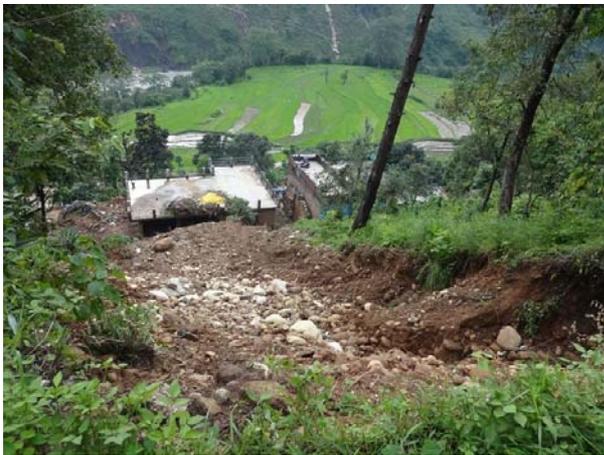
The slope above the village is observed to be steep and failure slope trending WNW. Increase in slope height by gully erosion due to excessive rainfall together with low cohesion of river born material is deduced to have contributed to the instability of the slopes in this area.

Fig. 26. Photograph depicts slope failure in river borne materials.

Mitigation measures: The slope is required to be modified at different levels in the area affected by bouldery debris slide at the upslope of the village by benching and erection of appropriately designed masonry buttress / retaining walls. It is recommended that the debris mass accumulated by the slope failure in the agricultural lands and houses of Daphla village be cleared. After removing of accumulated debris mass from house, reconstruct the damaged component.

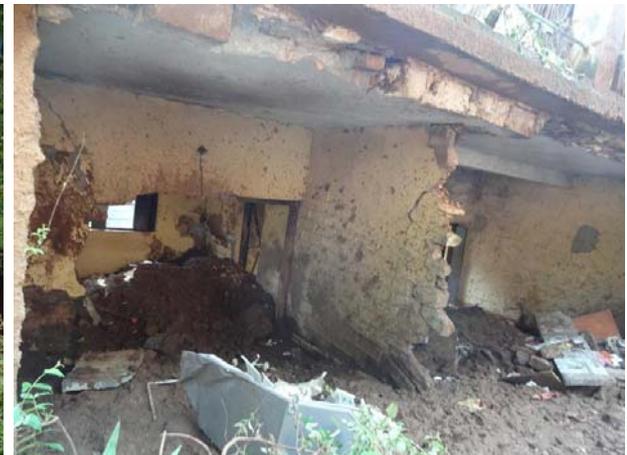
damaged due to slope failure. Back side wall of this house is totally damaged and debris accumulated into the house (Fig. 27).

Fig. 27. View of damaged walls of a double storied house.
