Non – structural seismic
vulnerability assessment of
Mahant Indires h hospital,
Dehradun (Uttarakhand)

**Disaster Mitigation and
Management centre**

July 2012

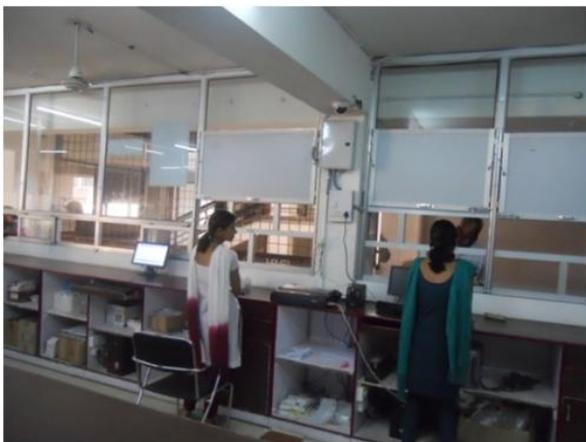
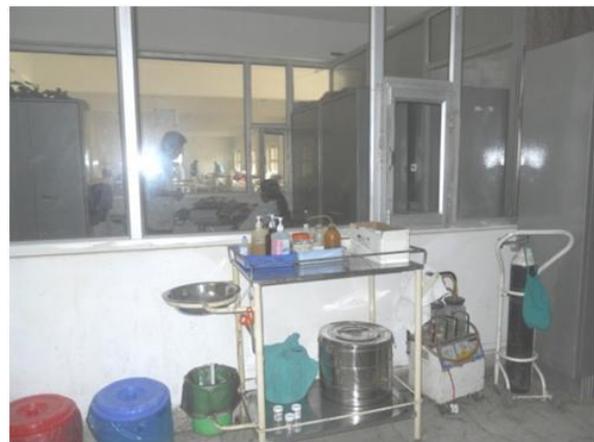
All the sections of the hospital were observed to have masonry partition walls as also glass partitions (Figs. 2 and 3). Both new and old building blocks have glass partitions and only in a few sections fibre based glass partition has been used. Composite section of aluminium and glass has been generally used in each section. It is worth noting that the use of glass could have been easily avoided at many places in the hospital premises. Splintering of glass in case of strong ground shaking would pose serious threat to the patient area adjacent to windows. The splintered glass pieces on the corridors would also obstruct movement. Use of glass in chemist shop and nursing stations (Figs. 2, 3 and 4) can cause injury during intense shaking apart from disrupting their functionality. All the nursing stations of the hospital have glass partitions. It is important to note that the glass used in the hospital should be laminated immediately and in future the same should be replaced with annealed and tempered safety glass.

Fig. 2. Use of glass panels in the chemist shop. Fig. 3. Use of glass panels at a nursing station.

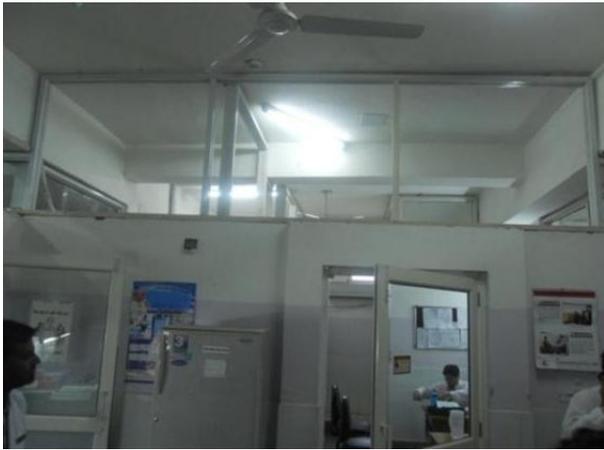
Fig. 4. Use of glass adding to the vulnerability.

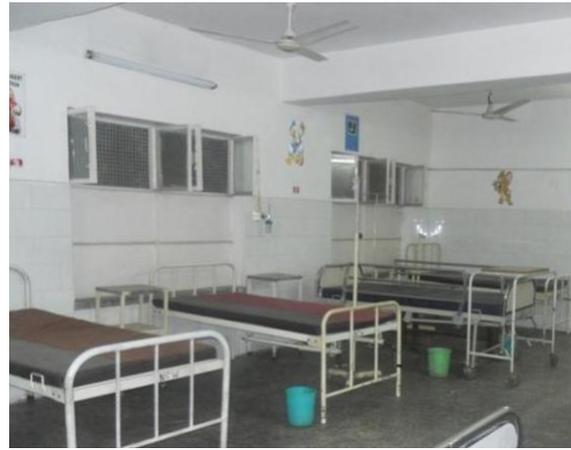
Absence of proper anchorage of ceiling fans which are in majority placed over the patient beds, poses a threat to the life safety (Fig. 5). Ceiling fans would swing during ground shaking and their snapping off could cause casualties. The swing of the fans can be limited by provision of chains / wire that would attach the fan body to the ceiling.

Fig. 5. Ceiling fans with inadequate anchorage above the patient beds.

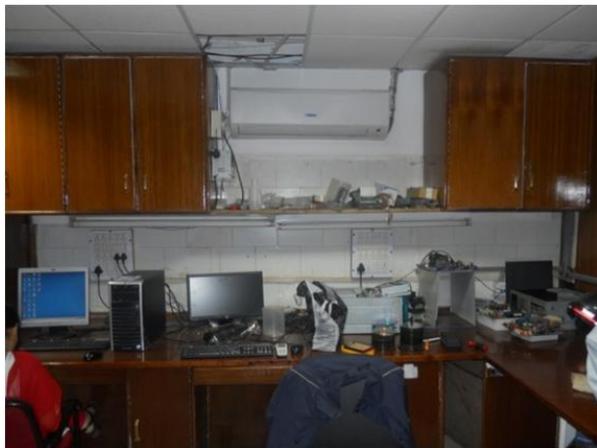
Fig. 6. False ceiling in computer / IT section.

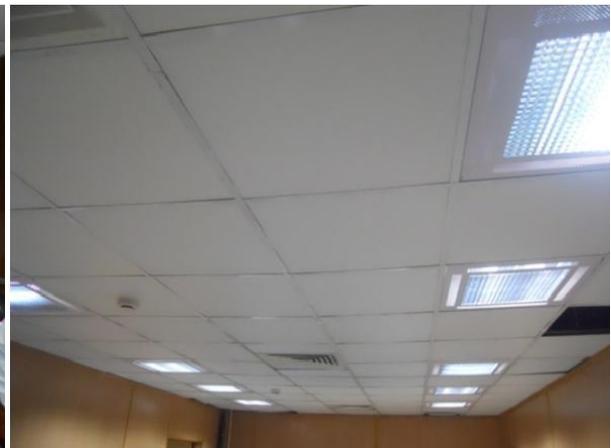
In the CT MRI section of the new building false ceilings has been used. During a fire or an earthquake, suspended ceilings might be very unstable (Fig. 7). Strong ground shaking can cause the false ceiling panels to fall, and disrupt the functionality of the area. The light fixtures supported by the ceiling system could also fall and cause injury (Fig. 7). The presence of such non-structural elements is enough to categorise the section as being vulnerable.

Fig. 7. Falling down of false ceiling and light fixtures could pose a major threat.

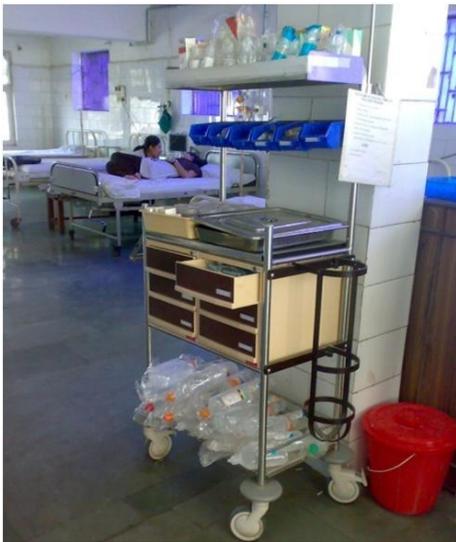
Fig. 8. View of the trolley containing supplies.

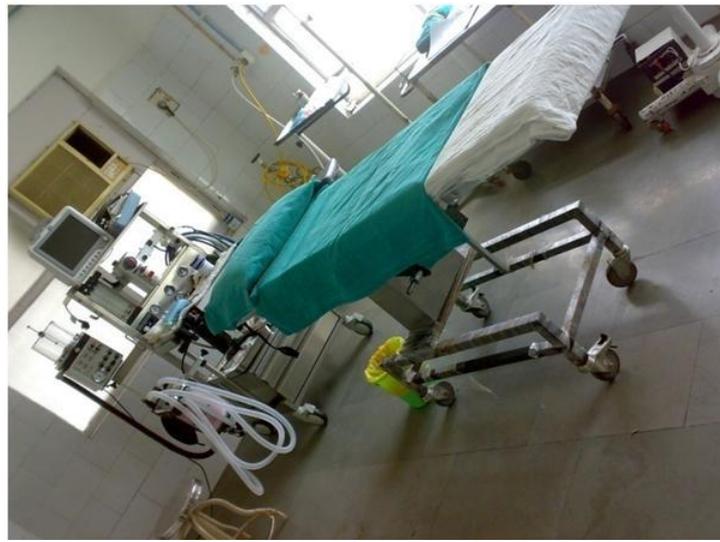
Fig. 9. Wheel mounted operation table and anaesthesia machine.

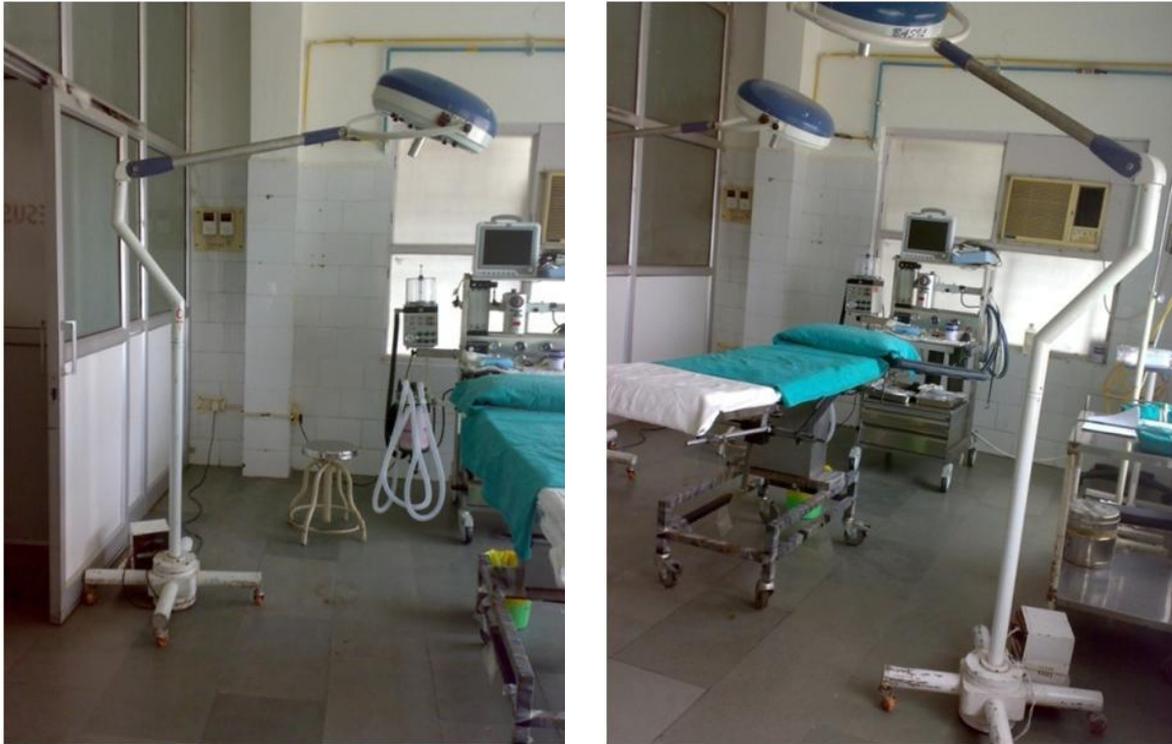
The reception staff sitting area of the emergency ward has normal glass windows which can threaten the safety of the staff. The blood / glucose / saline stands were observed to be placed alongside the bed. These should either be attached to be beds or anchored properly. The cupboards were observed to be ill placed and might block the exit. Wheel mounted anaesthesia machine and operation table were observed in the yellow section that is the operation theatre (Fig. 9). During strong ground motion these equipments might topple or slip past jeopardizing life safety. Provision of non slip mat needs to be provided for ruling out possibility of the equipments sliding off. The heavy equipment like monitor needs to be anchored. Oxygen and suction pipelines also need proper anchorage particularly at the joints. Wheel mounted lights were observed in the operation theatre. Strong shaking can cause these to topple or

Figs. 10 and 11. Wheel mounted lights in the operation theatre.

slip past. These are thus required to be anchored with chains which can easily be removed at time of operation.

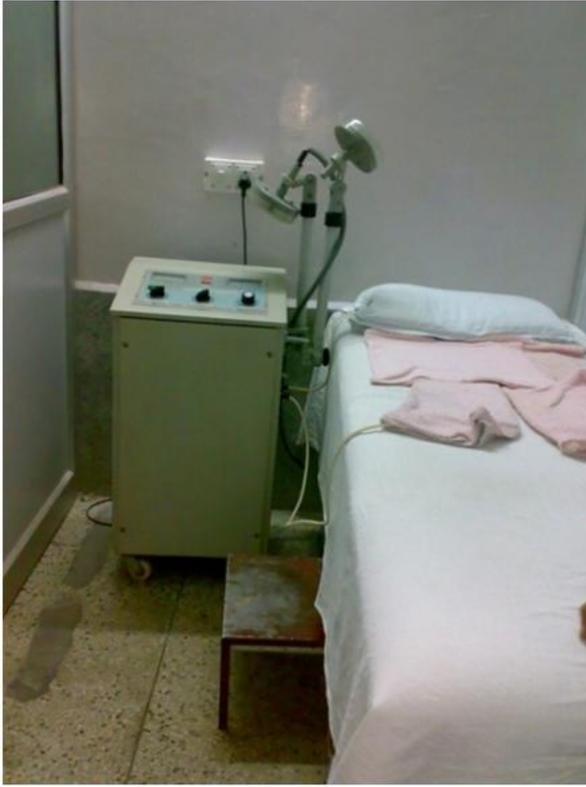
Fig. 12. Unanchored medical equipments placed close to the bed in the physiotherapy section.

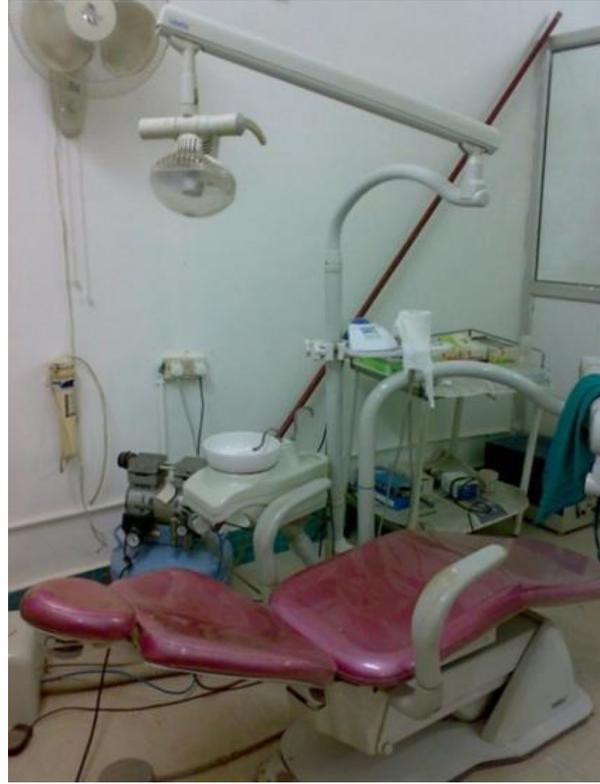
5.2.4 Dental section: The patient chair in the dental section, though not trolley mounted is required to be properly anchored to the floor so as to rule out possibility of its rolling down in case of intense ground shaking (Fig. 13). The bench mounted equipments including the portable X - ray machine must be anchored with straps or chains.

Fig. 13. The dental chair though not trolley based is required to be properly fixed with the floor.

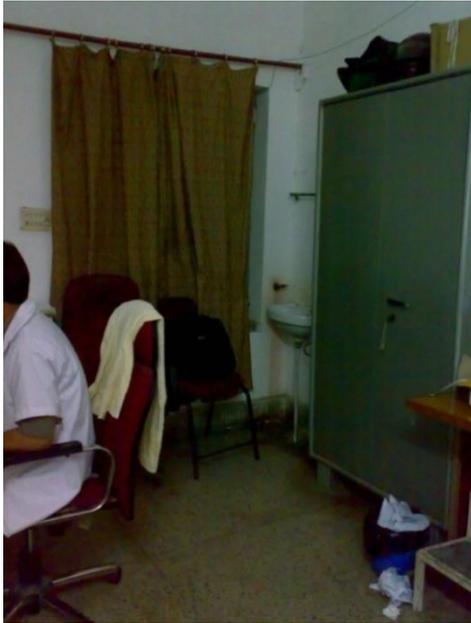
Fig. 14. Cupboard threatening life safety in cardiac section.

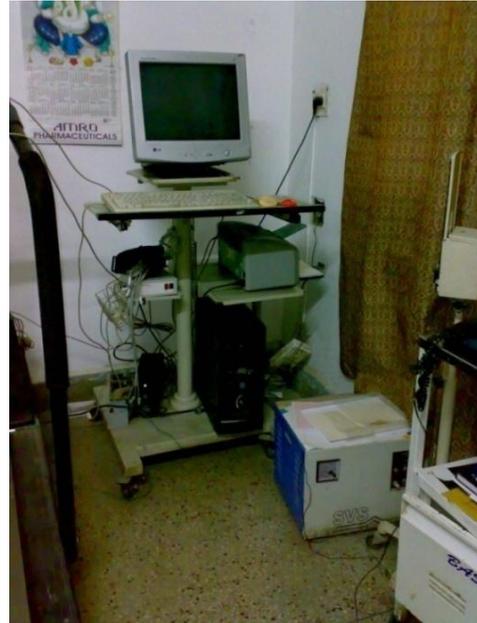
Fig. 15. Trolley mounted ECG equipment in the cardiac section.

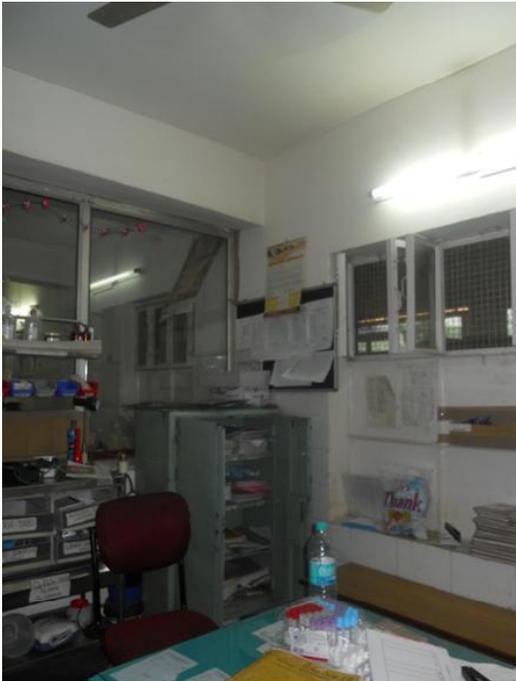
The supplies are observed to be placed on trolleys and the trolley mounted refrigerators contain emergency drugs (Fig. 16). These are required to be secured as their loss might disrupt the operational continuity of the ward. The oxygen cylinder and autoclaves machine also require proper anchorage (Fig. 17). Toppling and leakage from these cylinders can cause a major disaster.

Fig. 16. View of the supplies placed on trolleys in the nursing section of the neuro ward.

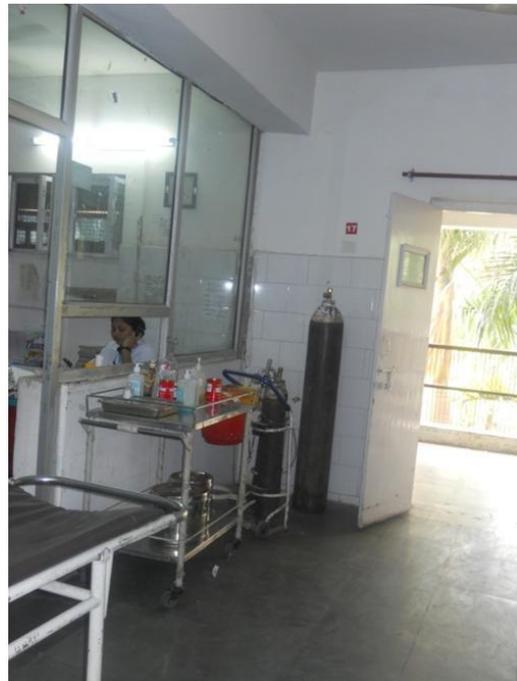
Fig. 17. View of unanchored oxygen cylinders.

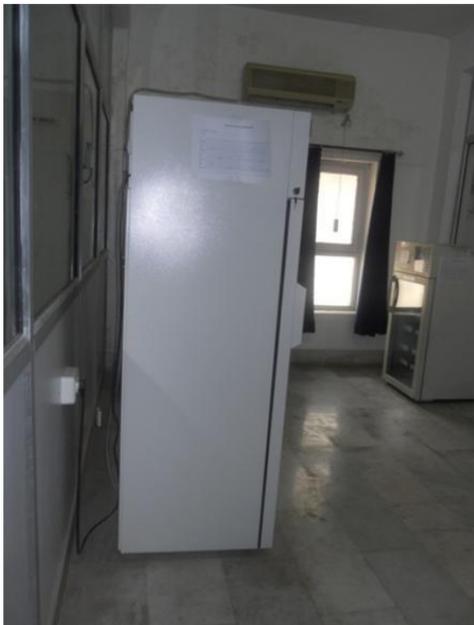
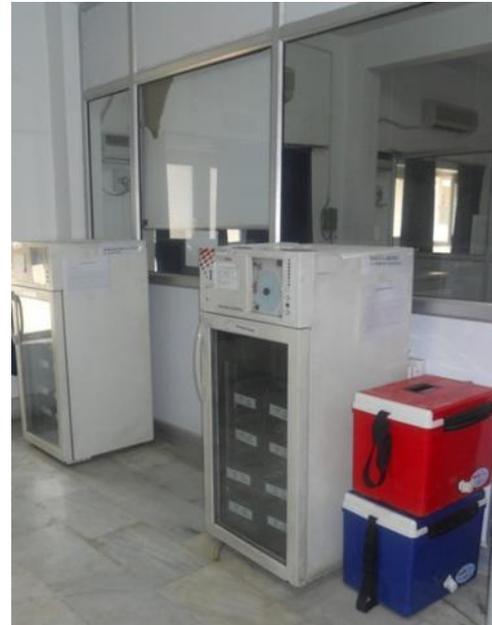
Figs. 18 and 19. View of unanchored refrigerator that is required to be anchored properly in blood bank section.

The main body of the refrigerators should be secured to the proximal wall. The oxygen cylinders are also observed to be placed alongside the trolley / racks without proper anchorage. Trolley mounted equipments and supplies placed on trolleys are required to be properly secured (Fig. 20). The cupboards placed close to the doors and refrigerators containing medicines are required to be relocated and secured (Fig. 21).

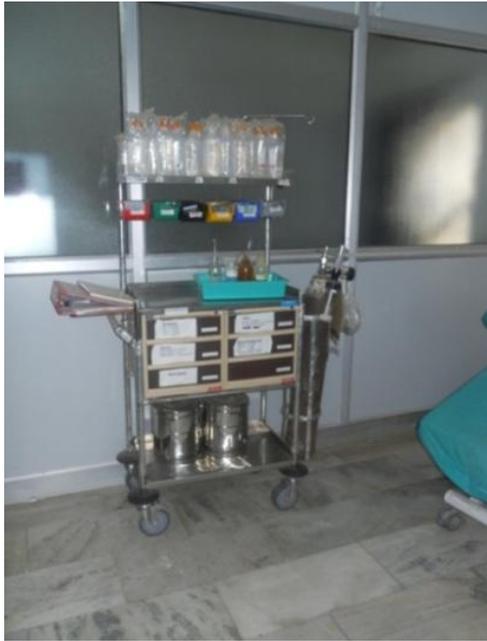
Fig. 20. View of the supplies on the trolley.

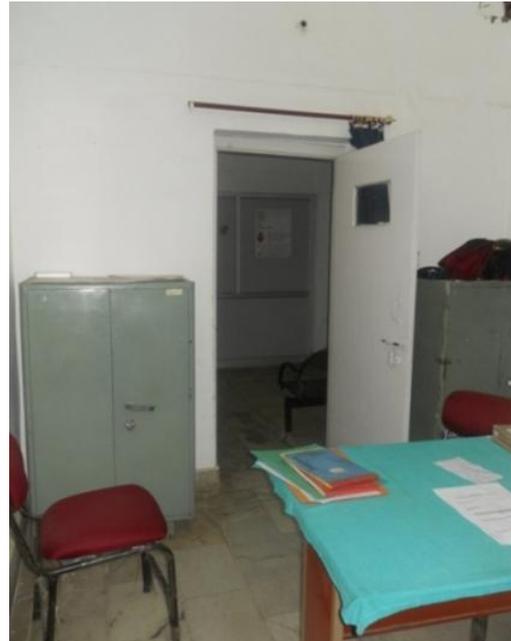
Fig. 21. The positioning of cupboards might block the exit.

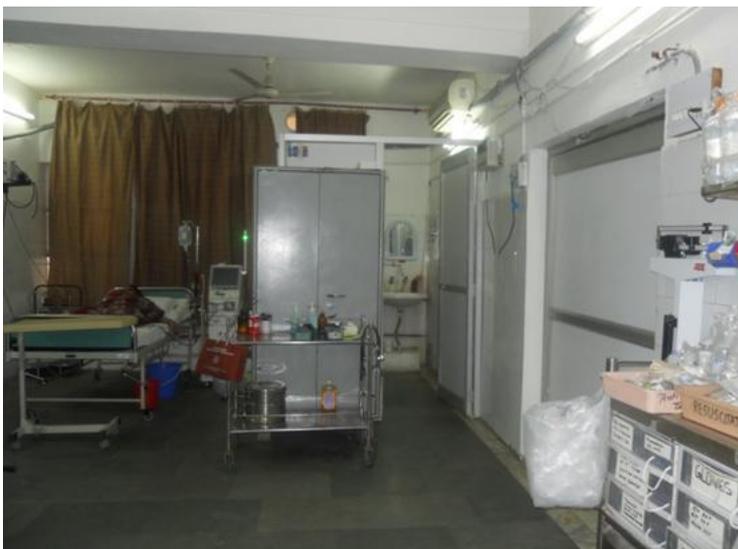
Fig. 22. View of the cupboard and the trolley containing supplies.

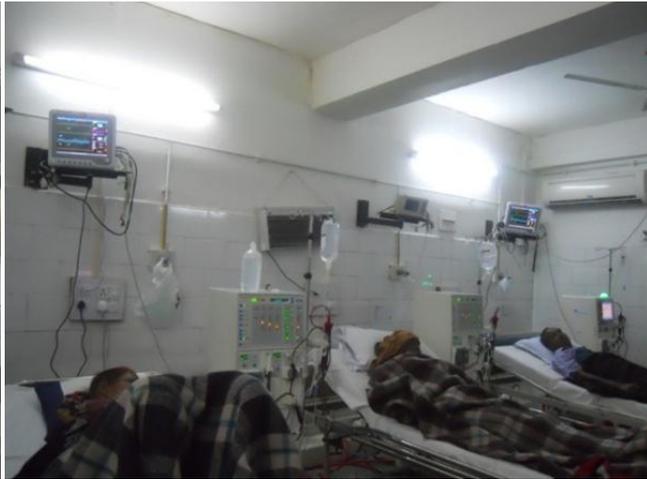
Fig. 25. View of the wall mounted monitors and others mounted on commercially available brackets but not properly secured to these.

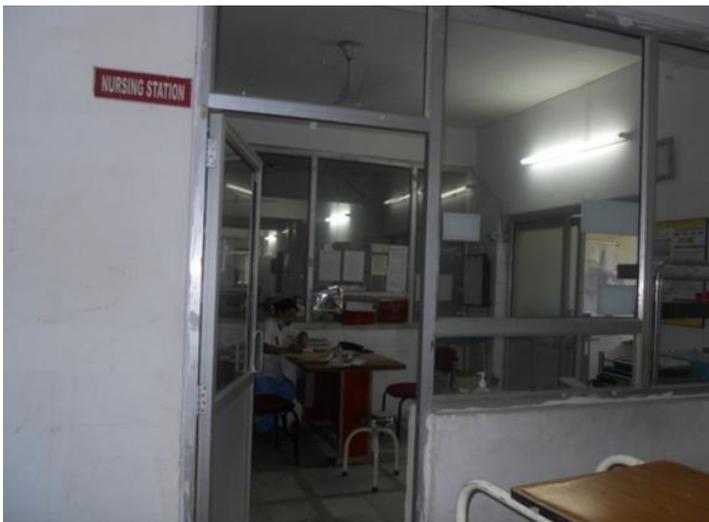
5.2.9 TB chest section: Supplies together with the emergency drugs are observed to be placed on trolleys without proper anchorage in the nursing station of the TB chest section (Fig. 26). Anchoring of the beds is required in the wards while the oxygen cylinders have to be secured and placed at alternative location.

Fig. 26. View of the Nursing station of the TB ward.

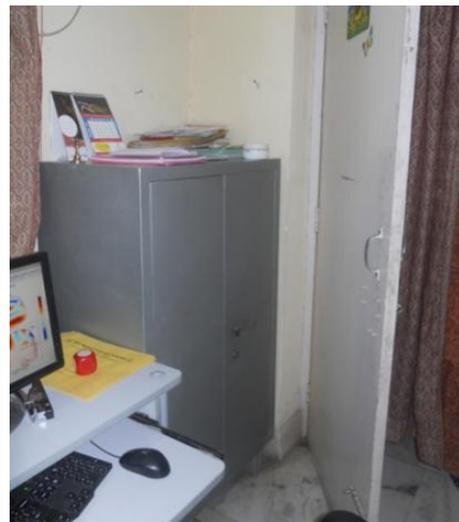
Fig. 27. View of the cupboard in EEG OPD that can lead to blockage.

5.2.10 EEG section: In the EEG OPD section the positioning of cupboards was observed to be such that their toppling during strong ground shaking could block the passage and hinder smooth movement (Fig. 27). These are therefore required to be relocated and anchored. Majority of the psychiatric wards located on ground floor were observed to be not occupied by patients regularly. The walls of the building have however developed cracks at many places and this has resulted in dampening of the walls. This problem needs to be fixed immediately as ignoring it might result in major structural problem.

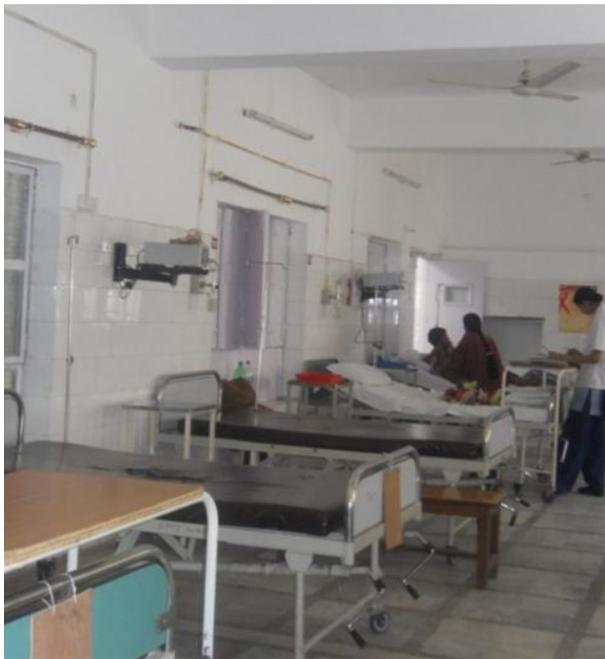
Fig. 28. The ENT section also have trolley based beds need to be anchored together with the ceiling fans.

5.2.11 ENT section: As in other sections of the hospital the ENT section wards also have problems related to anchoring of the beds together with trolley based equipments (Fig. 28). The placement of the refrigerator is such that it will block the exit route and also lead to loss of emergency drugs (Fig. 29). The need is to relocate and reposition along with anchorage.

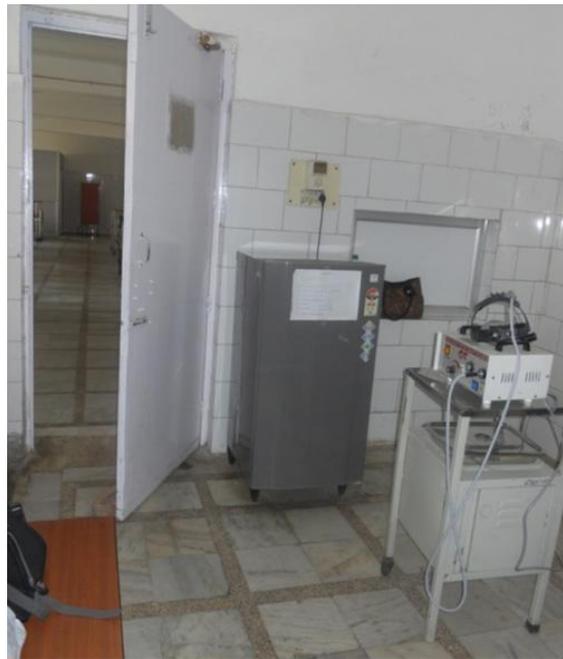
Fig. 29. The referigerators in the ENT section needs to be anchored.

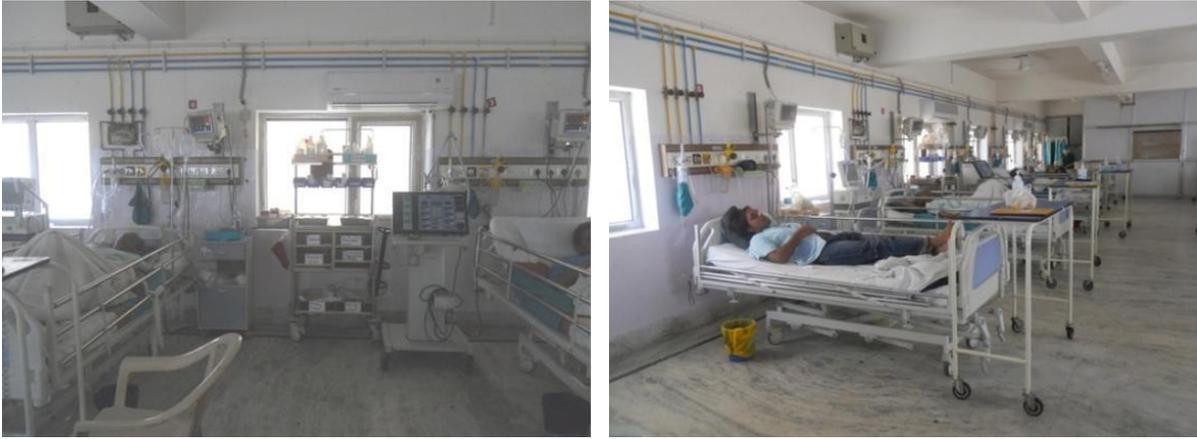
Figs. 30 and 31. View of the ICU section having a number of wall and trolley mounted equipments and storage facilities.

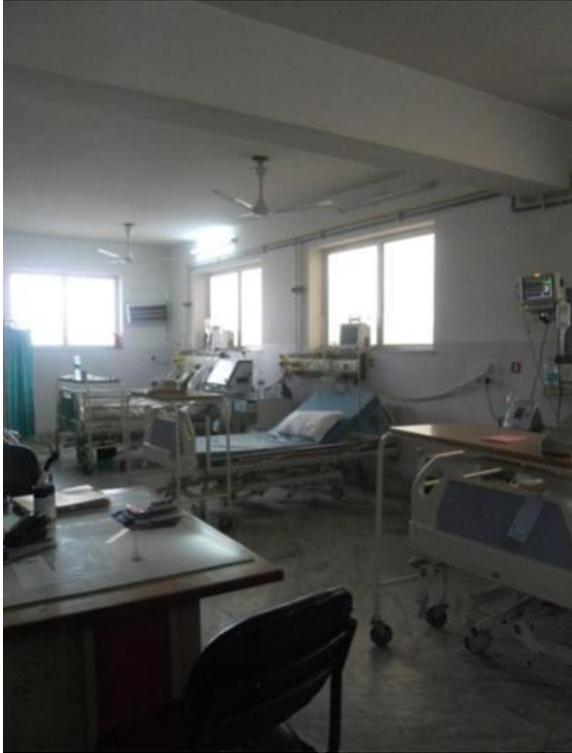
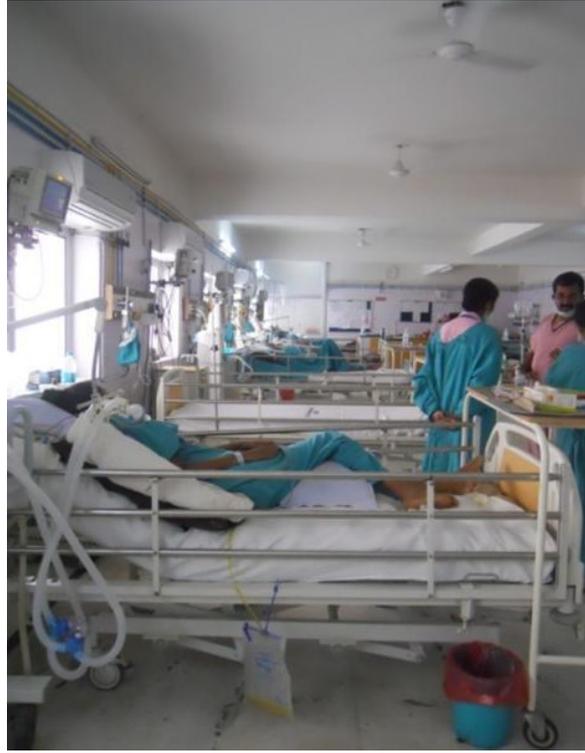
Figs. 32 and 33. View of the surgical ICU and R - ICU sections having wall and trolley mounted equipments.

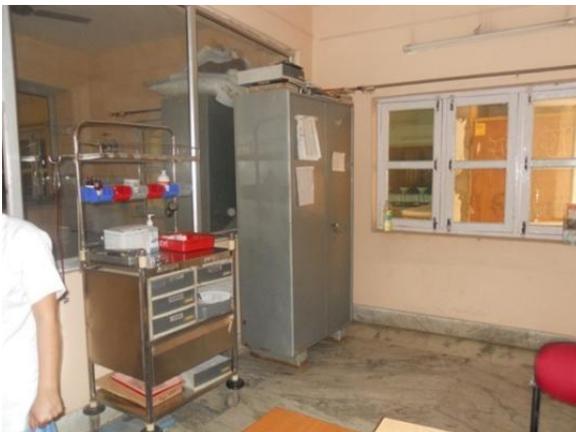
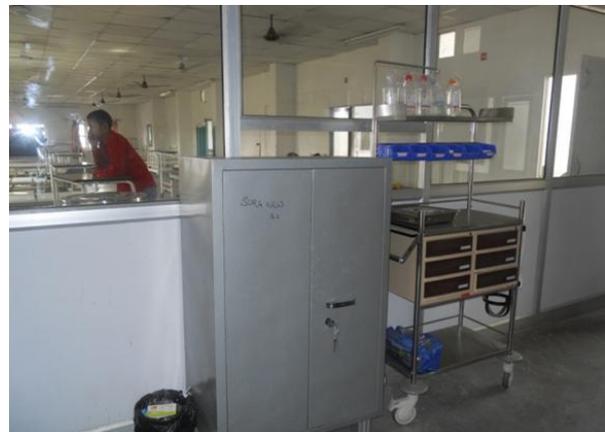
5.2.13 Nephro and eye section and private ward: In comparison to the ICU the nephro section has low vulnerability. This is largely attributed to lesser number of equipments and not so heavy rush of the patients. The placement of refrigerator in the nursing station of the nephro ward is however a cause of concern as it can lead to blockage of the exit route. Anchoring is also required for the trolley containing the supplies and the cupboards. L - brackets or steel angle can be used for securing the cupboards with the wall (Figs. 34 and 35).

Figs. 34 and 35. View of the nephro section having supply trolley as also unanchored cupboards.

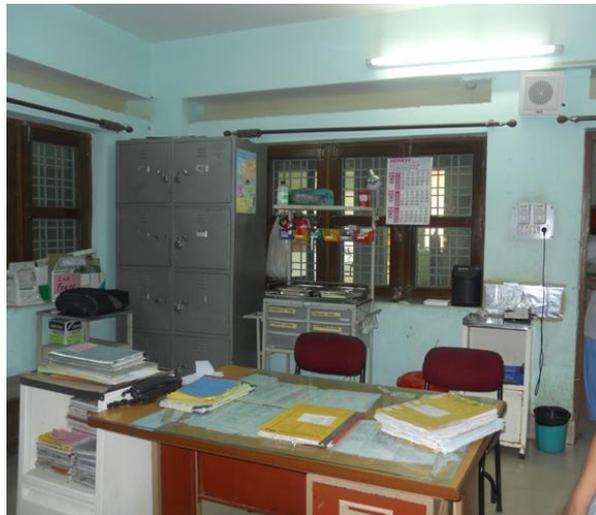
Fig. 36. View of the reception section of the private ward showing unsecure trolleys and cupboards.

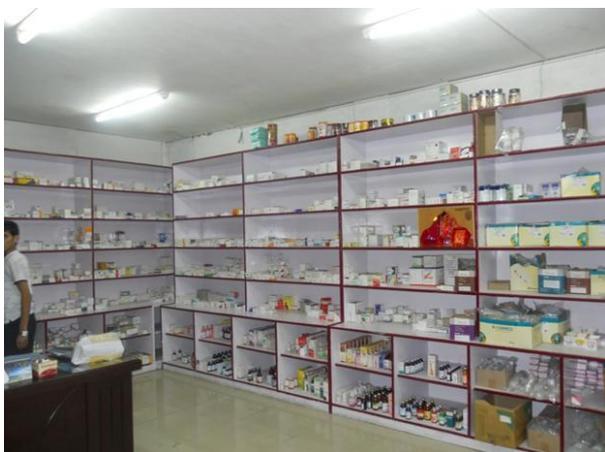
Fig. 37. View of the chemist shop of the hospital.

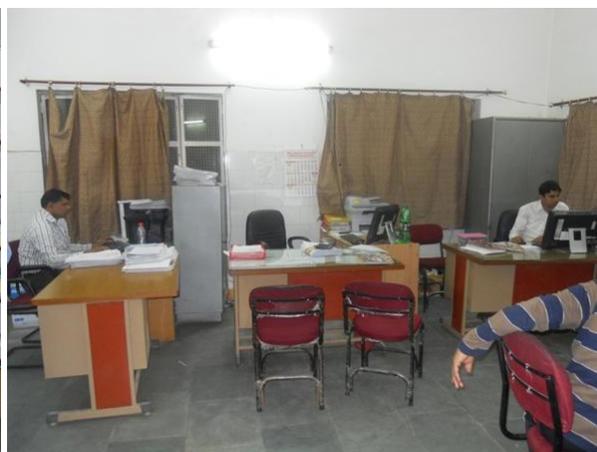
Fig. 38. View of the staff room with unanchored non-structural elements. Toppling of cupboards can hurt the staff members.

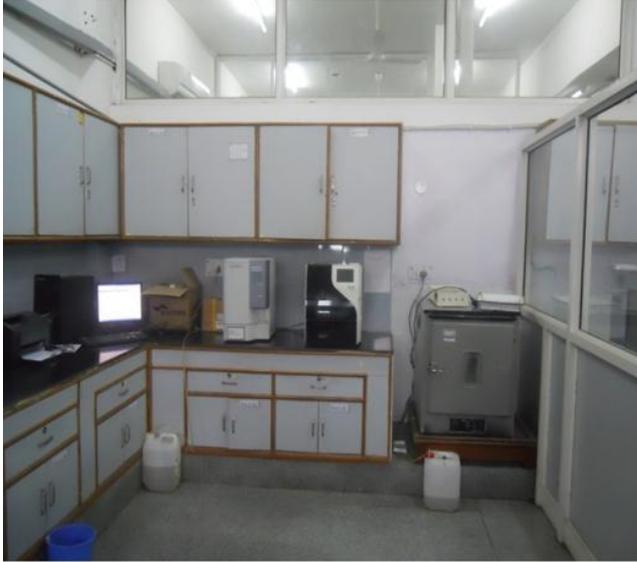
Fig. 39. View of the bench mounted equipments together with file cabinets.

walls using L – brackets (Fig. 39) while the cupboards can be repositioned and anchored to rule out possibility of blockage of passage ways (Fig. 40).

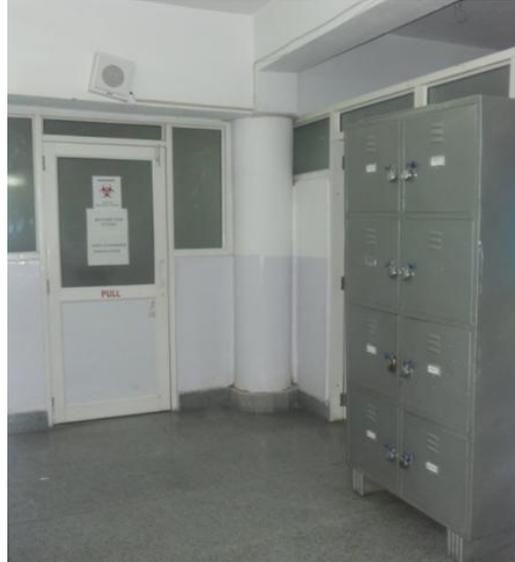
Fig. 40. Toppling of the of cupboard can cause blockage of exit routes.

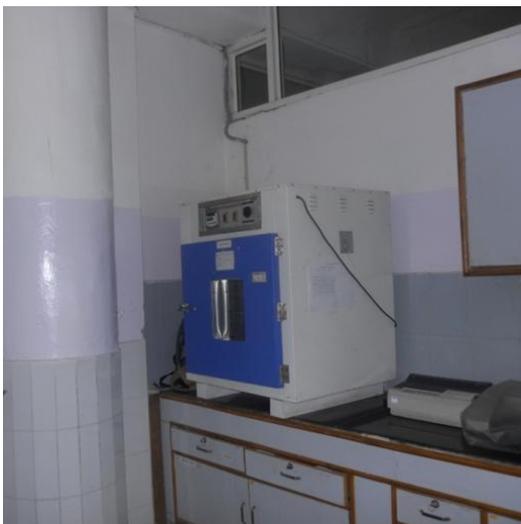
The incubator in all the sections is heavy machinery which is observed to be placed without proper support system or anchorage (Fig. 41). Automatic analysers are heavy equipment observed to be placed without proper anchorage. Damage to these equipments during intense ground motion is sure to adversely affect the operational capability of the hospital. The placement and anchoring of the cupboards and freezers also needs to be revisited (Figs. 42, 43 and 44).

Fig. 41. View of the incubators need to be fixed with the help of L brackets.

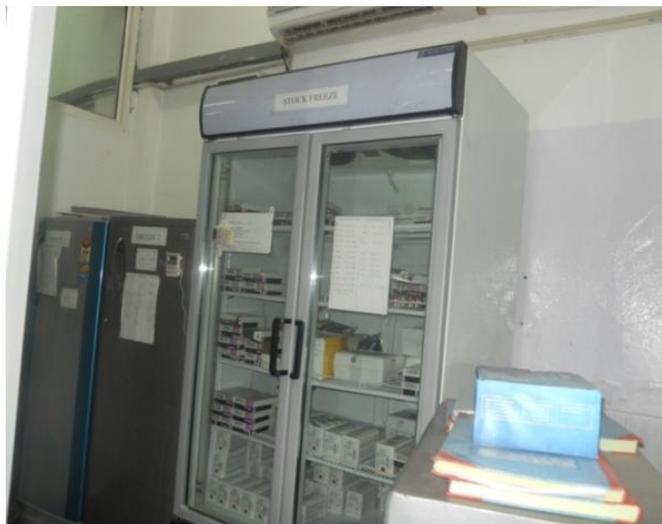
Fig. 42. View of the unanchored freezers in the medical laboratory.

The heavy equipments in the laboratory include fridges, and stock freezers. These are required to be anchored to avoid losses and injury. The anchoring with the help of brackets and angles need to be provided at the base with the floor as also at the top with the wall.

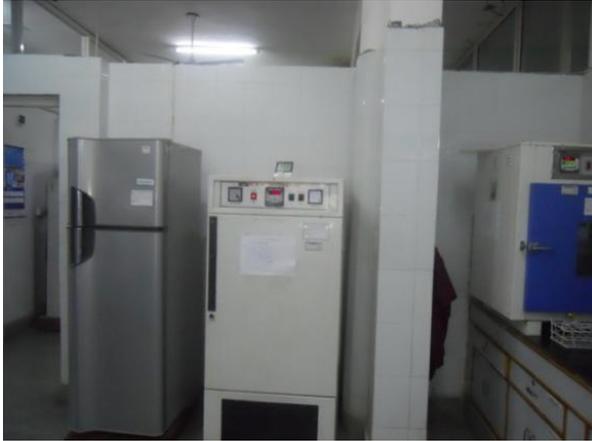
Fig. 43. View of the incubators need to be fixed with the help of L - brackets.

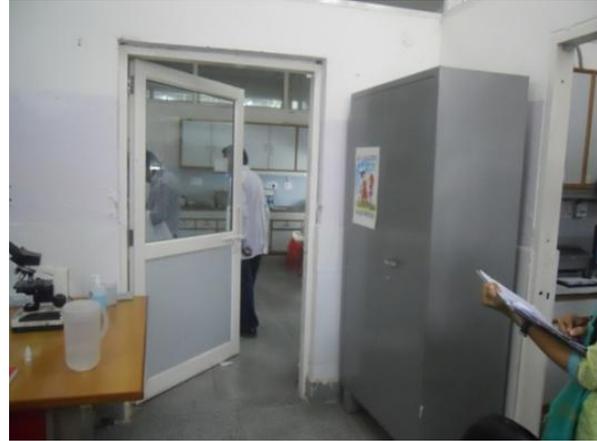
Fig. 44. View of the placement of cupboard in the microbiology section that can lead to the blockage of exit routes.

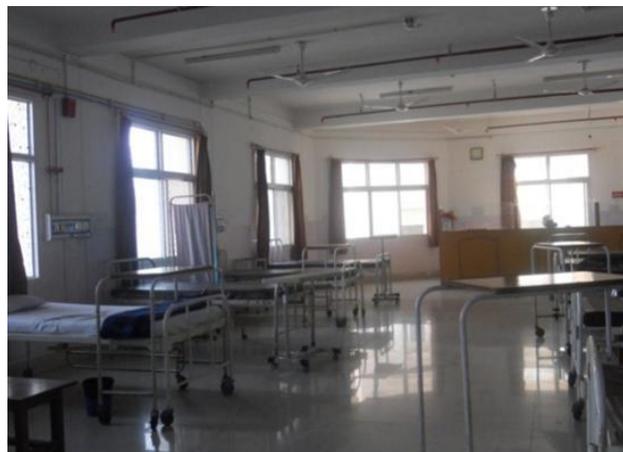
5.2.16.2 Orthopaedic and radiology sections: The orthopaedic ward located in the new building has minimal equipments and machinery and therefore it is not highly vulnerable. The wheel mounted beds and fans over the patient beds are required to be properly secured together with racks and oxygen cylinders (Fig. 45).

Fig. 45. The ceiling fans need to be anchored along with emphasis on trolley based beds.

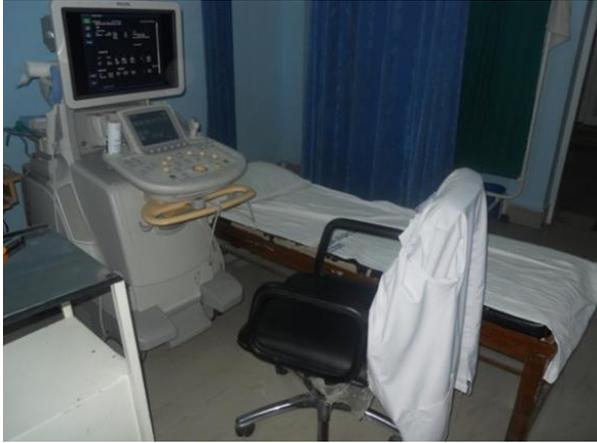
Fig. 46. View of the radiology section having unsecured equipment that can easily topple during intense ground motion.

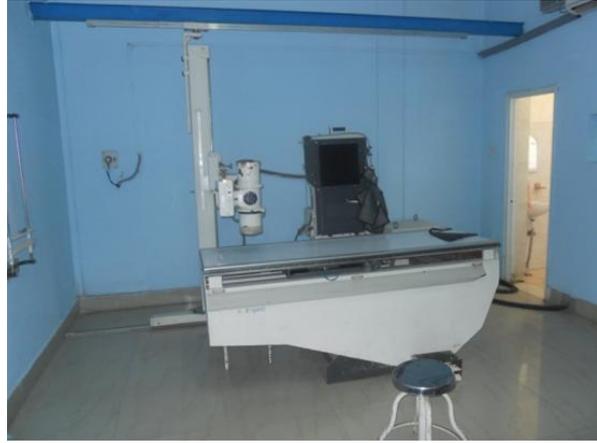
Fig. 47. View of the X - ray machine which needs proper check for the present anchorage made to the floor

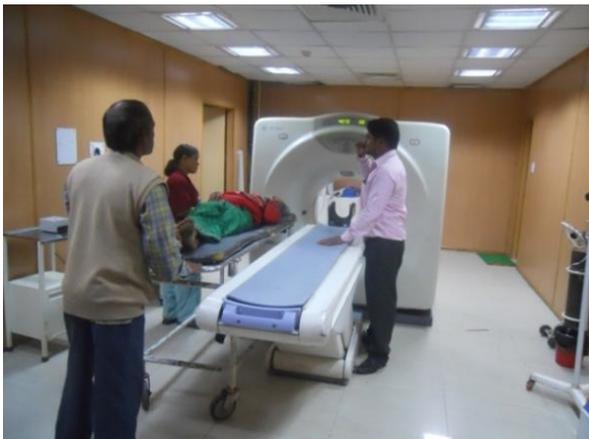
Fig. 48. View of the unanchored equipment in the CTMRI Section

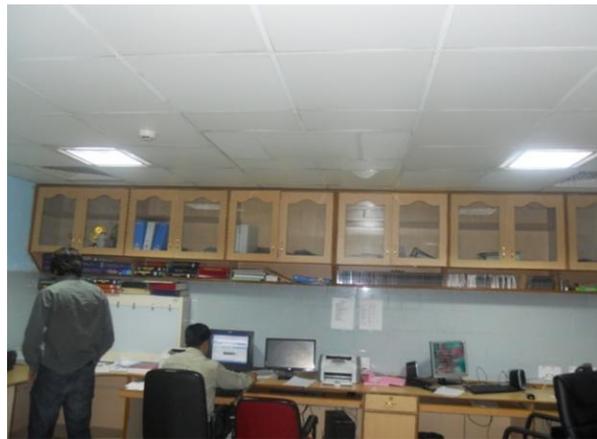
Fig. 49. View of the unanchored file cabinets.

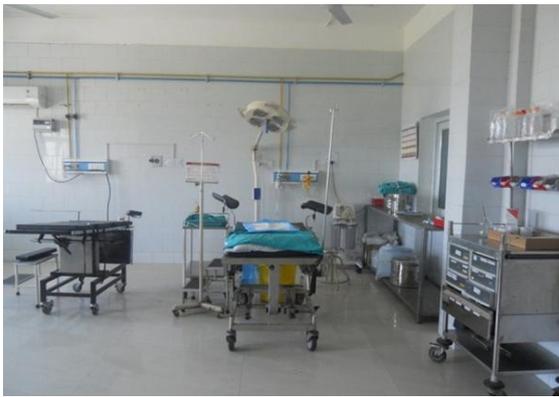
5.2.16.3 Obstetrician and Gynaecology section: This section contains relatively less equipments and it is therefore less vulnerable. Operation table (OT) is the main concern in this section. OT lights in the labour room are observed to be wheel mounted and are therefore required to be anchored together with the trolley containing supplies (Fig.50).

Fig. 50. View of the wheel mounted lights and supply trolley in the labour room.

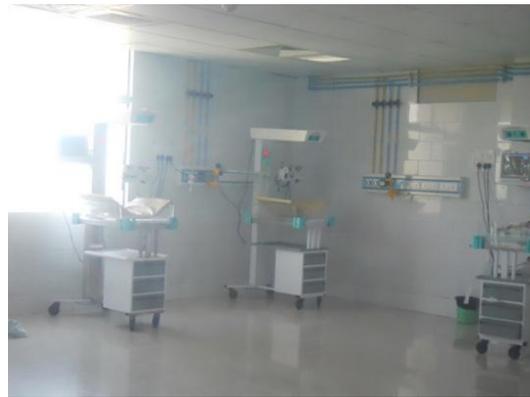
Fig. 51. View of NICU with wheel mounted incubators placed close to the windows.

5.2.16.4 NICU (Neonatal Intensive Care Unit): This unit is dedicated to the care of ill or premature newborn infants. Babies were observed to be placed in wheel mounted incubators which makes the unit critical with regard to its non - structural vulnerability. At the same time the placement of incubators by the side of the windows needs to be avoided (Fig. 51). Incubators are therefore required to be anchored and placed differently.

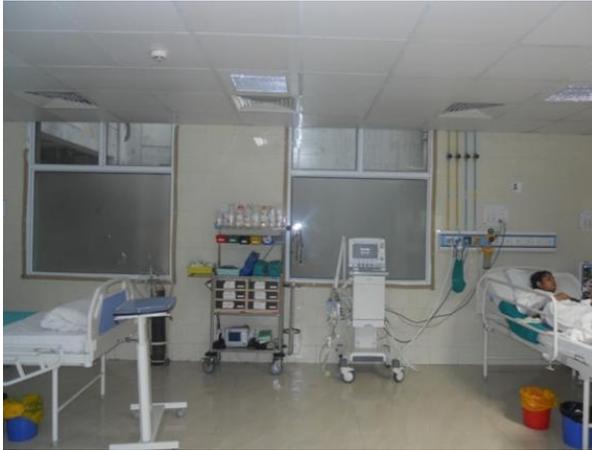
Fig. 52. View of the PICU showing unsecured trolleys and other wheel mounted equipments.

5.2.16.5 PICU and paediatric ward section: The PICU is adjacent to the NICU. Wheel mounted equipments were observed in this unit. These include supply trolley and monitors (Fig. 52). These are required to be anchored properly so as to avoid their slippage during intense shaking. In comparison to this the paediatric ward has minimal medical equipments and the only concern is the anchorage of the ceiling fans and wheel mounted beds (Fig. 53).

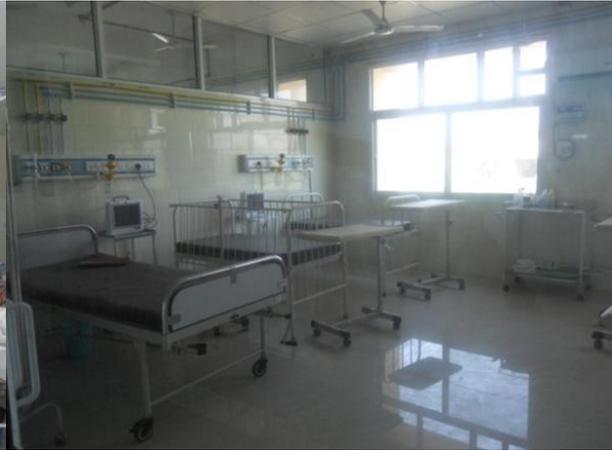
Fig. 53. View of paediatric section.

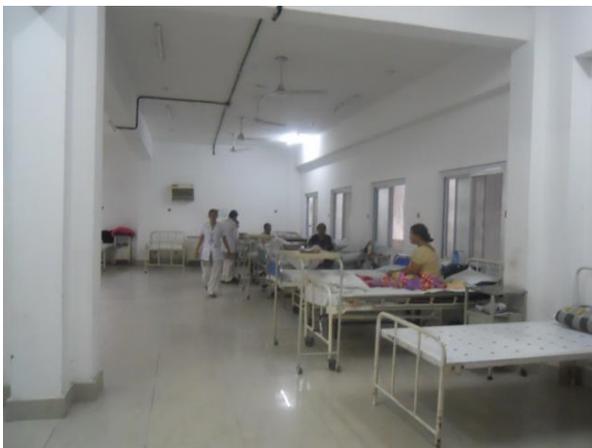
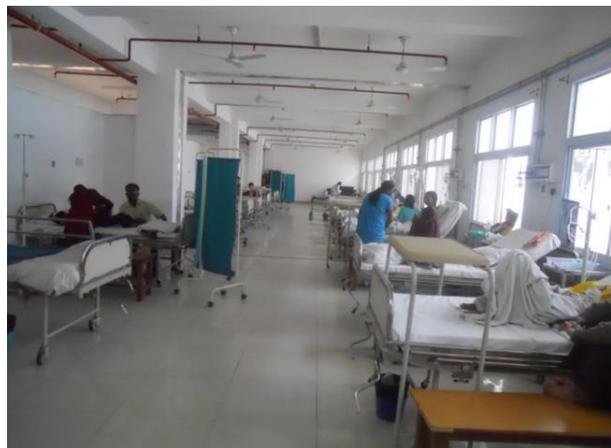
Figs. 54 and 55. View of medicine and surgery wards where ceiling fans and oxygen cylinders are required to be anchored.

in the wards. These are required to be properly anchored. The medicine and surgery wards were observed to house many patients and therefore simple mitigation measures must be implemented to reduce the risk (Figs. 54 and 55). The private ward also falls under low vulnerability.

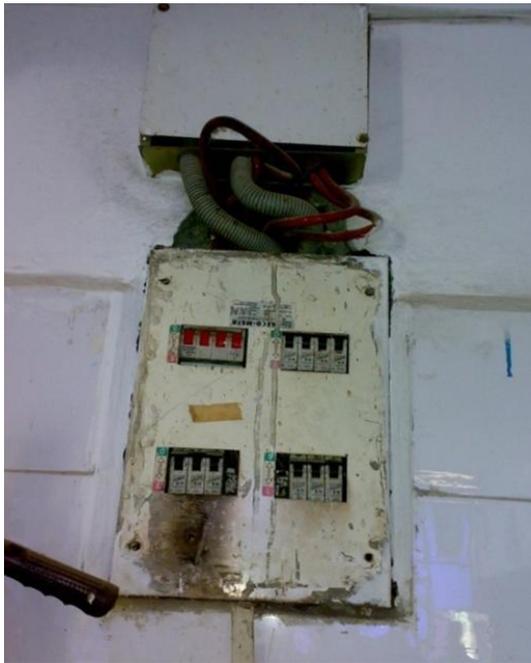
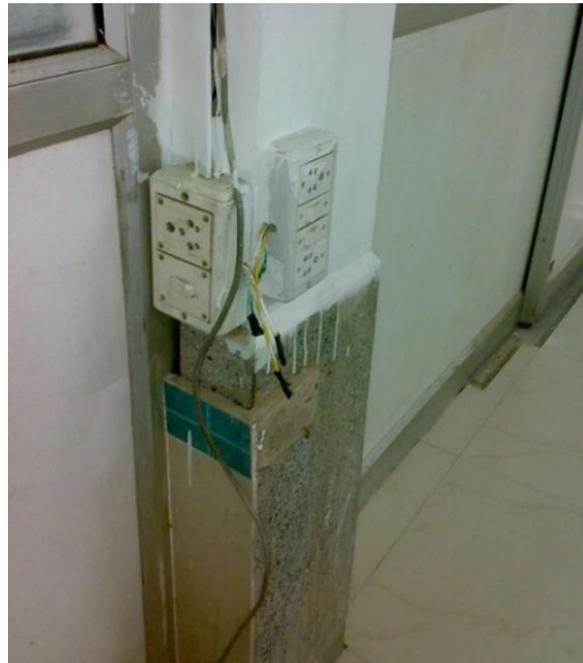
The problems relating to these aspects were observed to be similar in almost all the sections. Lack of proper conduits was universally observed. The conduits were observed to be broken at many places. Damage to the conduits could shut down power or even cause fire hazard. Main circuit breaker (MCB) boxes were observed to be open at many places in different sections. Lack of proper wiring in the emergency ward can lead to short circuit (Figs. 56 and 57). The dressing of the conduits was observed to be improper, particularly near the distribution boxes (DBs) at many places.

Figs. 56 and 57. View of the emergency ward showing lack of proper conduiting, damaged cover and open wiring.

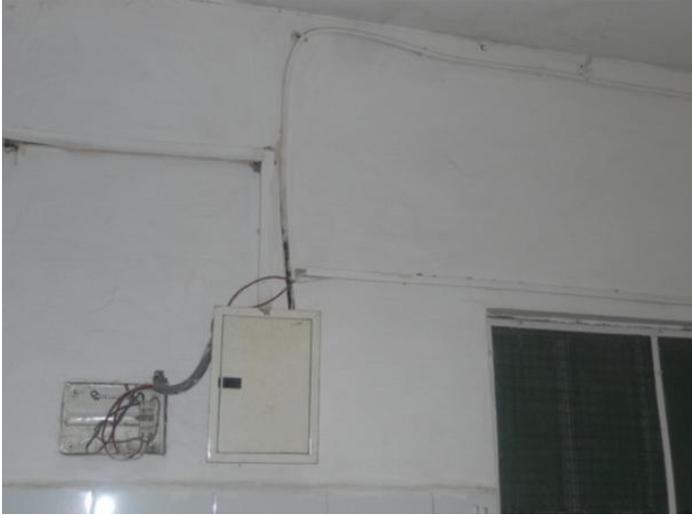
Fig. 58. View of the DB with the cover plate either absent or damaged.

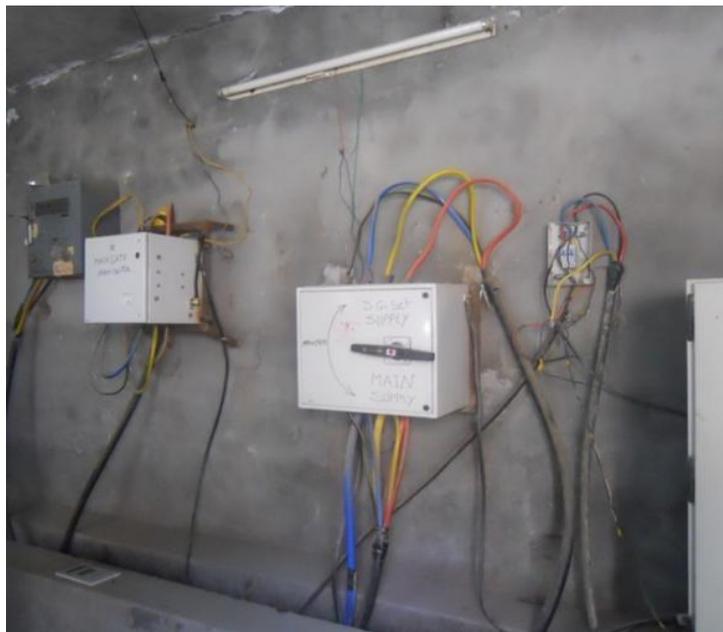
Fig 60 . View of the main electric control panel of the hospital.

The main electric supply unit and the control panels of the hospital are located in the front side of the hospital (Fig. 60). Main distribution boards of the electric control panel located in the front section of the hospital building premises need proper anchorage. The dressing and clipping of the inlet and outlet cables was observed to be missing in some boxes. This needs to be fixed immediately to avoid any type of short circuit in the main control panel area.

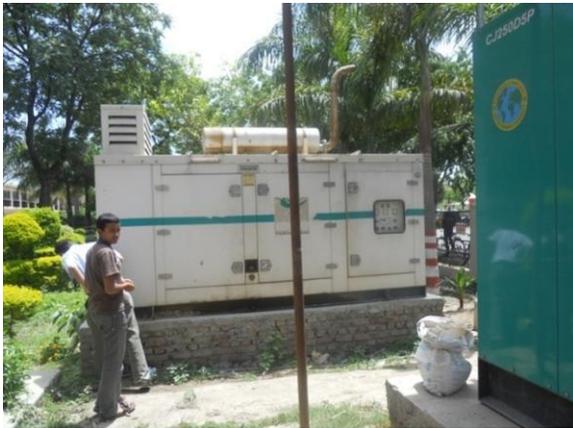
Fig. 61. View of the generator that has been kept in open without anchoring the same to the ground and without proper shade.

The generators were observed to be housed without proper shed and framing (Fig. 61). These are required to be provided to ensure smooth electric supply even in case of a major emergency. This would at the same time protect these from direct sunlight and rain. Proper dressing of the cables in the panel room was observed to be missing. These have to be fixed properly at places. The generator has also to be anchored properly to the ground to avoid the danger of its falling down (Fig. 62).

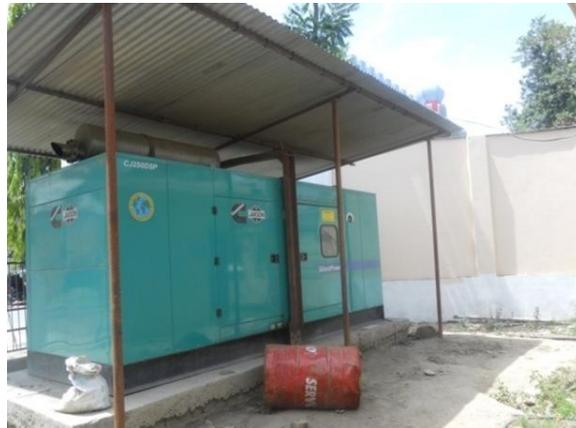
Fig. 62. View of the generator requiring anchorage at the base.

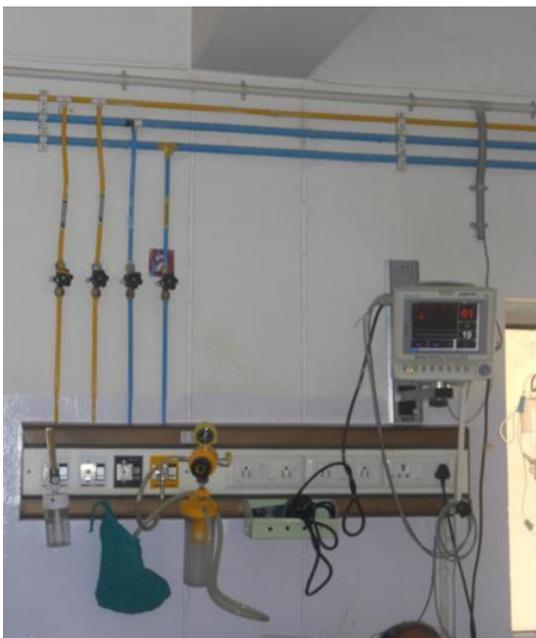
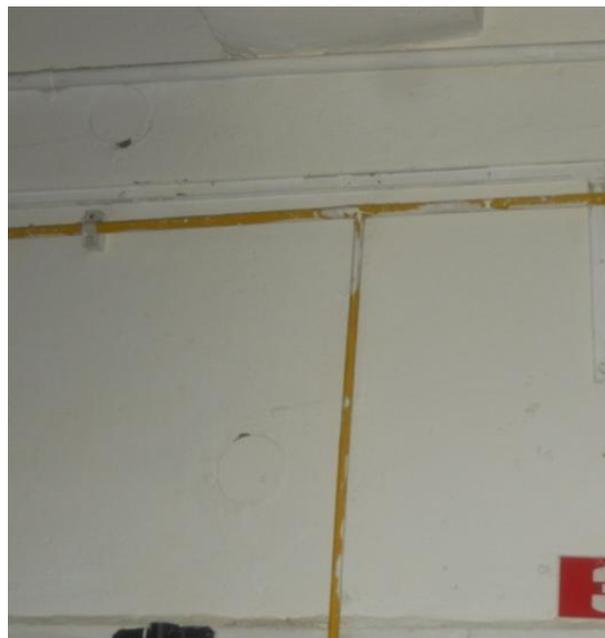
Figs. 65 and 66. View of unanchored T - junctions of oxygen and suction lines in the hospital.
