Non – structural seismic
vulnerability assessment of
Mahant Indires h hospital,
Dehradun (Uttarakhand)

**Disaster Mitigation and
Management centre**

July 2012

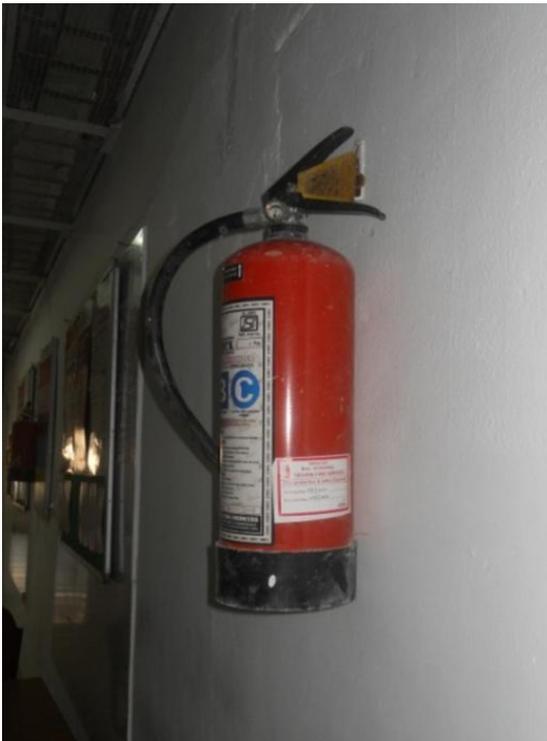
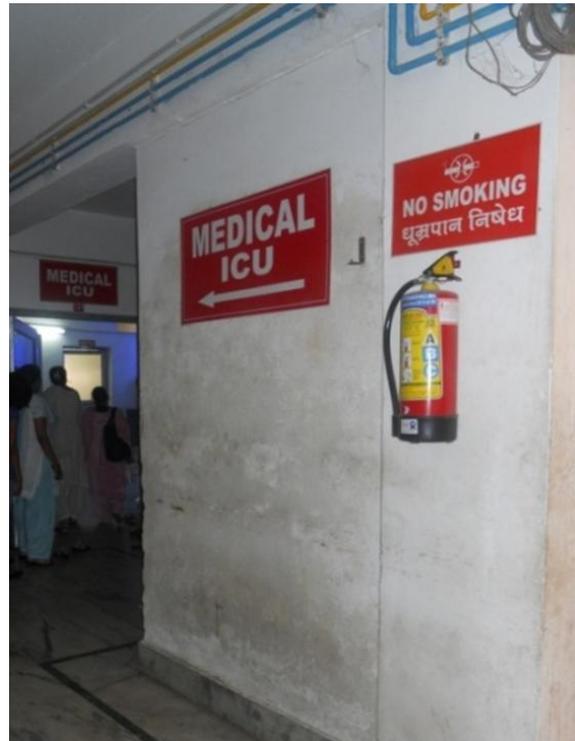
Figs. 67 and 68. The fire extinguishers must be anchored with the help of chains and to the wall at the base.

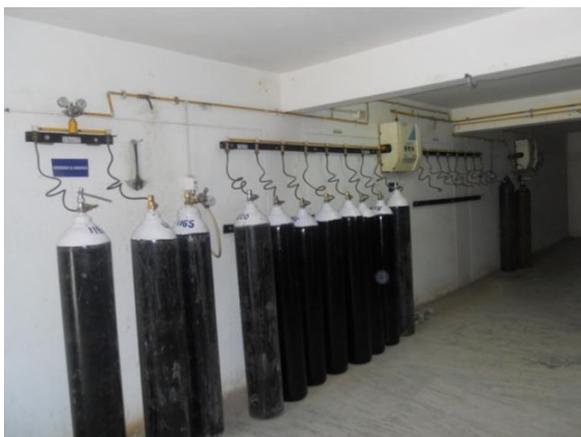
Fig. 71. View of the oxygen cylinders without proper anchorage in the CSSD section.

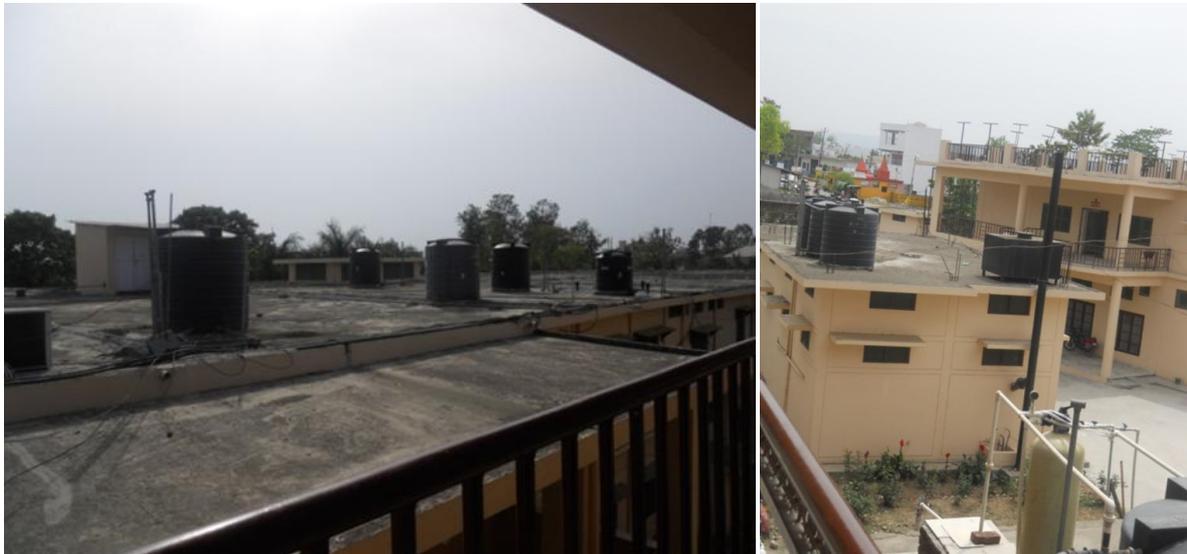
Figs. 73 and 74. View of the water tanks placed on the roof of the various sections of the hospital.

The overhead water tanks placed on the roofs were observed to be without any anchorage. All the tanks are required to be provided with proper anchoring and framing (Figs. 73 and 74).
