# **Investigations in the Asi Ganga valley on the aftermath of flash flood / landslide incidences in August, 2012**

## **A report**

**Disaster Mitigation and Management Centre  
Department of Disaster Management  
Uttarakhand Secretariat  
Dehradun - 248 001**

**October, 2012**

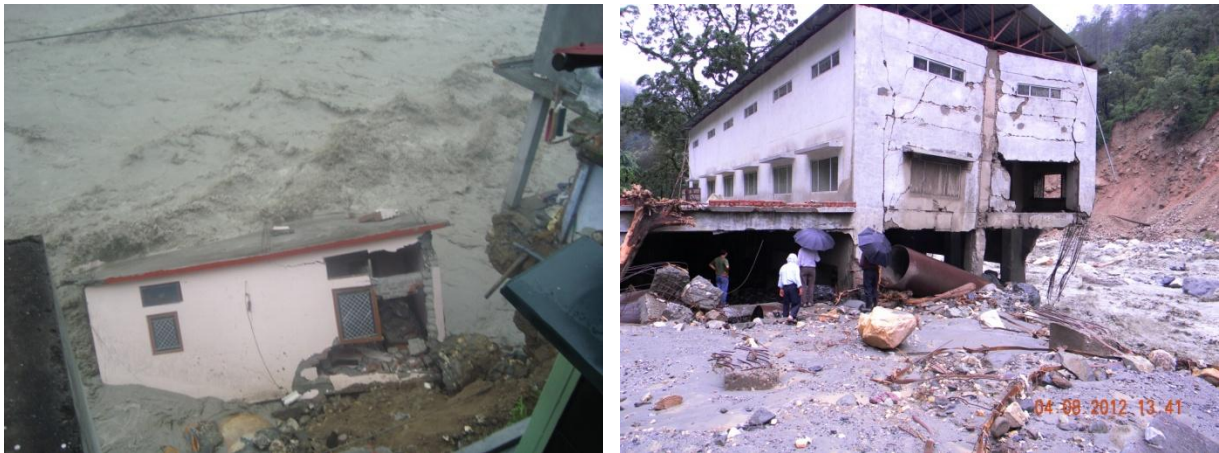
**Figs. 3 and 4. Photographs depicting devastation by flash flood in Uttarkashi.**

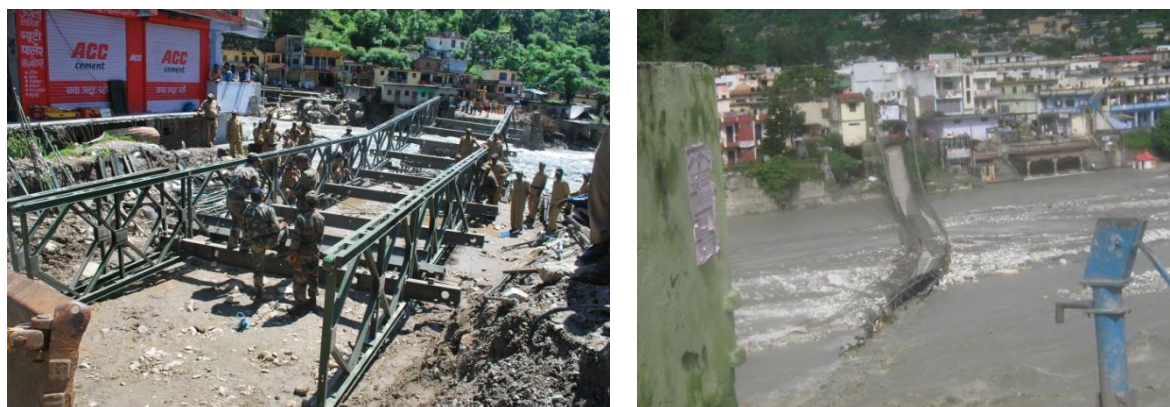
**Figs. 5 and 6. View of the bridges damaged by the flash flood in Uttarkashi.**

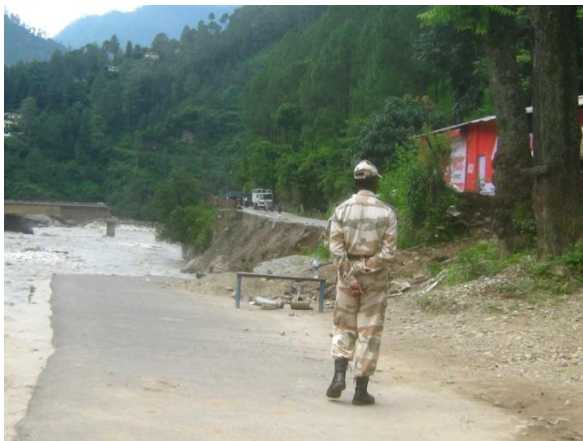
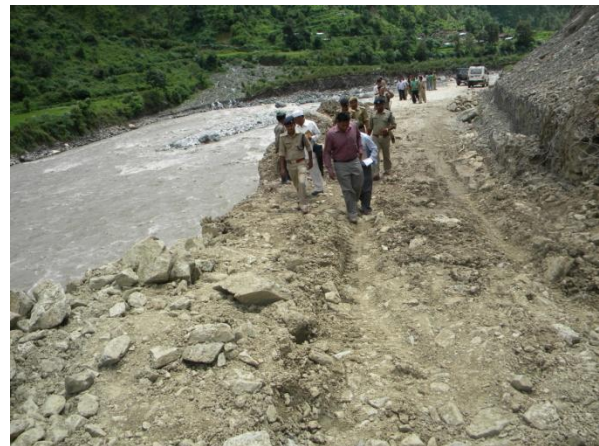
Transport sector was hit particularly hard by landslide and flash flood events (Fig. 7 and 8). Rishikesh - Gangotri National Highway, along with link roads were disrupted and the State Government had to strive hard to maintain normal supply of essential commodities in the remote areas. The summary of traffic disruption along the Char Dham Yatra route is enough to highlight the situation (Table 1). It is worth noting that both the National Highways of Uttarkashi; Gangotri and Yamonotri, remained closed all through in the month of August.

**Figs. 7 and 8. View of the roads damaged by the flash flood in Uttarkashi.**

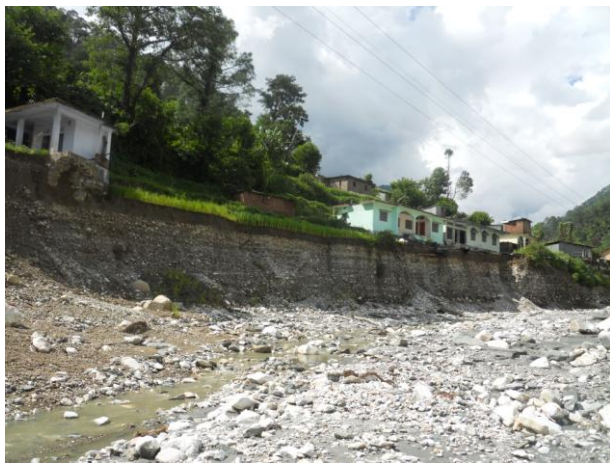
Abnormally high sediment laden discharge of Asi Ganga has eroded the terrace on its right bank and has also completely damaged the approach road to power house. Terraces are observed to have been cut vertically by Asi Ganga. An eroded terrace with around 3.0 m vertical cut is observed on the right bank of Asi Ganga. Some houses on this destabilized terrace have not been destroyed but the possibility of these being affected by continuing erosion of the terrace cannot be ruled out. These are therefore required to be relocated.

**Fig. 14. Photograph depicting the state of houses on the eroded terrace together with the damaged approach road to the power house on the right bank of Asi Ganga at Gangori.**

***Mitigation measures:*** In this area there exist several severely damaged structures located on extremely critical slopes that are continuously threatened by bank erosion by Asi Ganga. These are required to be removed immediately.

Construction of concrete slabs / retaining structures of appropriate height is recommended so as to prevent the toe cutting / bank erosion by Asi Ganga. It would help in protecting the bank of Asi Ganga as also rest of the village. It is recommended that construction / anthropogenic intervention in the area in close proximity of the river channel be strictly banned. This applies equally for all other areas including Uttarkashi town. For this detailed survey of the area and identification of high risk prone zones is recommended.

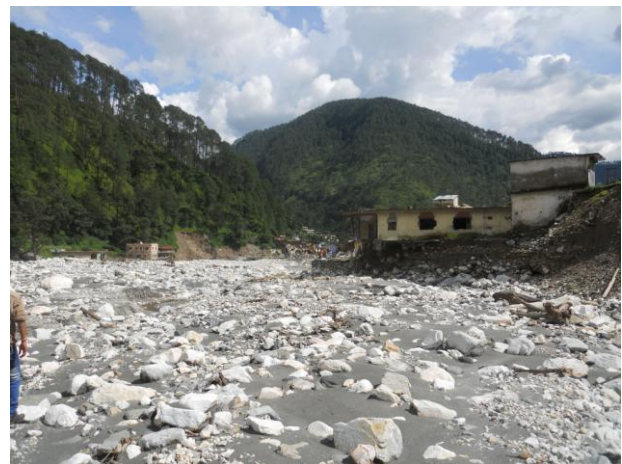
**Fig. 15. Photograph depicting the state of houses located on the eroded terrace of Asi Ganga on its right bank. Even though spared by the present tragedy these houses pose a major risk due to the instability of their foundations.**

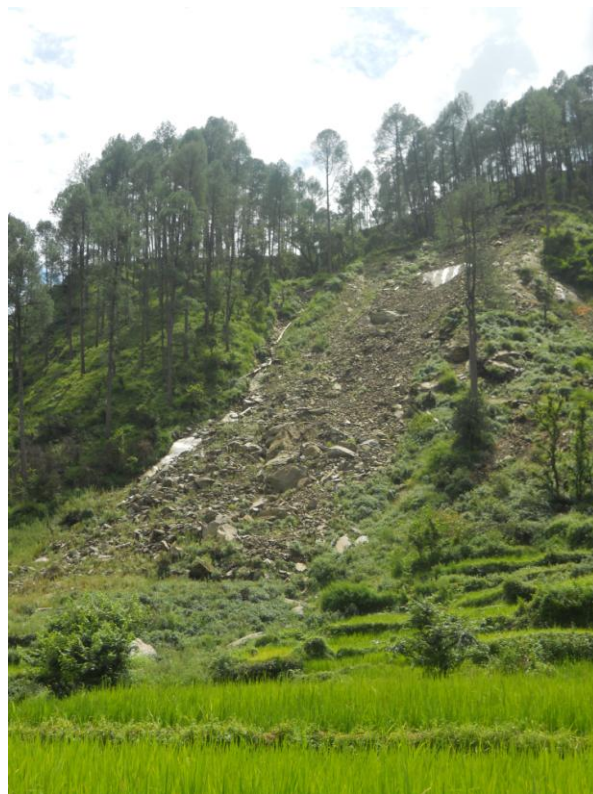
The rock slide is observed to have occurred on the northeastern slope of E-W trending ridge. The inclination of failure slope is observed to be  $35^{\circ}$ . Around the crown of the failure the inclination is around  $45^{\circ}$ . The width of the failure slope is about 35 m along the cultivated fields and height of the crown from cultivated fields is about 85 meters (Fig. 16).

No indications of major slope instability towards the village as also towards the valley side were observed during the field investigations. There are two large benches of cultivated fields that would prevent the dislodged mass from causing any major damage. There is no threat to the village from the slide.

**Fig. 16. Photograph depicting rock slide zone uphill of agricultural lands in Utron.**

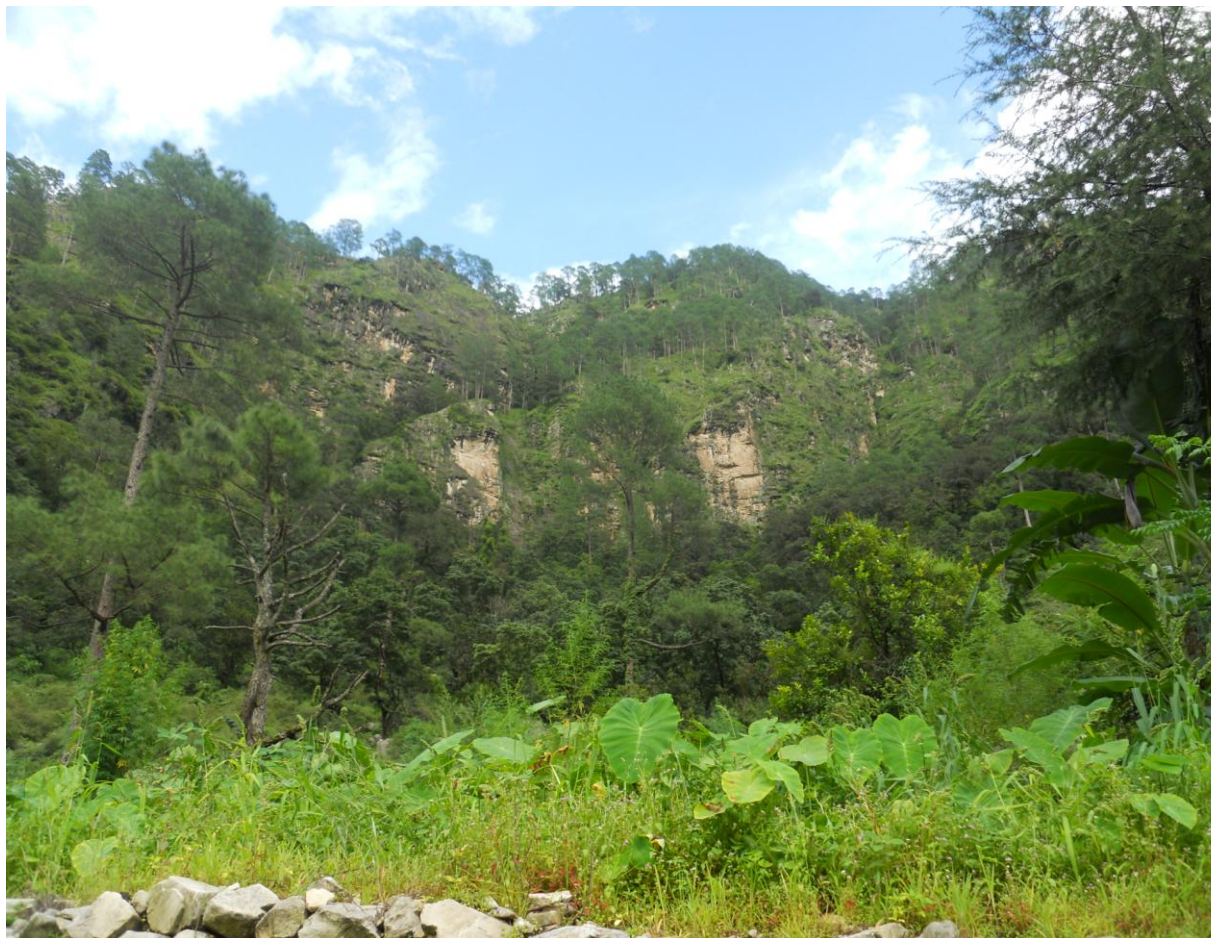
Back slope of the area around the village is observed to be a vertical rocky scarp. Four seasonal streams are observed to descend from that very steep rock cut slope and these contribute to the instability of the area (Fig. 17).

**Fig. 17. Photograph showing the vertical rocky cut slope above the village along which the seasonal streams come down.**

***Mitigation measures:*** The streams towards the eastern as also upslope side of the village are required to be diverted along a gully into the main stream with suitable gradient towards southeast. This would help in protecting the village from excessive rise in pore water pressure during the monsoons.

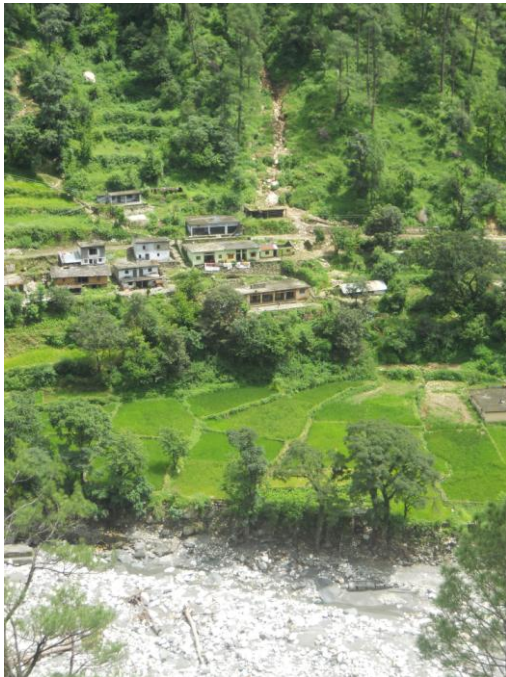
The slope failure is observed to have occurred on the southwestern slope of Rawara village. The width of the failure slope is about 8.0 m along the road and height of the crown from the road is about 18.0 meters. The inclination

of failure slope is observed to be  $35^\circ$  and the debris is observed to have partially damaged a house (Fig. 18).

**Fig. 18. Photograph depicting the debris slide upslope of the road with partially damaged structure.**

***Mitigation measures:*** Adequately designed stepladder buttress structures are required to be erected to prevent the slope failure. This would protect the area.

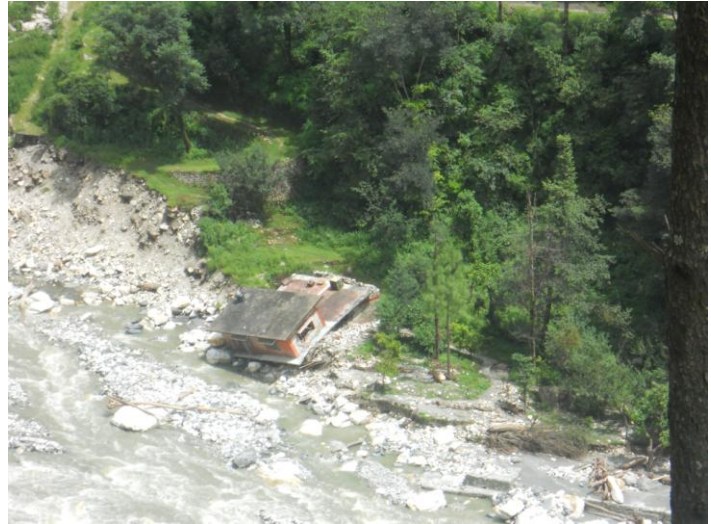
On the left bank of Asi Ganga a structure is observed to be completely destroyed due to flash floods (Fig. 19).

**Fig. 19. Photograph depicting completely destroyed structure on the left bank of Asi Ganga.**

Damaged structures are required to be removed from the left bank of Asi Ganga and construction of structures in close vicinity of the river should be banned.

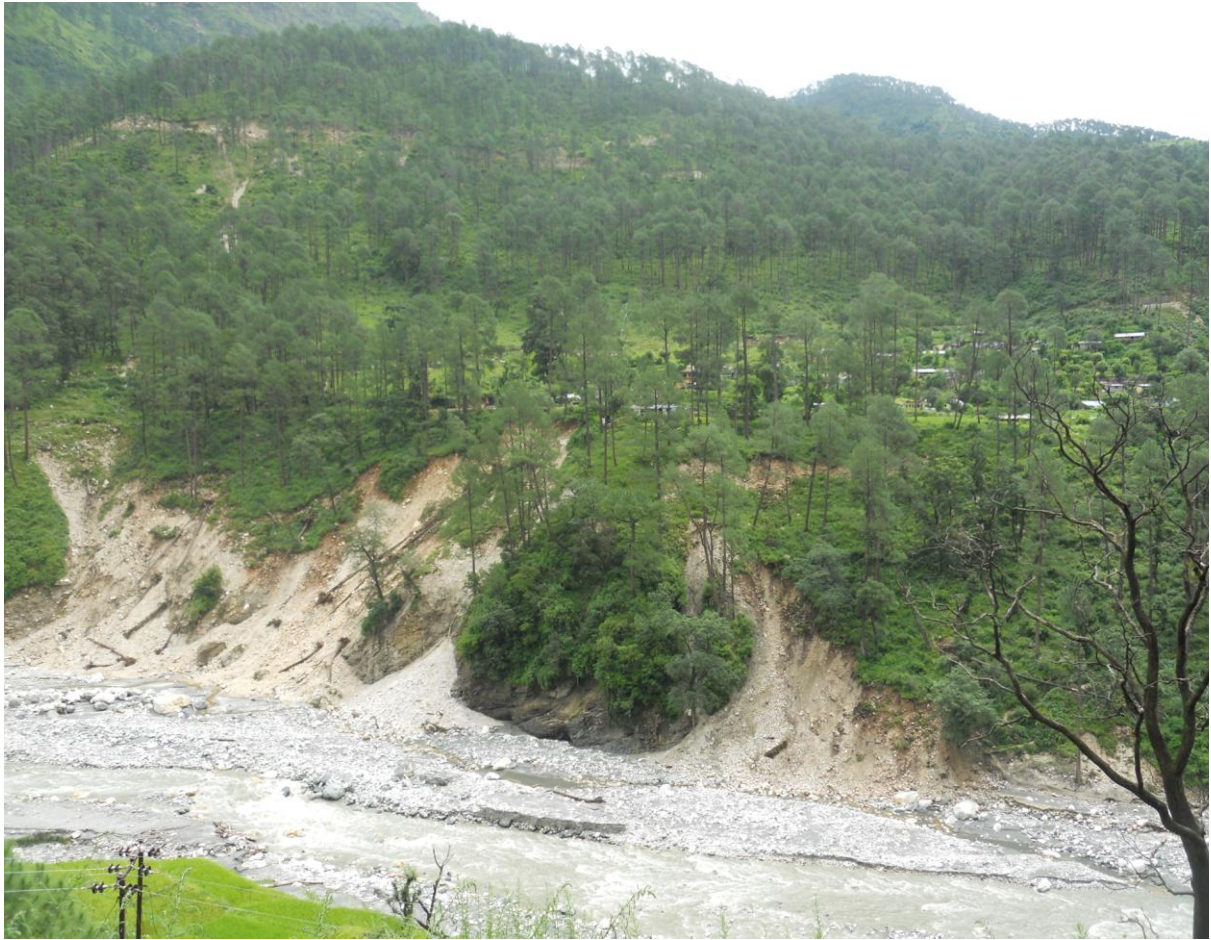
The Asi Ganga river is observed to indulge in erosion of its left bank down slope of the motor road. This has induced instability in the hill slope that is

particularly steep. Shallow debris materials with number of pine trees further contribute to slope failure (Fig. 20).

**Fig. 20. Photograph depicting bank erosion by Asi Ganga on its left bank below the Chiwa village.**

***Mitigation measures:*** Retaining structure with suitably deep foundation needs to be erected below the road where the failure has occurred. Concrete blocks on the river bed would further protect the bank as also the retaining wall.

At the same time tilted and dislodged pine trees around failure surface and subsided parts of landslide are required to be removed.

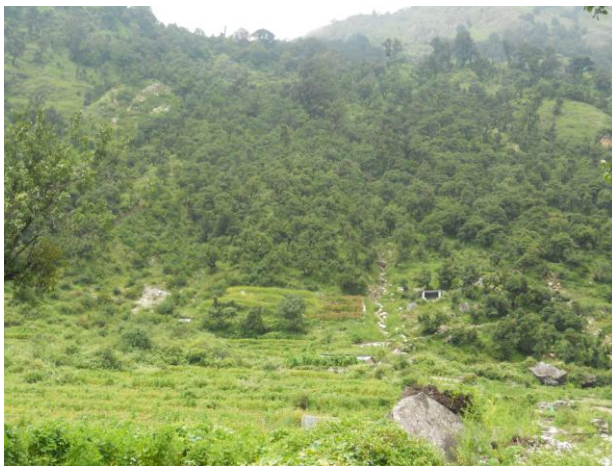
**Fig. 23. Photograph showing the seasonal stream upslope of Naugaon village.**

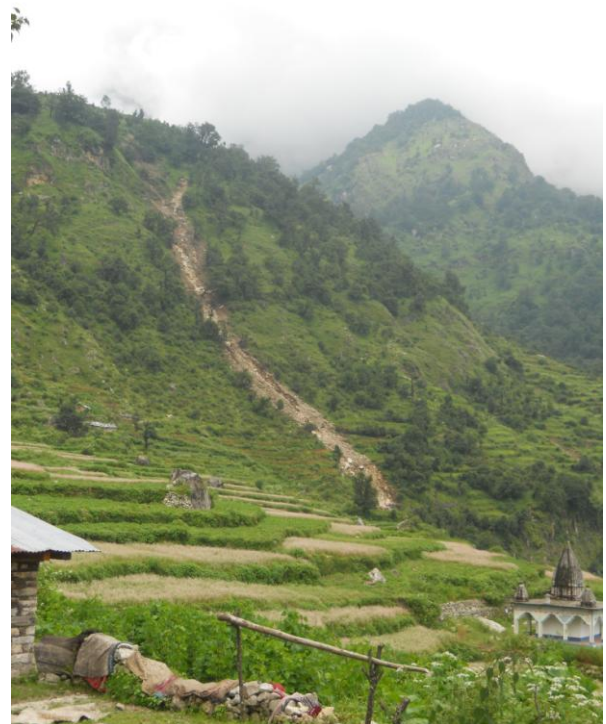
On the northeast side of the village shallow debris slide is observed. A number of agricultural fields are observed to be damaged by this slide (Fig. 24).

**Fig. 24. Photograph showing shallow debris slide that damaged numbers of cultivated fields.**

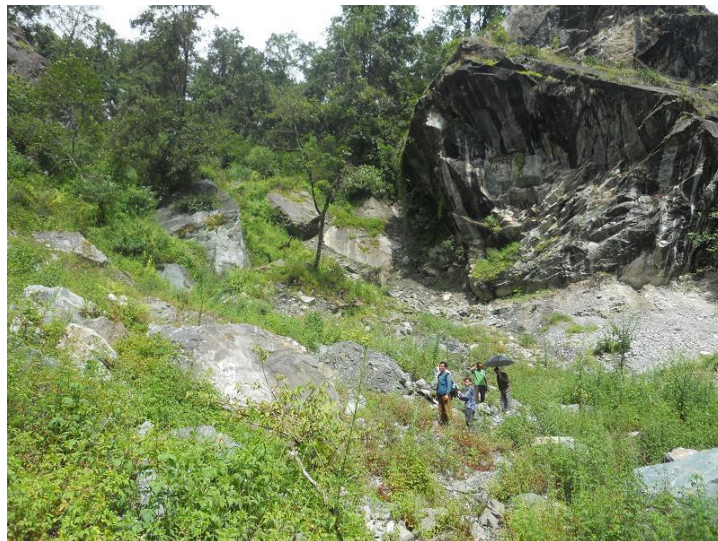
The western end of the village was reportedly affected by landslides about fifty five years before. The past landslide is observed along southwesterly slip surface where a number of tilted atish trees are also observed. This is indicative of likely future risk. Crown portion of the failure slope is observed to have slope of around 45° (Fig. 25).

**Fig. 25. Photograph depicting old slide zone to the west of Bhakoli village.**

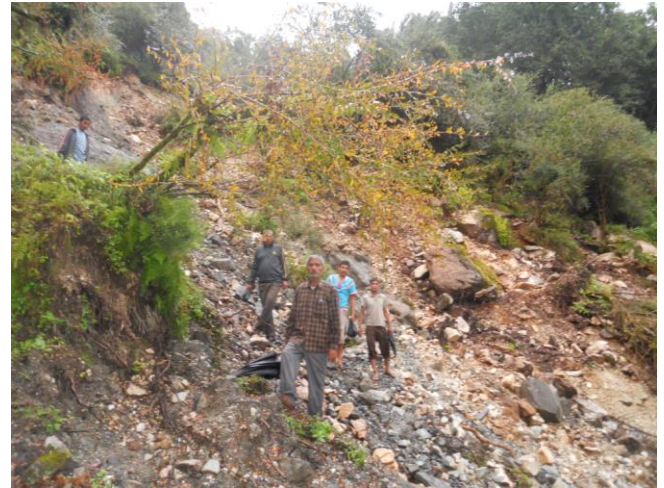
**Fig. 27. Photograph depicting slope failure along a perennial stream up slope of Dasra village.**

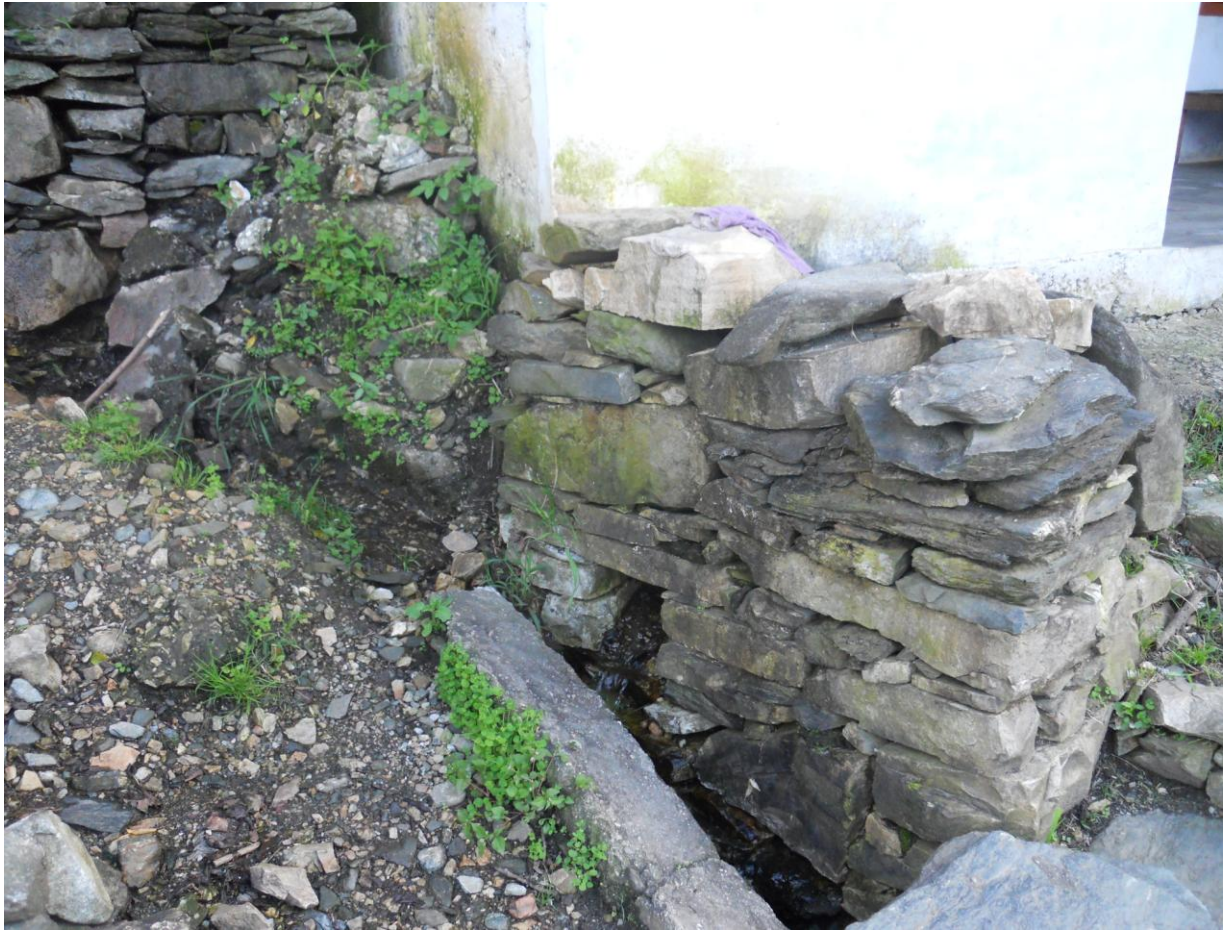
Construction of houses on unconsolidated soil is the cause of settlement cracks in the structures. Some houses are observed to be constructed on the course of the seasonal streams. This is the causes of seepages observed around sill level in many houses during monsoons (Fig. 30).

**Fig. 30. Photograph depicting seepage around the base of a house.**

***Mitigation measures:*** The upslope area of the village, particularly towards the toe of the hill slope, should be kept free of anthropogenic intervention of any sort. Constructions should only be carried out at respectable distance from both seasonal and perennial stream courses. Construction should at the same time be avoided on vulnerable slopes as also over unconsolidated soil. Retaining / bursts walls of appropriate height with suitable provision of weep holes should be constructed at the site of the area affected by mass movement. The foundation of these structures should be on solid rocks and compact soil materials.

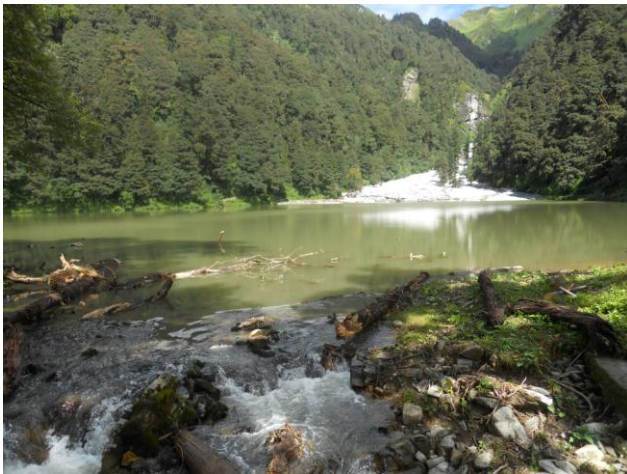
**Fig. 31. Photograph showing the transported materials deposited at the far end of the lake.**
