TENDER DOCUMENT

(SEISMIC RETROFITTING OR IDENTIFIED SCHOOL BUILDINGS)

Title: Seismic retrofitting of one identified school building each in Rudraprayag and Bageshwar districts of Uttarakhand

Reference No. 25 /DMMC/XIV-369 (2012) TC

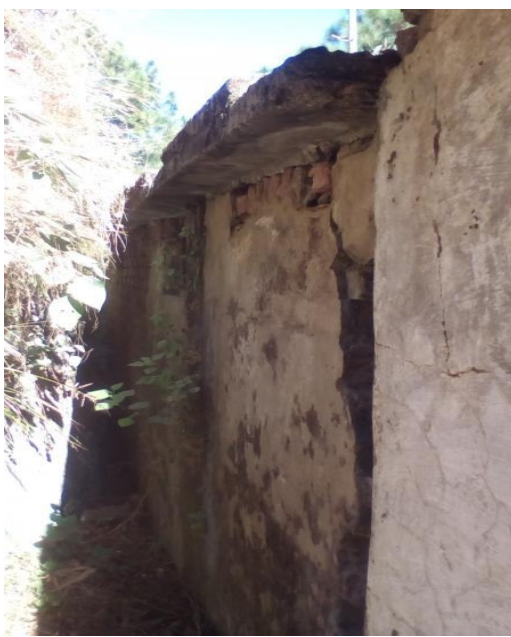
Backside wall is damaged

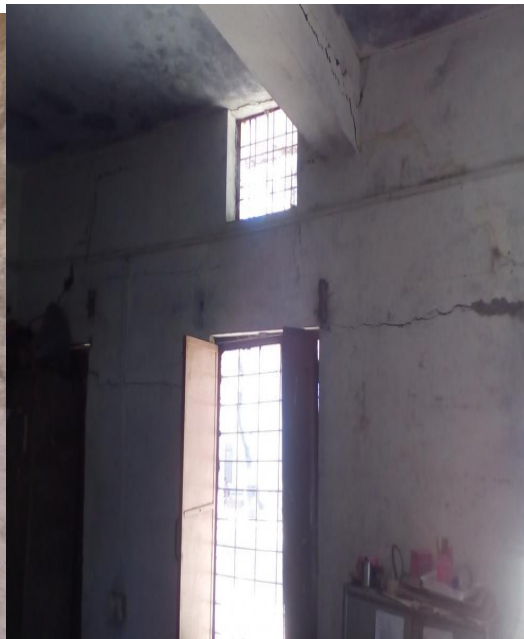
Major cracks in wall and beam

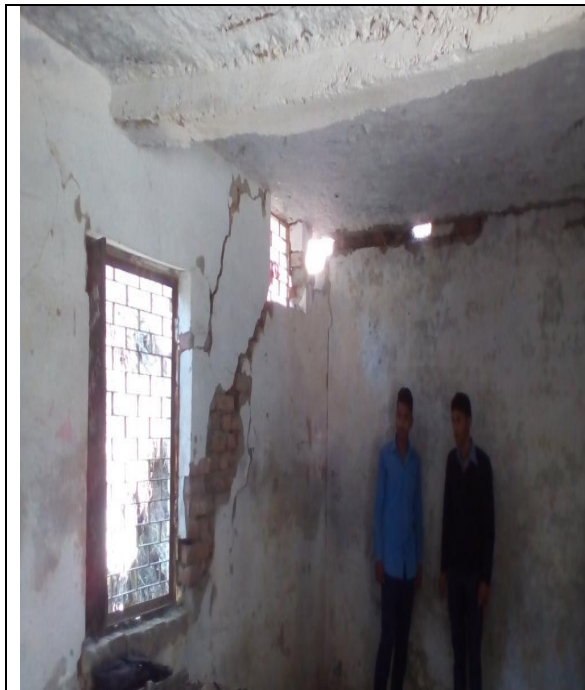
Wide cracks in walls and deflected beam

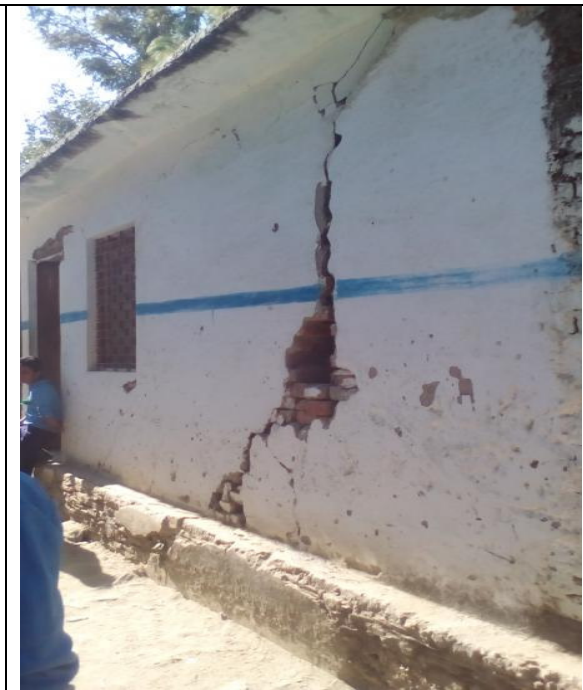
Shear cracks in beam

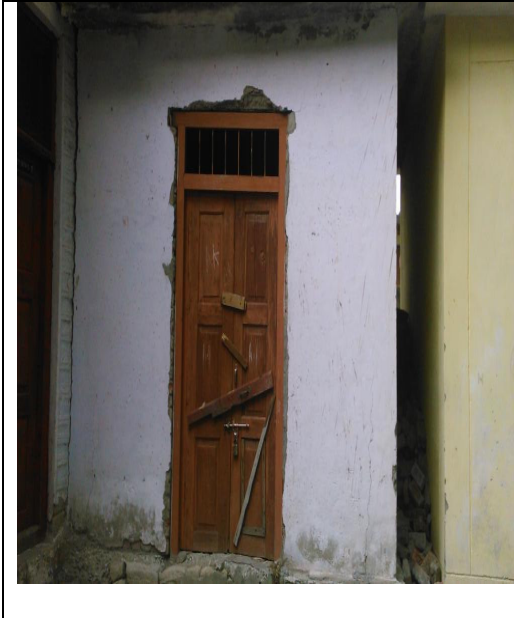
Lintel Band not provided

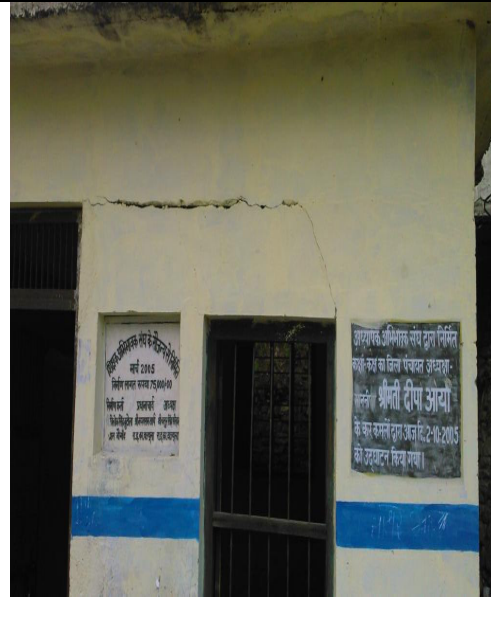
Major Crack above window

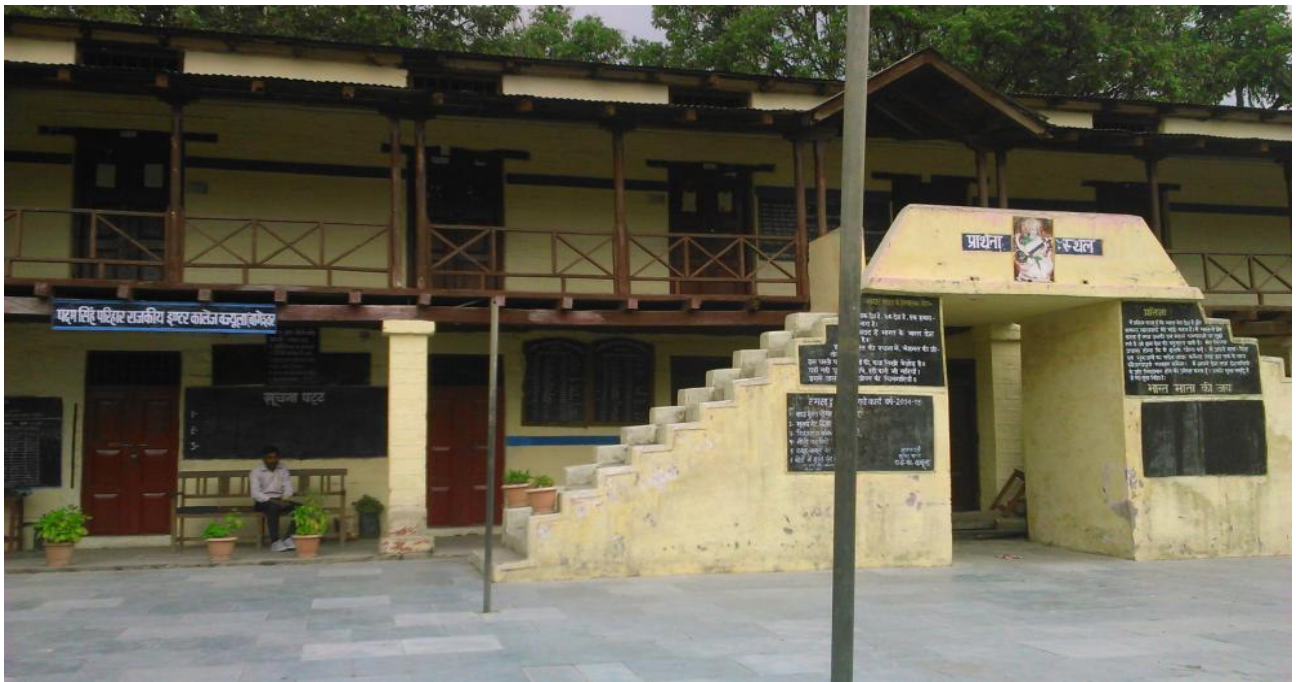
Irregularity in main Building.

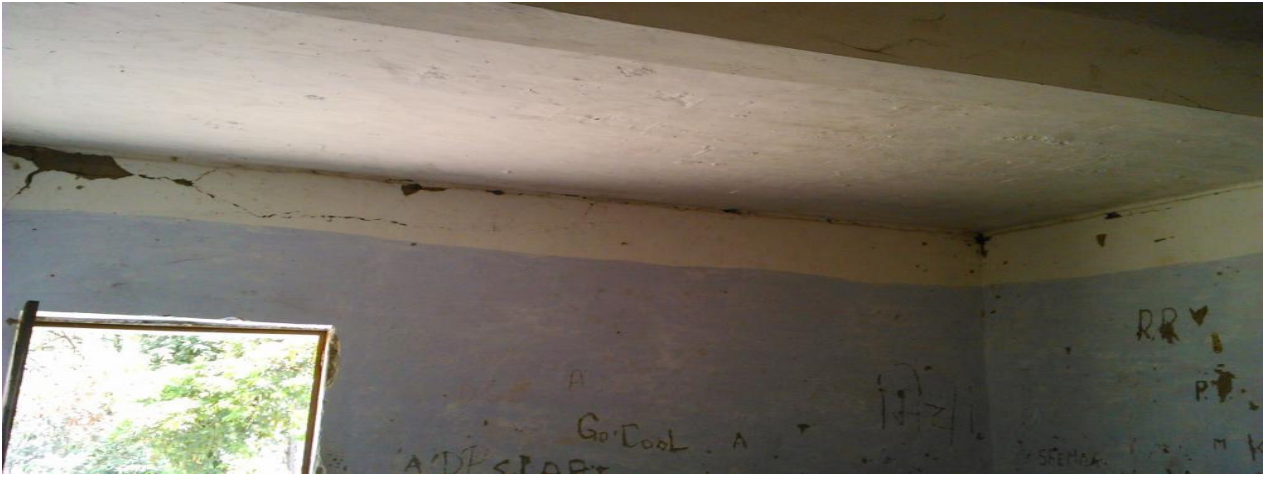
Cracks below the slab
