Assessment of Land Subsidence and Mass Wasting around Lata-Malla and Bhatwari area, Bhagirathi valley, Garhwal Himalaya, Uttarakhand

Dr. Krishna Singh Sajwan

Geologist, Disaster Mitigation and Management Centre (DMMC), Department of Disaster Management, Government of Uttarakhand, Uttarakhand Secretariat, Rajpur Road, Dehradun 248001, Uttarakhand, India

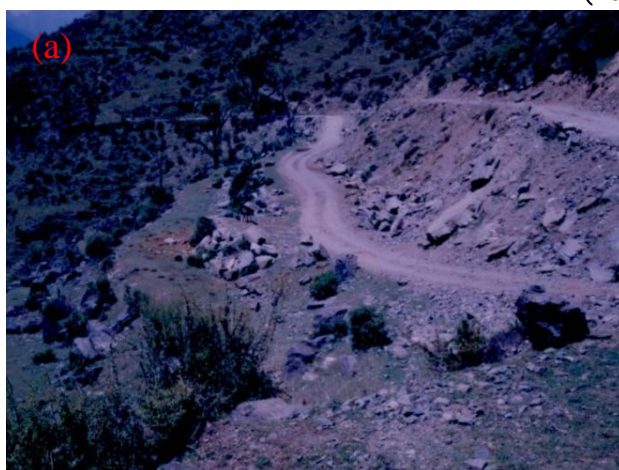
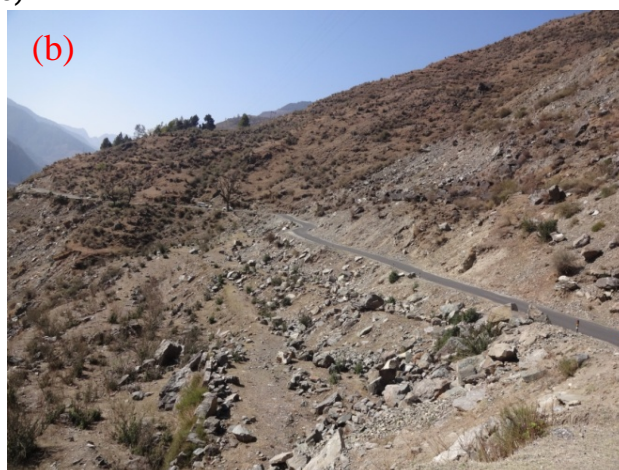
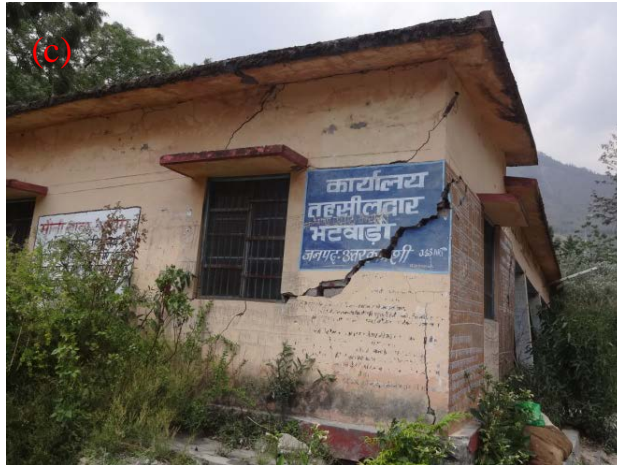
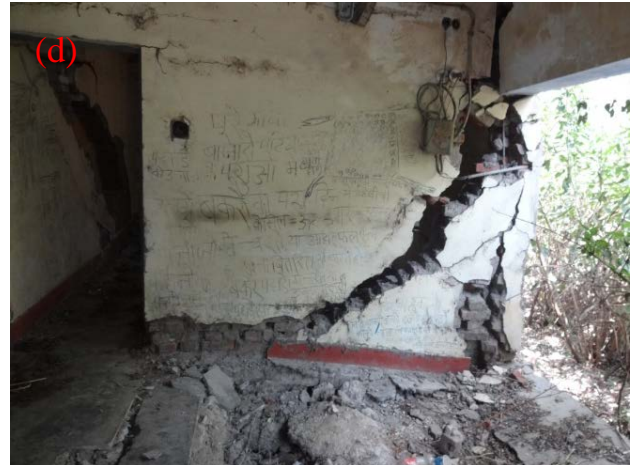
The Lata-Malla subsidence zone is located just downstream to Bhatwari town and covers a stretch of about 1.5 - 2.0 km. The zone actually represents a subsidence area which perhaps started after 1978 Bhagirathi floods or Uttarkashi earthquake of 1991. The field observation indicated different levels of road at different times in the past (Figs. 5 a and b). The landslide area is observed to be occupied by well exposed rocks of metavolcanics and gneiss, boulders and fragments of rocks together with overburden material. Landslide and subsidence zone consists of dominantly slope wash material and angular to sub-angular clasts of gneiss/schists embedded in silty, sandy and clayey matrix. Slope of the landslide zone on uphill side is observed to have very steep gradient ($>55^\circ$), whereas downhill side $35^\circ - 40^\circ$ with affected face towards SE.

Fig. 5 (a) View of land subsidence along NH-108 near Lata (2007) (b) Landscape changes along the road at Lata-Malla subsidence zone (2015), (c) Damaged building of Tahsildar office and (d) Severely damaged building of Tahsil office Bhatwari due to land subsidence by flooding in Bhagirathi river (2013).

The ground subsidence at Lata - Malla and Bhatwari area is caused by toe erosion by Bhagirathi river and subsequent down slope movement. The mass is moving under the influence of gravity along the preexisting tectonogenic weak planes. Toe erosion by river is accelerating the pace of movement and land subsidence (Fig. 5). The area is observed to be less vegetated in addition, high degree of fracturing, jointing and weathering of rocks and loose unconsolidated material permit greater amount of water to pass through the bed rocks and subsurface. During monsoon season Bhagirathi river swollen with rains and associate deluge has caused severe toe erosion of the colluvial deposit. As a result, the angle of repose of colluvial material has been changed and this in turn has caused the subsidence at Lata-Malla and Bhatwari area.

Avoidance is the best strategy of mitigation in case of chronic landslides and subsidence zone. Options of either realigning the road along the other bank of the river or bypassing the landslide through a tunnel therefore need to be explored. It is well recognized fact that unchecked road construction in the hills is adding to the menace of landslides in the hills. During the road construction, the removal of base support destabilized the slope and promotes extensive landslides (Nainwal 1999). Road construction along the river bed as also in close proximity of it should be invariably avoided and uphill side should be preferred, especially in case of overburden material and the presence of fractured / jointed rocks as well as in case of valley side dipping strata. Roads aligned along the ridges and over topographically higher ground have proved to be relatively free of landslides. Ghansali - Vasukedar - Guptkshi (Rudraprayag) and Ukhimath - Chopta - Gopeswer (Chamoli) roads are examples of such roads. These have remained open for vehicular traffic and proved their utility even when the state of hit by major disaster incidences. More of such alternative roads should be developed and existing ones maintained and repaired, especially before the monsoon season. Chardham Yatra, Hemkund Sahib Yatra and Kanwar Yatra; all take place in the rainy season. In this season in case of landslides and flooding traffic can thus be diverted to these alternative routes.

As toe erosion is one of the major triggering factor for the slope failure. Thus slope should be protected from toe cutting by river. It is recommended that appropriately designed flood protection walls of suitable height along with steps are required to be erected from river for checking slope failure in such areas if possible. Appropriate measures are required for checking infiltration of rainwater and surface runoff needs to be channelized by constructing contour drains, catch drains and lined toe drains. It is suggested that bio-engineering slope stabilization practices be promoted as these are cost effective and sustainable. For long term stabilization measures of such chronic landslide zones detailed geological as well as geotechnical investigation needs to be carried out.

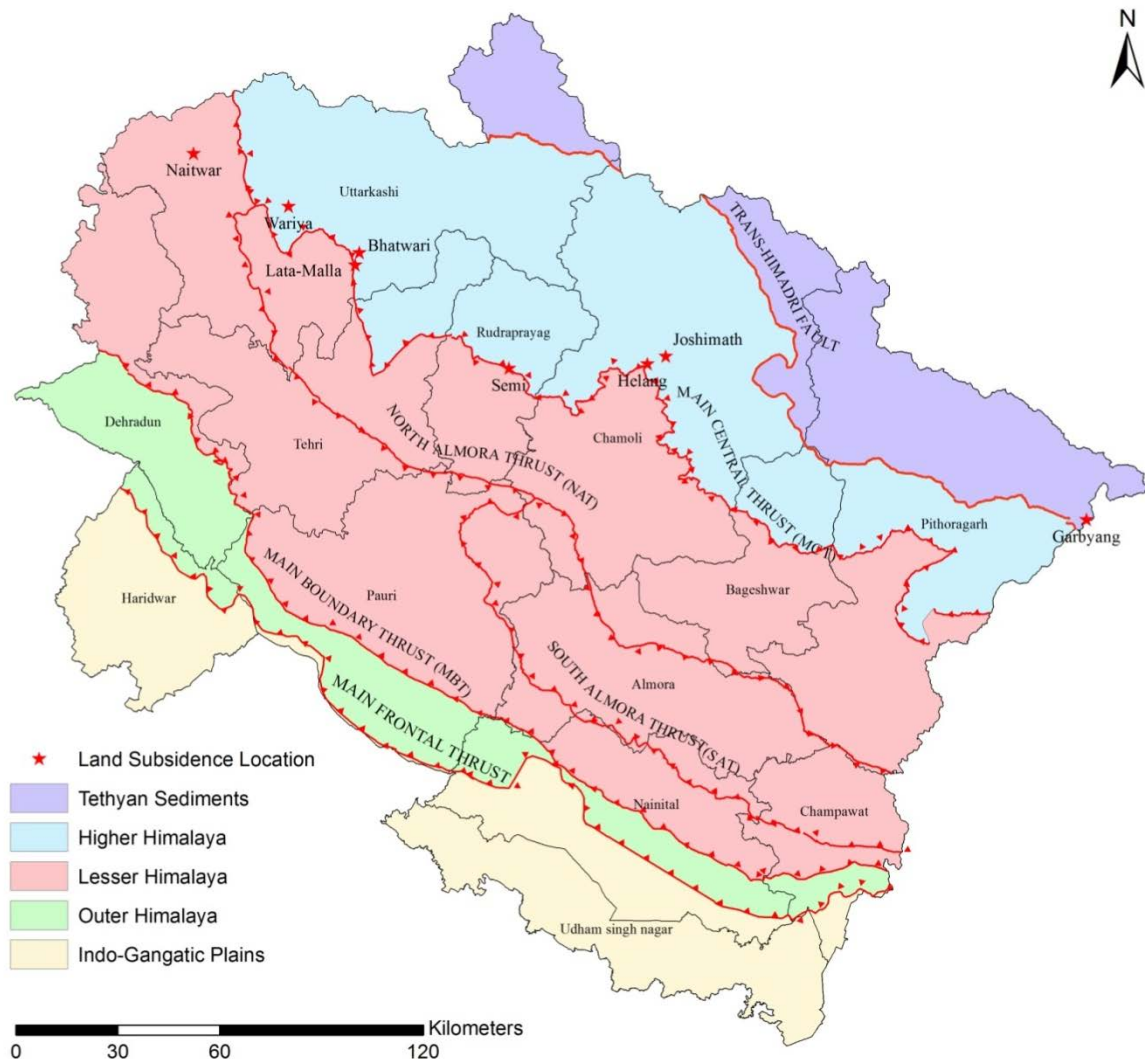
the Munsiari Thrust (MCT - I) at the bottom, the Vaikrita Thrust (MCT - II) in the middle and the Pindari Thrust (MCT - III) at the top (Valdiya 1980 and 2014). Such sites are very critical for the slope instability and these three factors i.e., toe erosion, vicinity of structural dislocation (MCT) and road cutting are dominant triggering factors behind most notorious landslides in Uttarakhand (Fig. 6).

Lata-Malla landslide in Bhagirathi valley, Semi landslide in Mandakini valley, Wariya landslide in Yamuna valley, Garbyang landslide in Kali valley and Naitwar landslide in Tons valley are few examples of chronic landslides witnessing incessant land subsidence in Uttarakhand Himalaya (Table 2 and Fig. 6). Semi village is situated just opposite to Okhimath town; it has witnessed worst condition of slope instability. National Highway (NH-109) going through the village, it was damaged and subsided at several portions after June 2013 disaster (Sajwan and Khanduri 2016).

Fig. 6. Land subsidence along with chronic landslide zones located close vicinity to major structural dislocation (MCT) in Uttarakhand
