Economics of seismic safety for earthquake-prone Himalayan province of Uttarakhand in India

Piyooash Rautela

Abstract

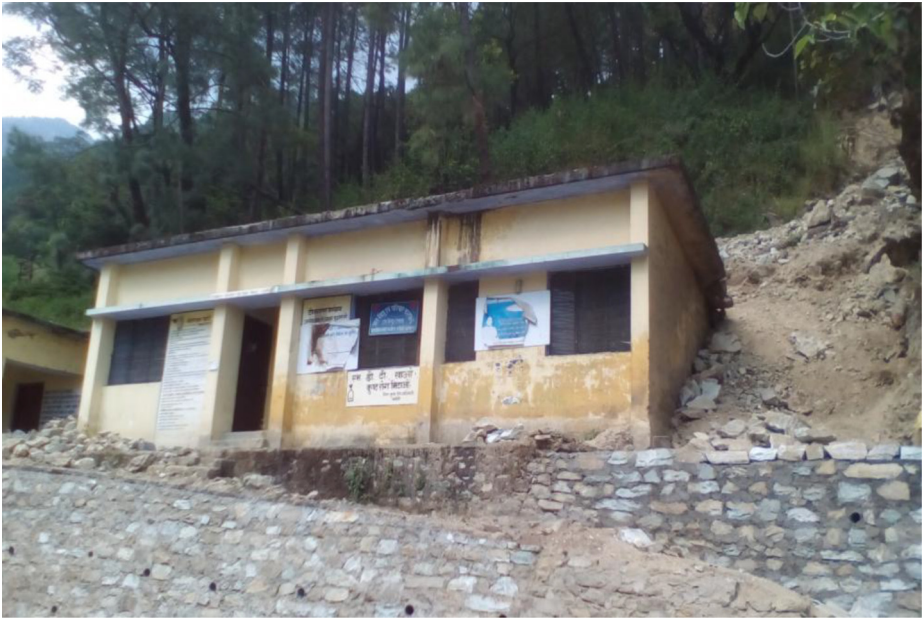
Of the surveyed buildings, 5.0 and 7.2 per cent masonry and RCC buildings, respectively, are observed to be built over ground with slope more than 45° (Plate 1).

Plate 1.
Primary school at
Upkendra Tangsa,
Dasholi (Chamoli
district) located on
high-sloping ground

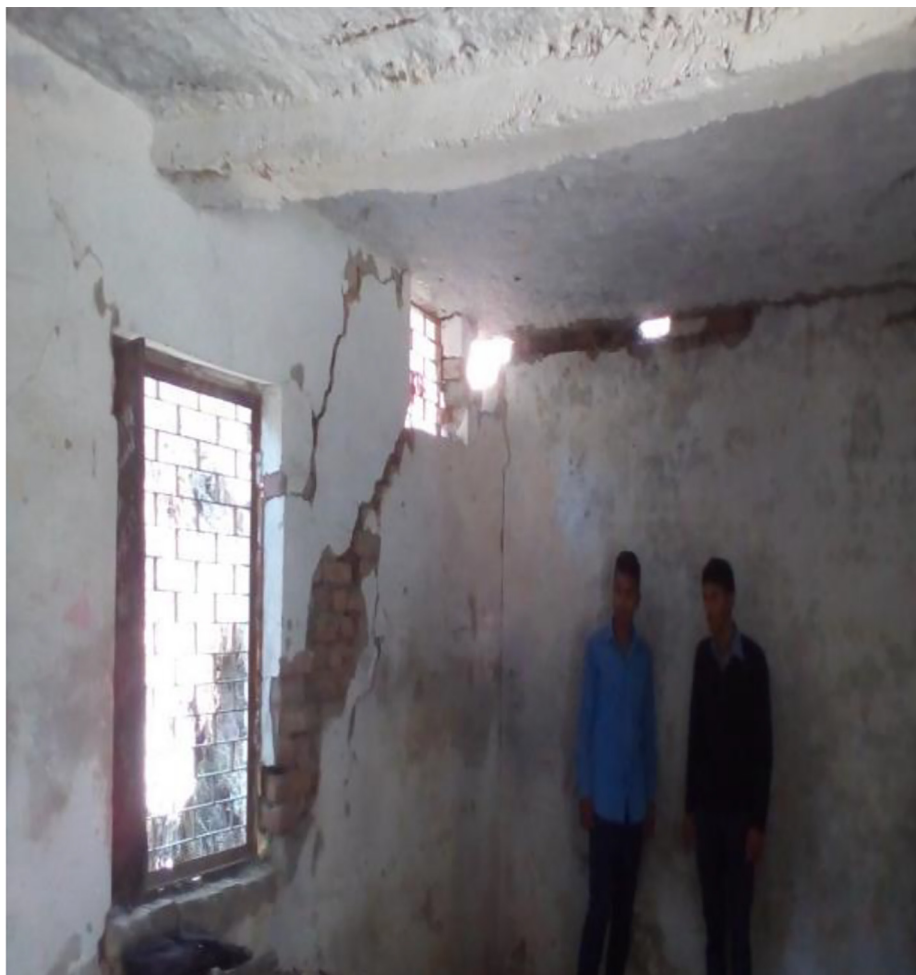
Lack of maintenance, faulty design, poor quality of construction, corrosion of reinforcement, settlement of foundation and extreme loading are observed to be the main causes of deteriorated condition of the surveyed buildings which is exhibited in the form of cracks in the building elements (Plate 2).

Plate 2.
Wide shear cracks in
masonry wall
together with poorly
constructed beam of
non-uniform shape
and deflection
observed at
Government Inter
College at Pitrdhar
(Augustmuni) in
Rudraprayag district

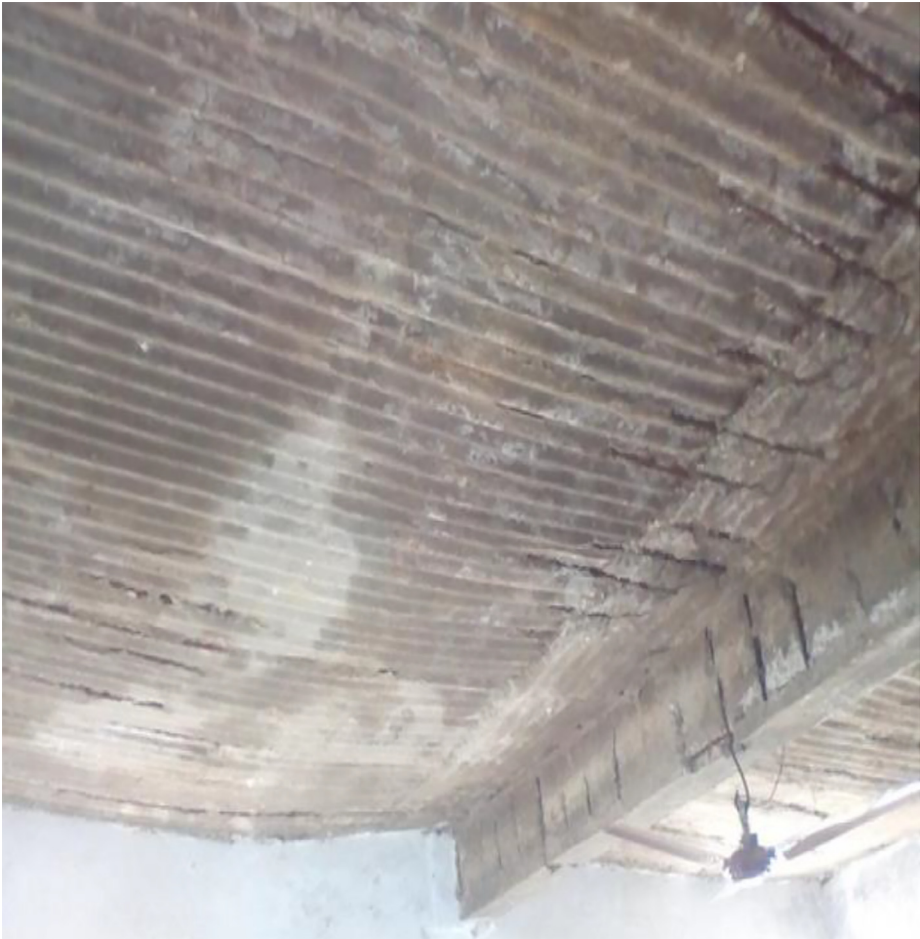
Cracks in the wall or roof are observed to result in the corrosion of reinforcement because of its exposure to rainwater, moisture and air (Plate 3). Corroded reinforcement is often observed to result in vertical and horizontal cracks in column and beam, respectively.

Plate 3.
Poorly constructed
roof with clearly
visible reinforcement
at Government
Primary School at
Mhalchora in
Bageshwar district

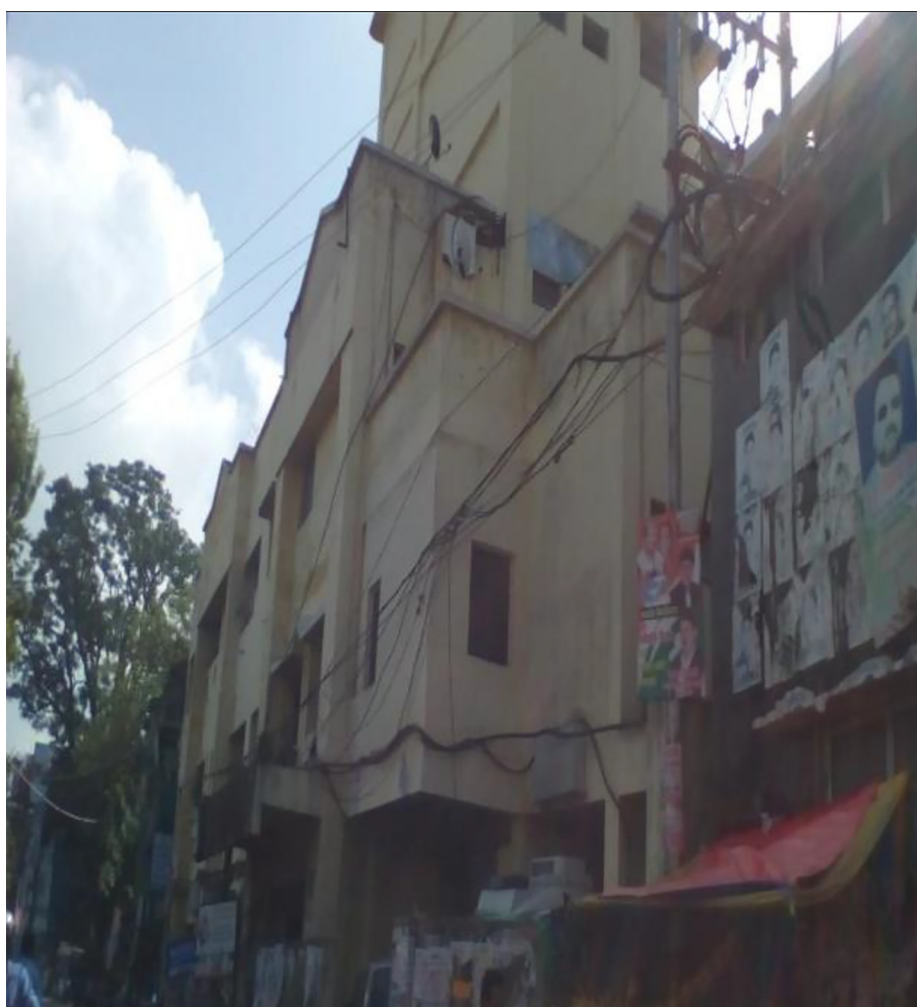
observed largely in Chamoli and Pithoragarh districts while reverse-T type dominantly in Almora and Champawat districts (Plate 4).

Plate 4.
Reverse T-shaped
hospital at
Hawalabagh in
Almora district

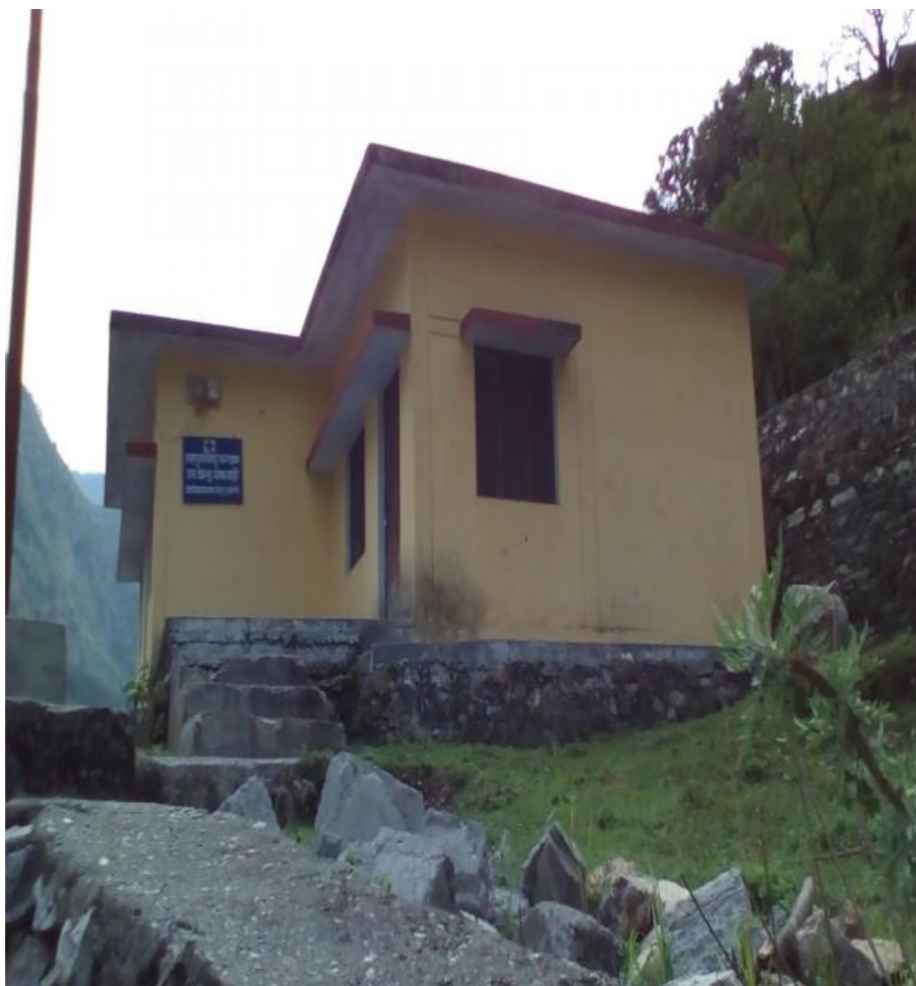
Plate 5.
Re-entrant corners in
Upkendra Gauna
(Dasholi) in Chamoli
district

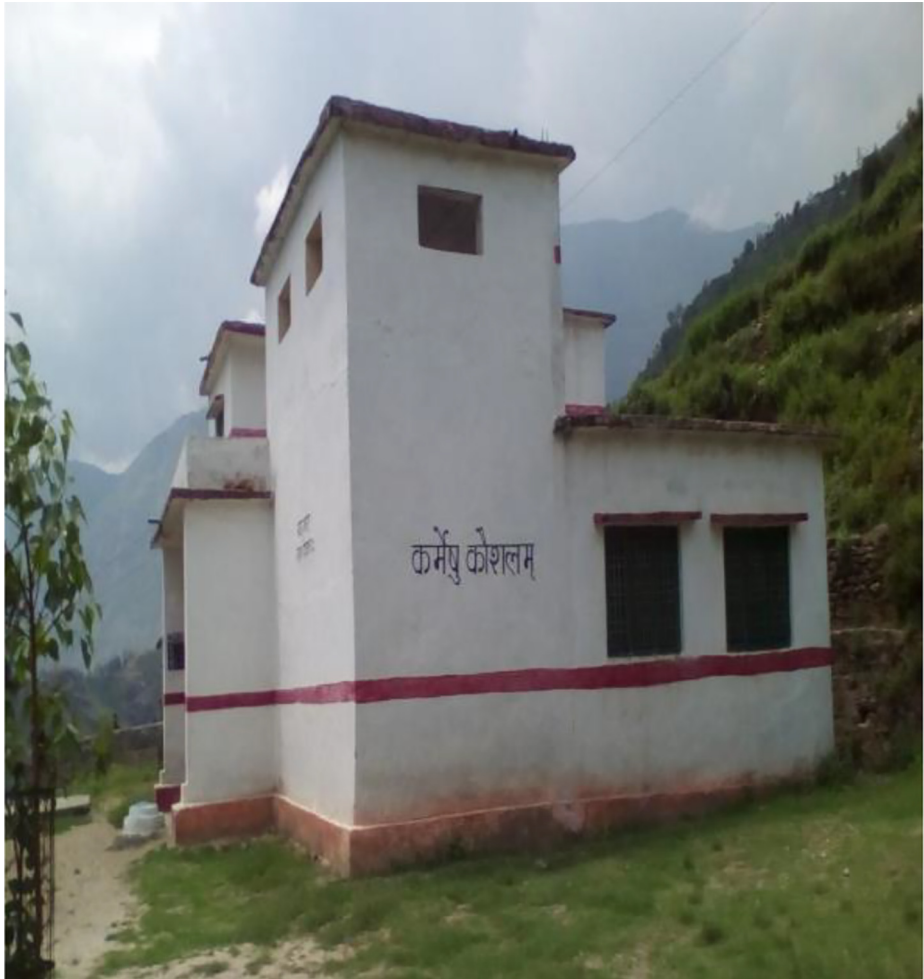
Plate 6.
Re-entrant corners
Upper Primary
School at Balidhar
(Dasholi) in Chamoli
district

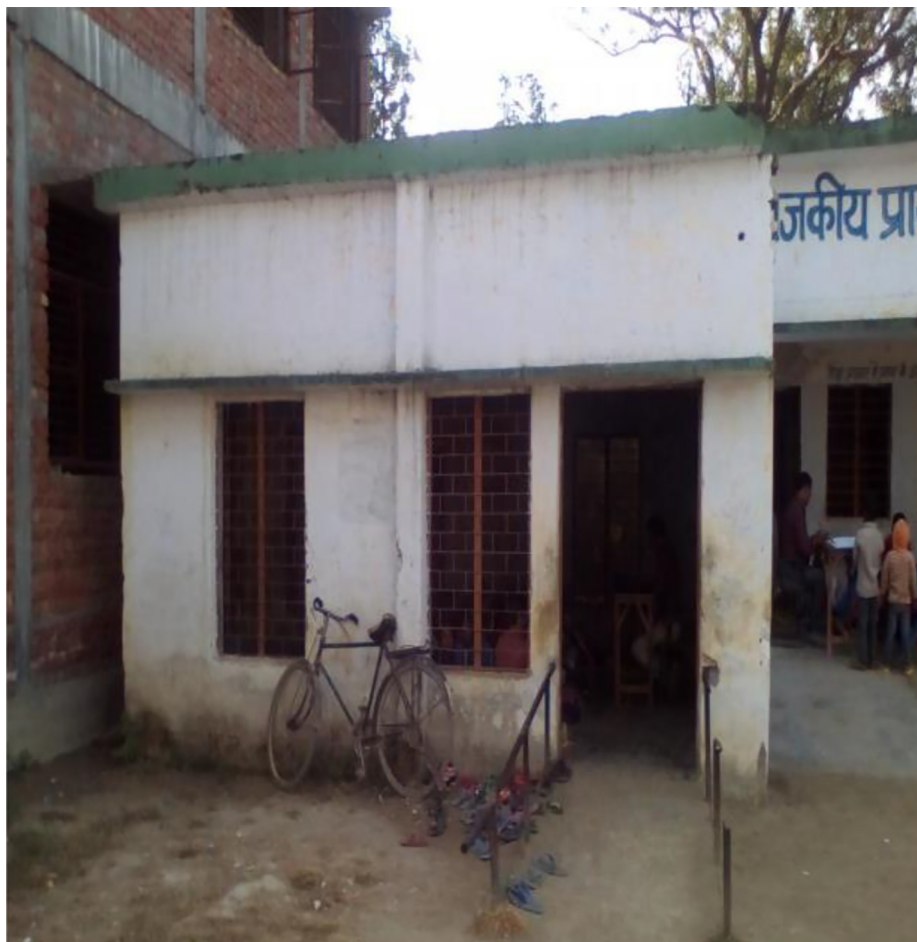
In all 26.8 and 19.3 per cent of masonry and RCC buildings, respectively, are observed to be vulnerable to pounding (Plate 7).

Plate 7.
Pounding related
vulnerability in
Government Primary
School at Bajpur in
Udhamsingh Nagar
distric
