**Geological note on landslide affected villages in
Kapkot tehsil of Bageshwar district in
Uttarakhand**

A report

**Disaster Mitigation and Management Centre
Department of Disaster Management
Uttarakhand Secretariat
Dehradun 0 248 001**

November, 2012

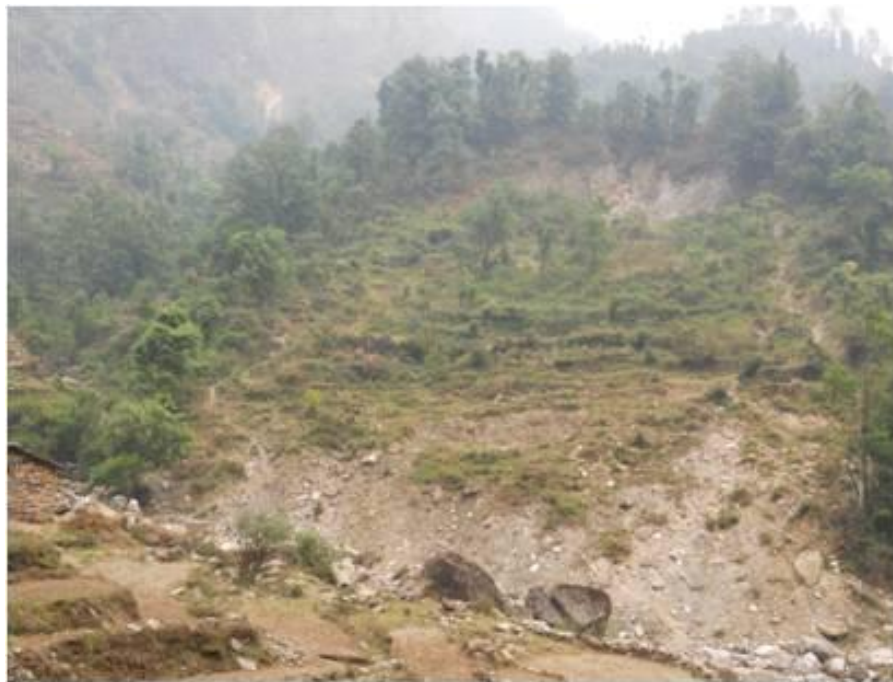
The slide was observed to have occurred on the northwestern slope of NE - SW trending ridge. The inclination of failure slope was 30° to 35° whereas in the crown portion it was observed to be 50° . The width of the failure slope was about 50 meters along the Khamiya gad and height of the slide from gad to the crown was about 85 meters (Fig. 2).

Right flank of the slide was observed to be active and extending towards the houses around the crown. Cracks and ground fissures observed in loose overburden on agricultural fields were indicative of this.

Toe cutting / bank erosion by gad and water charged debris material during intense rain seemed to have facilitated the slide. Existing five houses at southeastern side of the slide above the crown were observed to be located at a distance of around 25 to 30 meters from the slide. This was observed to pose grave threat to these houses.

Fig. 2: View of huge detached slide mass just below the Ukhrani tok.

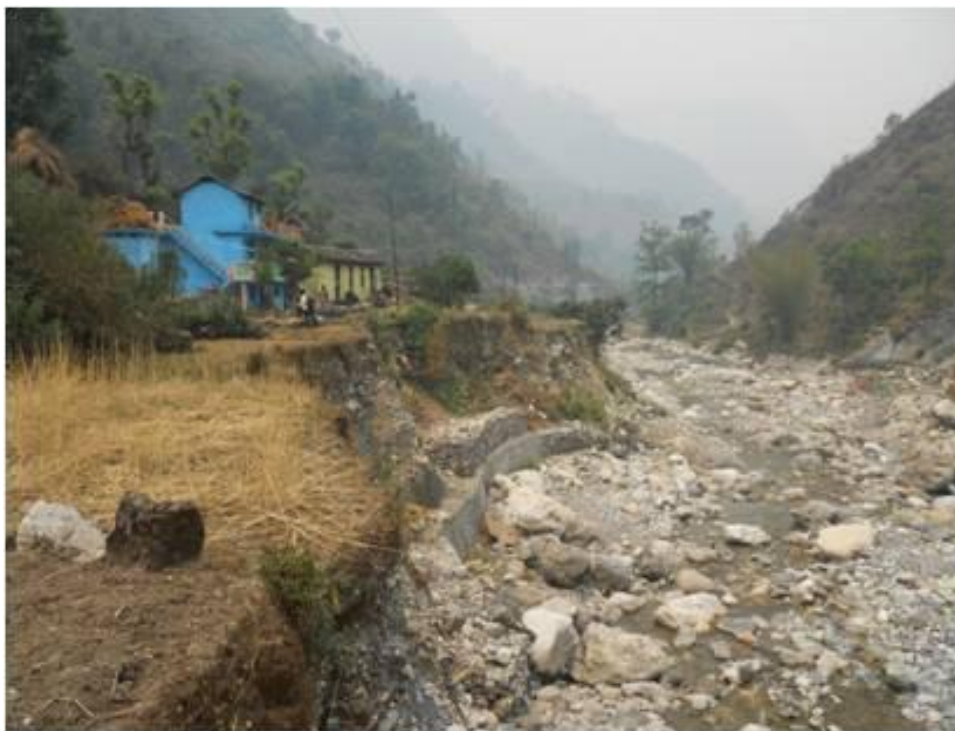
Fig. 3: Photograph depicting bank erosion/ toe cutting by Revati Ganga at Bhaliyabagar *tok* in Baret.

Bank erosion caused by spate in Revti Ganga during excessive rainfall events in this valley was observed to have contributed to the instability of the slopes in this area. The river terrace was observed to be cut vertically by this stream. An eroded terrace with vertical cut around of 5 meters was observed on the left bank of Revti Ganga (Fig. 3).

Mitigation measures: Appropriately designed retaining structures of suitable height with firm foundation are required to be erected for preventing toe cutting / bank erosion by Revti Ganga. This would help in protecting the affected site as well as bank of Revti Ganga from stream erosion.

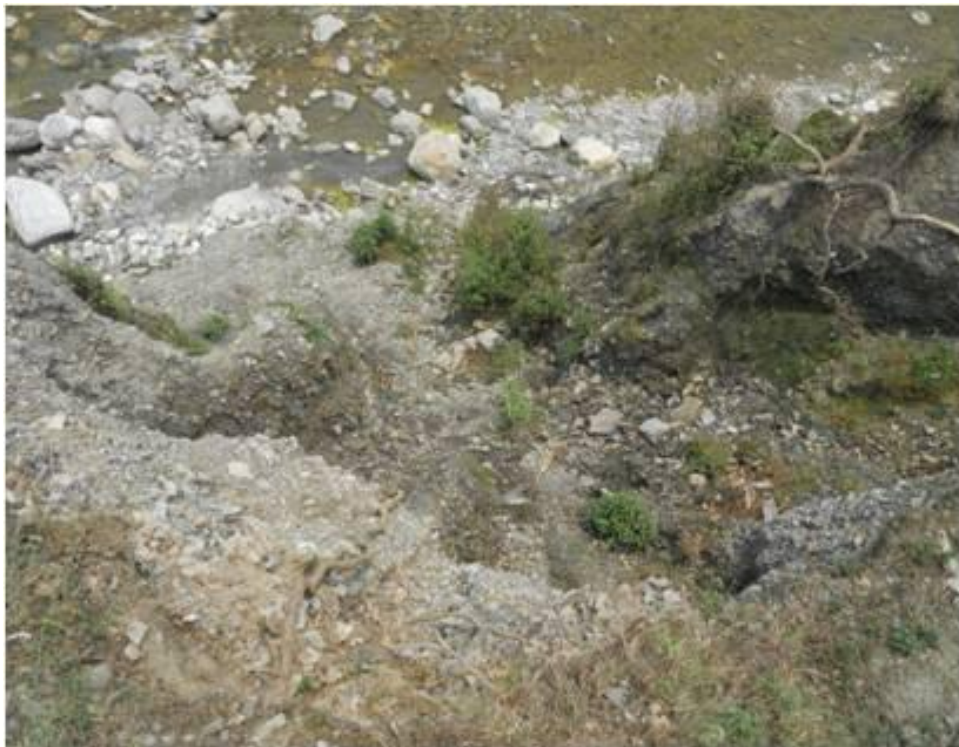
Terrace was observed to be eroded by Revti Ganga and vertical erosion of around 4 meters was observed. This was attributed to high flood and intense rainfall events in the catchment and the same was deduced to have contributed to slope instability in this area (Fig. 4).

Fig. 4: Photograph depicting bank erosion in agricultural land by Revti Ganga just below Tallabagar *tok* in Baret area.

Mitigation measures: Western end of the affected area has a seasonal stream that flows in northeast direction. It is recommended that the course of this stream be properly trained and appropriate measures be taken to dispose off all the water that often gets accumulated on the road by this stream.

Appropriately high concrete retaining structure with stepladder and deep foundation needs to be erected at the location of the affected site. This would protect the house as well as agricultural fields from stream erosion.

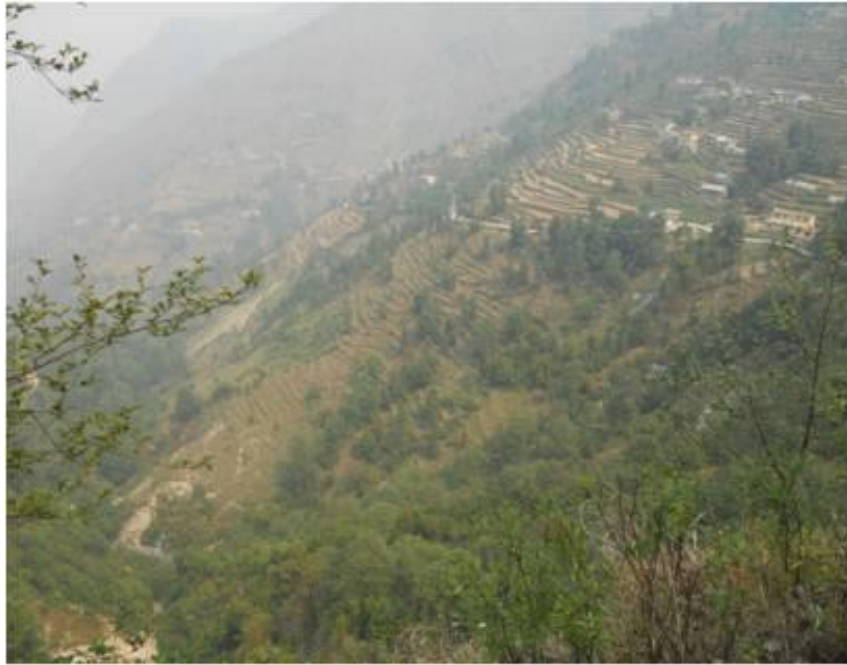
Fig. 5: View of agricultural fields damaged by bank erosion by nala located down slope of Sama.

The slope failure was observed to have occurred on the southern slope of the strike ridge around Sama Dhura *tok*. The width of the failure slope was about 30 – 40 meters along the west flowing seasonal nala while the height of the slide from nala bed to the crown was about 75 – 80 meters. The inclination of failure slope was observed to be around 30°.

The failure slope was observed to be beneath the habitation and grass was observed to be growing over it. Soil creep often builds up stress in the soil mantle and the same is sometimes relieved by tension cracks. Cracks up to 4 cm deep and 10 cm wide were observed and these ground fissures continued for 0.5 meters.

Two seasonal streams flowing south and west were observed around the village. These were observed to have contributed to the instability of the area.

Mitigation measures: Appropriately designed retaining structures with deep foundation are required to be erected to prevent the toe cutting / bank erosion by nala. These would protect the slopes below village Sama.

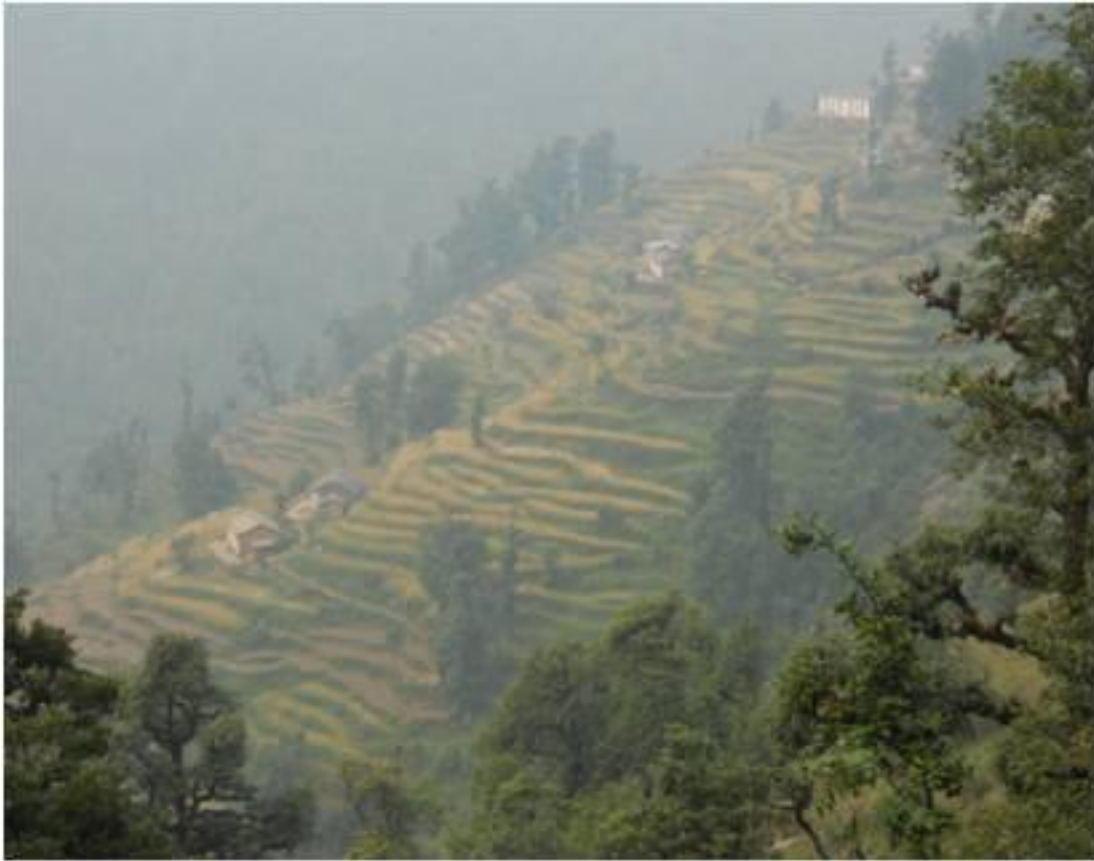
Building material was observed to be excavated from the southern extremity of the natural slopes for construction of houses in the *tok* by the local community. This was deduced to have triggered slope failure.

Fig. 6: Panoramic view of Maubheri tok.

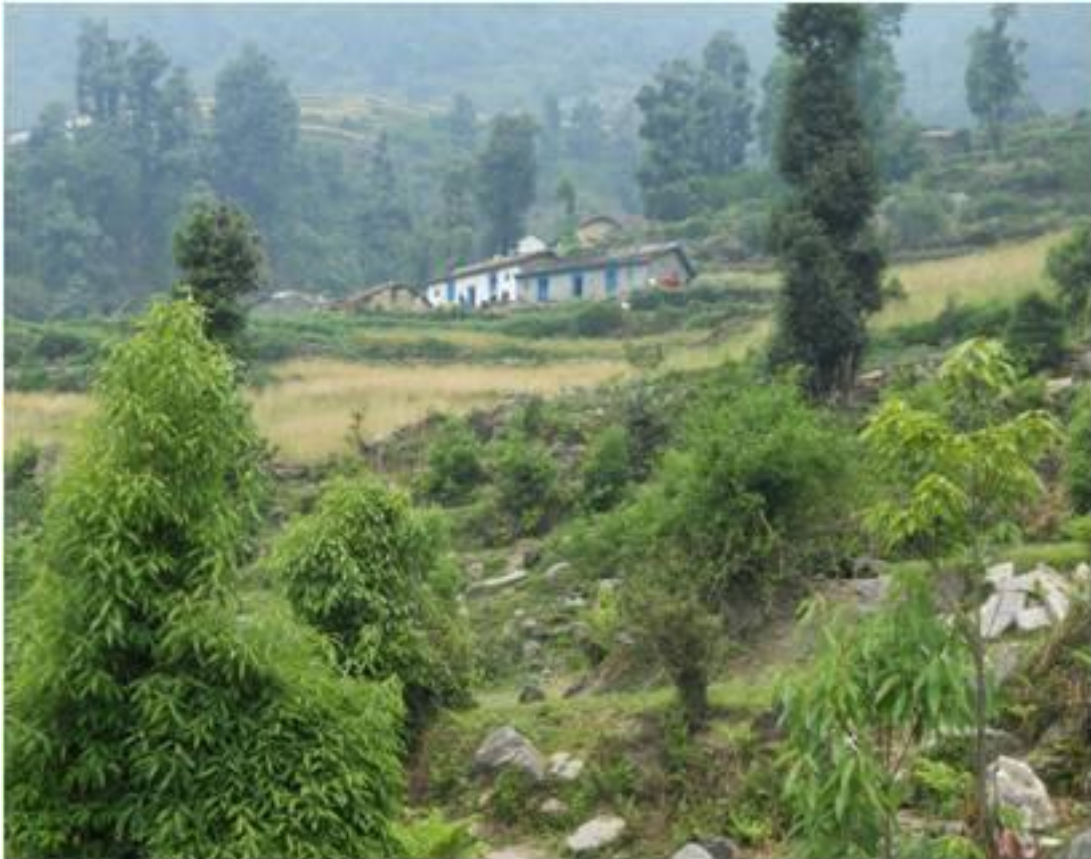
erosion on its right bank. Resultant ground fissures were observed on the agriculture land below the *tok* (Fig. 7).

Fig. 7: Ground fissure in agricultural lands caused by bank erosion by nala below Tallagara *tok*.

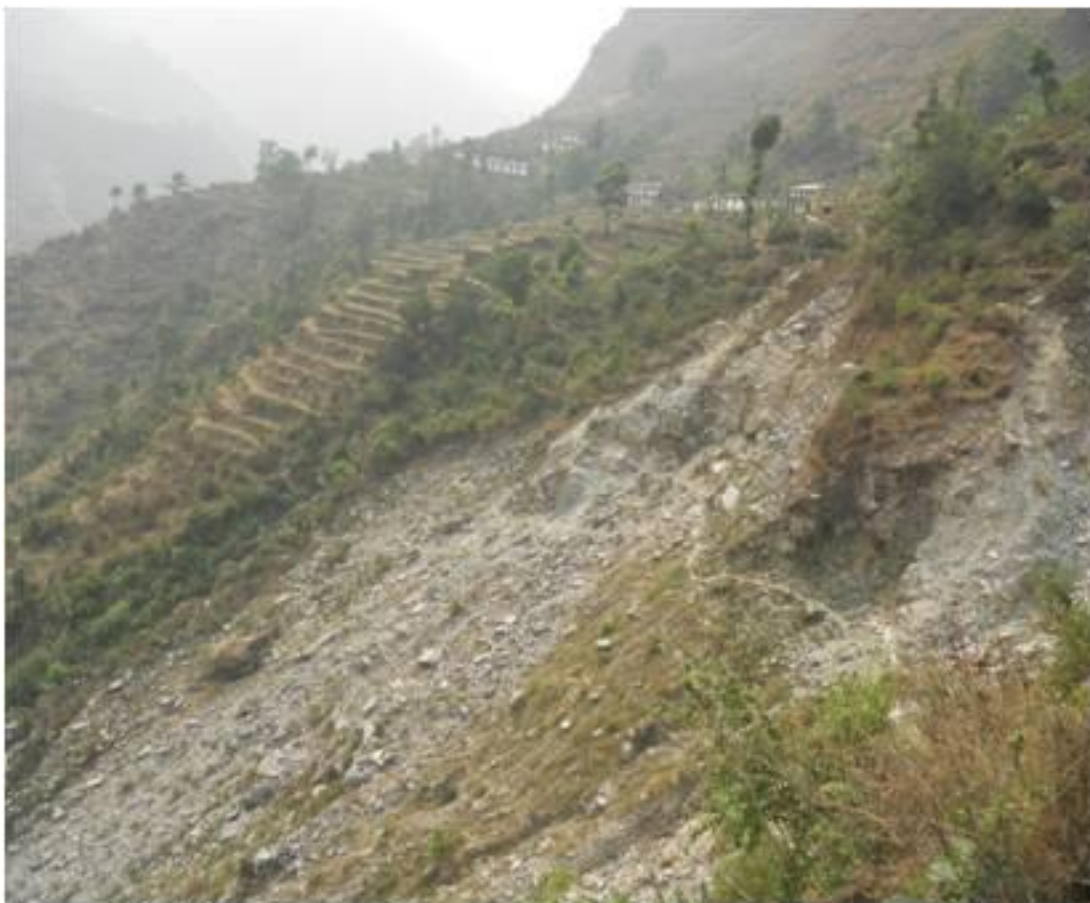
Around 5 years ago a number of agricultural fields at the eastern end of the *tok* were reportedly damaged by the landslide that was observed to have been reactivated (Fig. 8). Crown portion of the failure slope had steep to very steep slope and jointed, folded, fractured and locally sheared rocks were observed to be exposed in that area. Primary school and a house located just above the crown of the slide were observed to be in highly vulnerable state.

Fig. 8: View of agricultural fields damaged by slope failure in the area around Kimu *tok*.

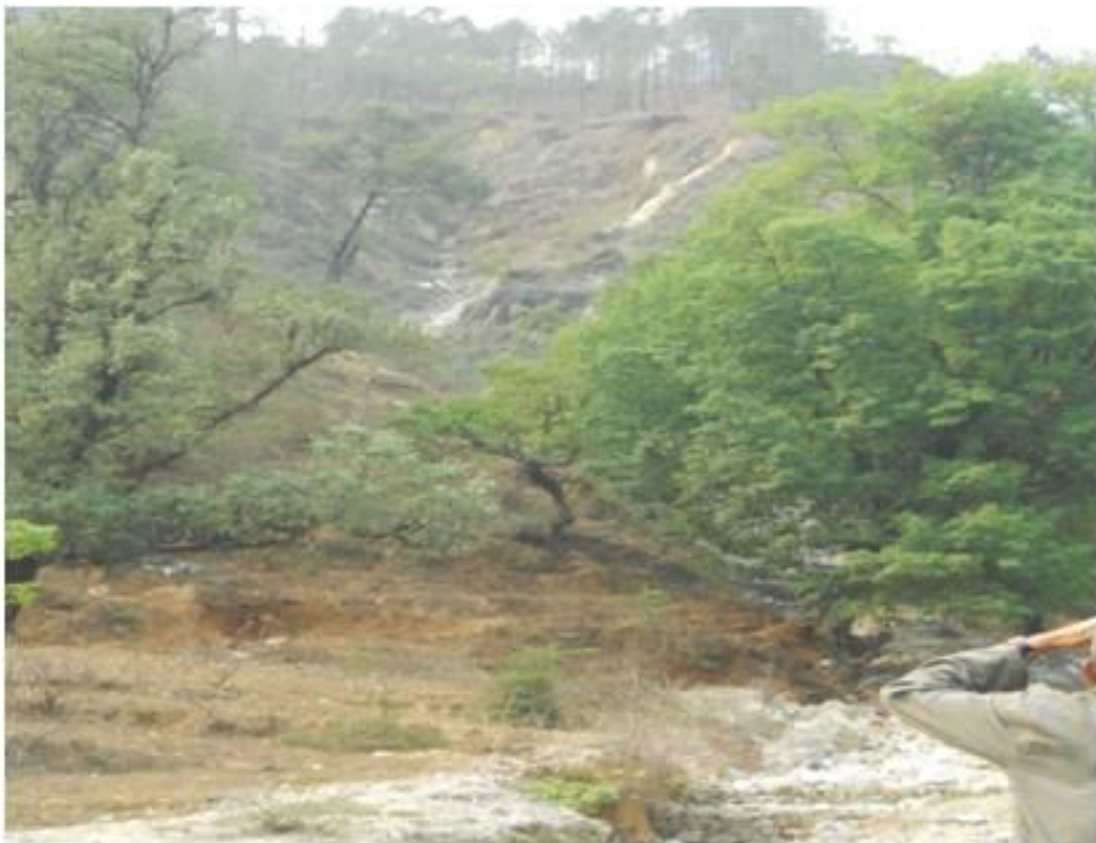
Fig. 10: View of nala and failure slope on the uphill side of Gunthi village.

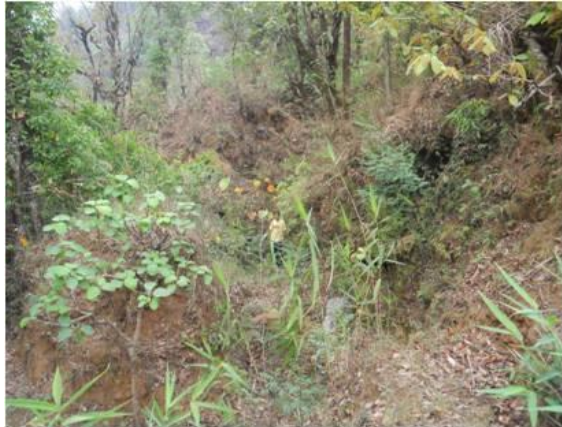
Fig. 11: Photograph depicting ground fissure in agricultural fields.

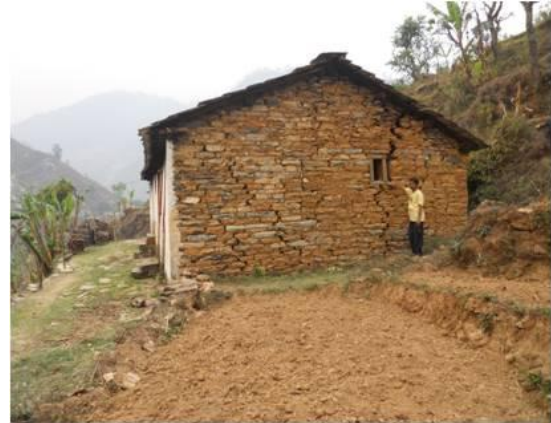
Cracks were observed in two houses located on the slope. These were up to 3 cm wide and were attributed to active slope movement with local settlement of the loose overburden material (Fig. 12).

Fig. 12: Photograph showing cracks and bulges in the house.

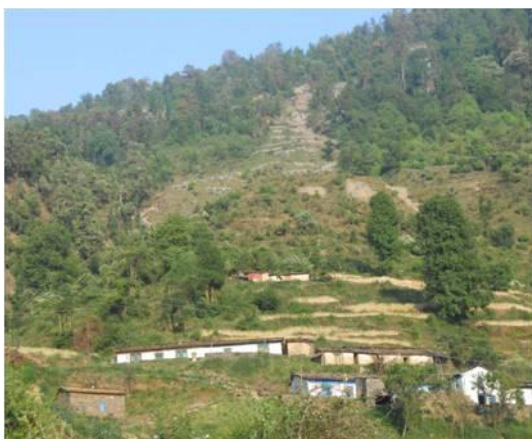
Fig. 13: View of reactivated old landslide upslope of Kuwari village.

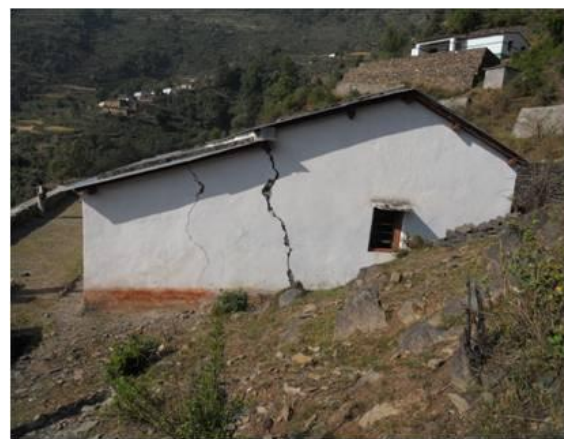
Below the village and on the northeastern side of the village as well as on the nala bed shattered, sheared, folded and heavily jointed phyllites were observed. These enhance the risk. A major spring was also noticed at the base of village. Primary School, Junior High school and Milan Kendra located in the northwestern extremity of the village on the left flank of the local nala were observed to show local settlements (numbers of cracks in walls and floors) and active creeping due to toe erosion by the stream (Fig. 14).

Fig. 14: Photograph showing cracks in Junior High School building.

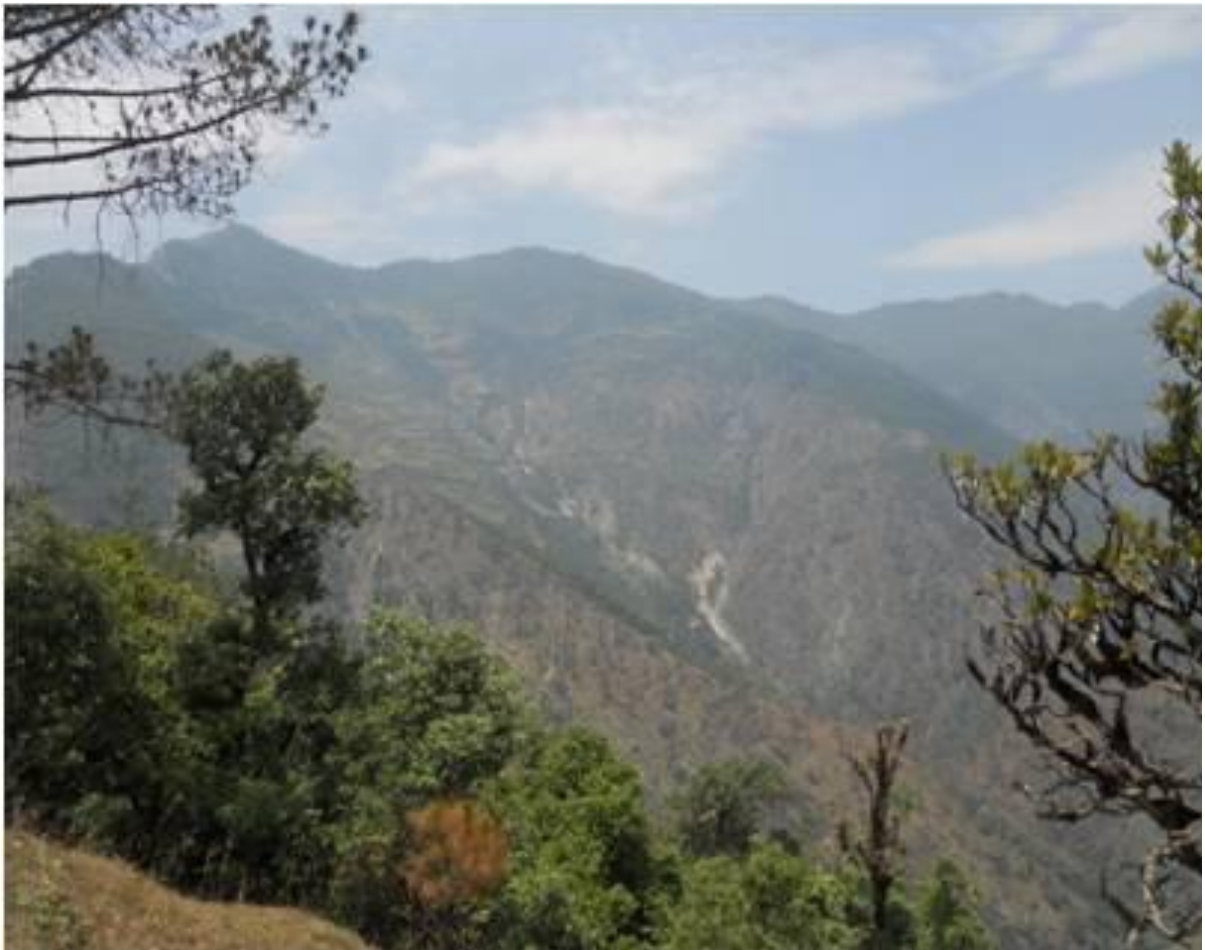
The thinly foliated and fragile nature of the phyllites had resulted in the formation of landslide that was observed to facilitate movement of huge slope mass below the village. The angle of failure slope was observed to be around 45° and even more. The direction of the slope was observed to be towards northeast. The ground fissures in the failure slope area were observed to be 2 to 5 meters long (Fig. 15).

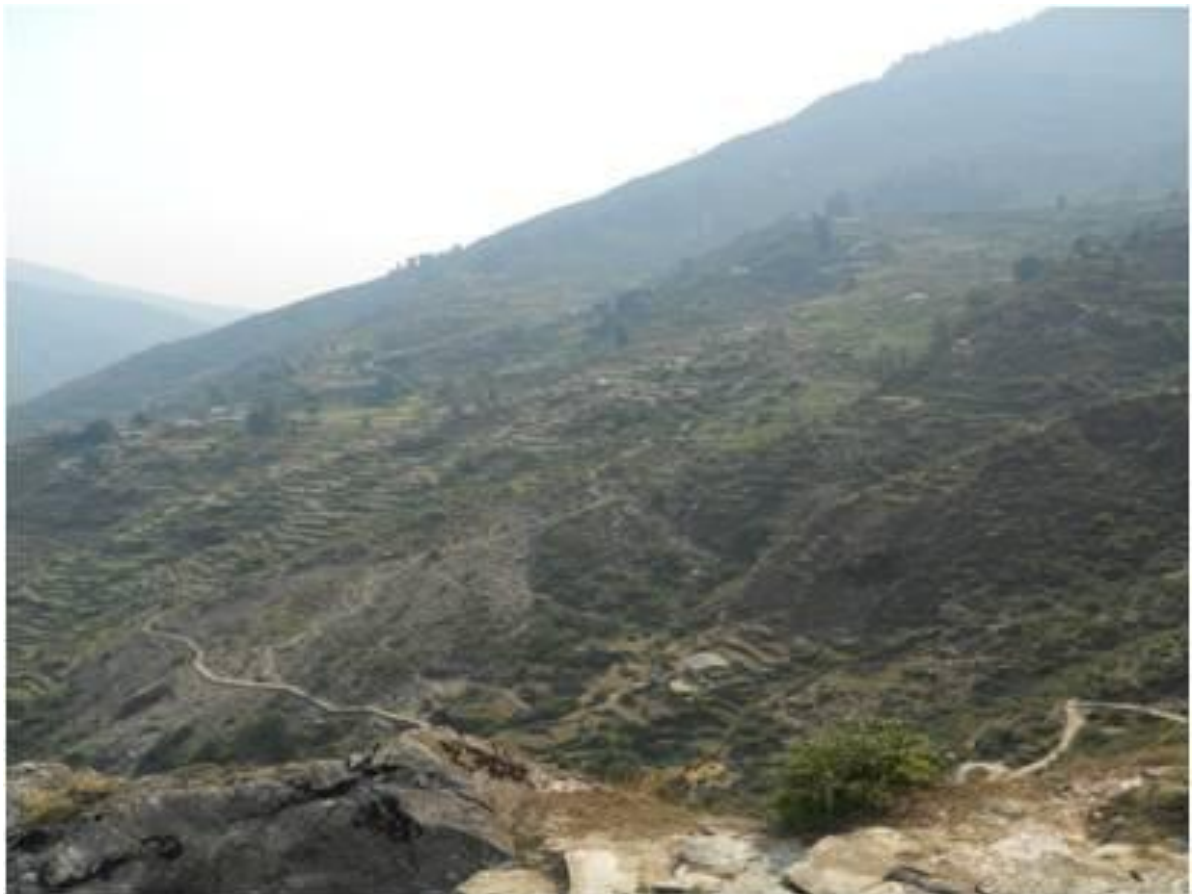
Fig. 16: Photograph depicting slope failure around Kilbara village.

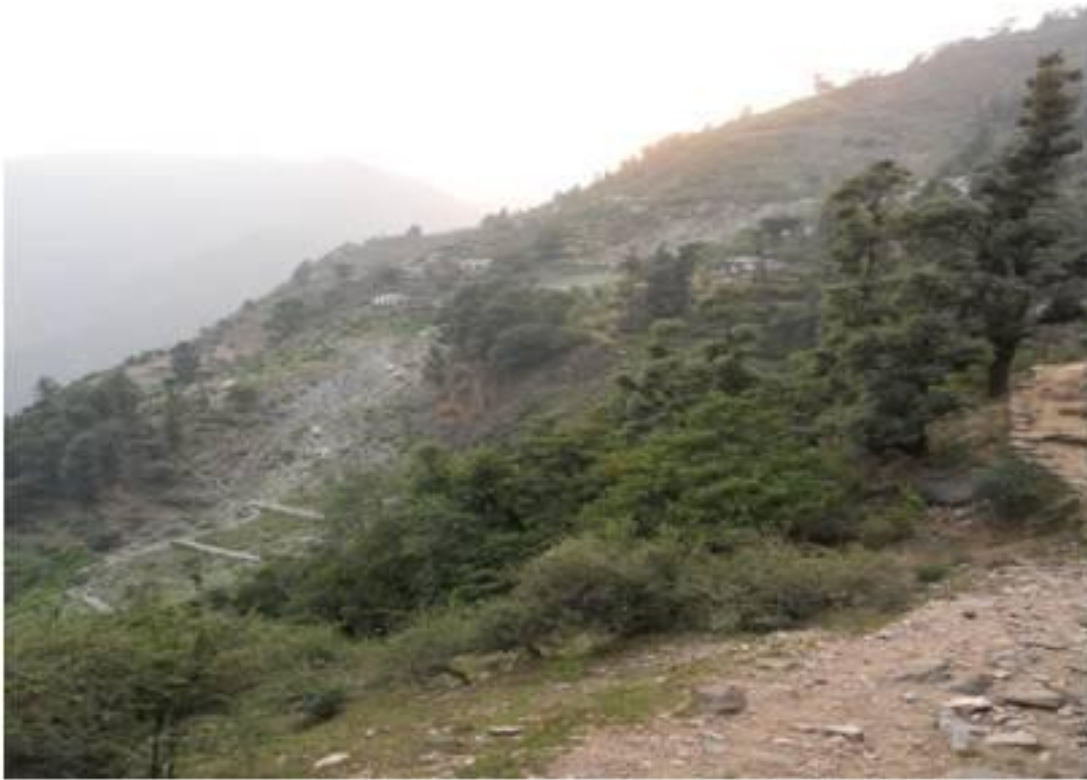
40 meters and vertical height of the slide was about 95 meters. Bouldery debris was mostly observed along the failure slope (Fig. 17).

Fig. 17: View of the landslide around Patak *tok* where it has damaged a number of agricultural fields.

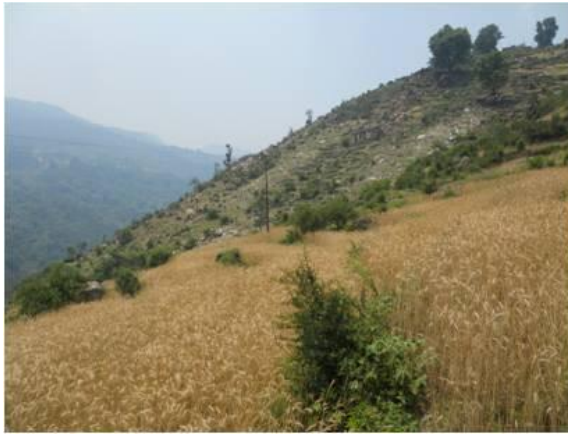
The slide was observed to have occurred on the southwestern slope of NE - SW trending ridge. Two houses were damaged in the southern side below the *tok* due to bank erosion by the local seasonal drainage on its right flank (Figs. 17 and 18).

Fig. 17: Photograph showing slope failure below Talla Wachham caused by bank erosion.

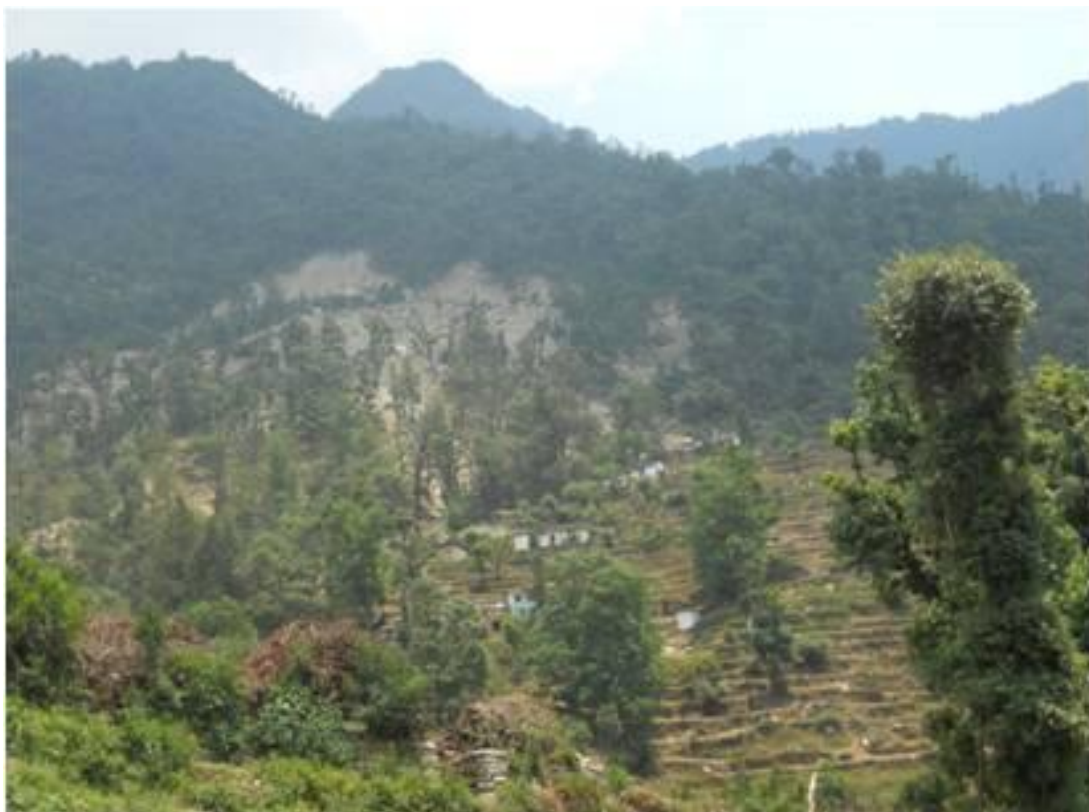
The saturation by rainwater was held responsible for increased pore water pressure in the overlying overburden mass. This at the same time provided lubrication amid the underlying jointed and fractured weathered rock layers. This was deduced to have reduced shear resistance of the slope forming materials and triggered the landslide.

Fig. 19: Photograph showing huge critical landslide mass over Lora tok.

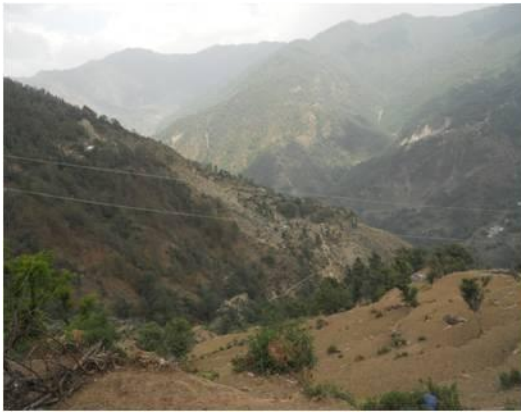
South of the Primary School, Rikhari jointed and fractured rocks mass was observed on the steep rocky slope. The loose blocks on the hill slope were observed to be hanging over the *tok*. These were deduced to have potential of falling down and damaging the houses (Figs. 20 and 21).

Fig. 20: View of rock fall zone over Malla Rikhari *tok*.

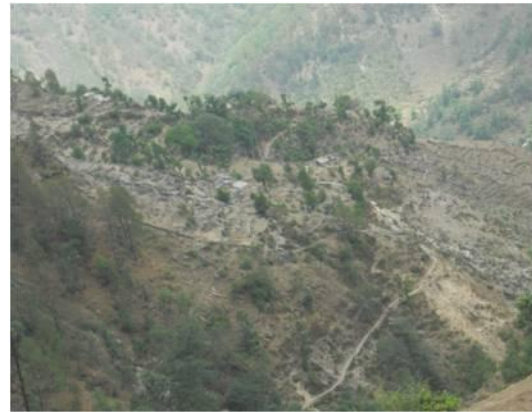
Fig. 21: Photograph depicting slope failure below Malla Rikhari *tok*.

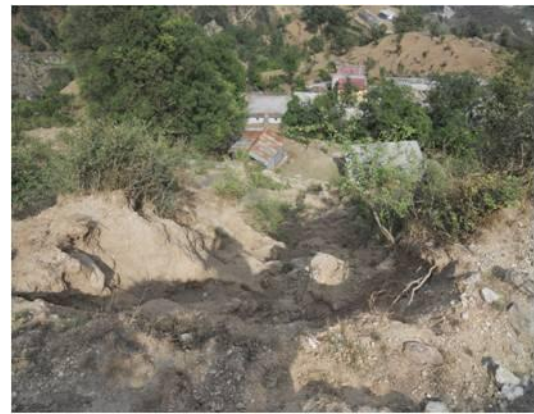
The shallow debris above the steep rocky slopes was deduced to have potential of initiating debris flow during heavy rainfall events. This could pose danger to the habitation below (Fig. 23).

Fig. 23: Photograph showing shallow debris slide over Dhurkot *tok*.

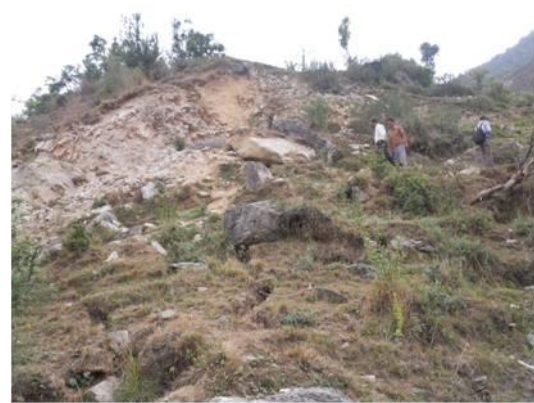
The failure was observed to have occurred on agricultural fields below the houses. A number of agricultural fields below the *tok* were completely damaged due to the slope failure. The quartzitic rocks were observed to be shattered by blasting undertaken during the road construction and this was deduced to have adversely affected the rock mass strength (Fig. 24).

Fig. 25 : Photograph showing landslide below existing houses

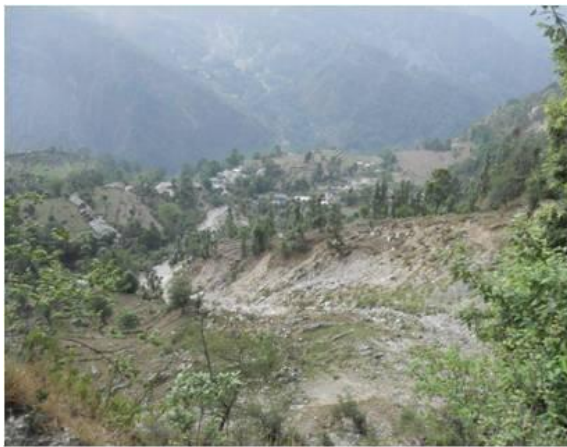
Fig. 26: View of landslide on the uphill side of Suding village.

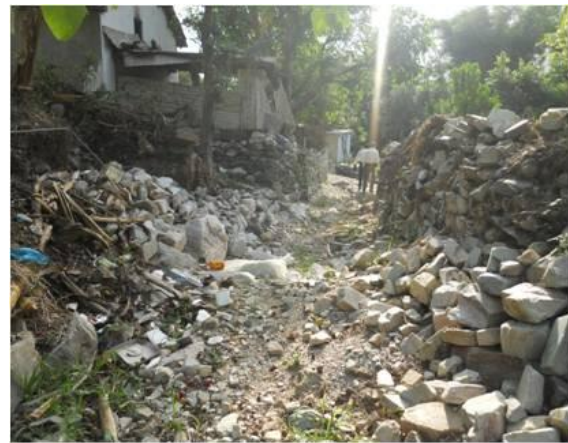
Landslide debris deposited upslope of the village along the nala bed was observed to pose threat to Suding village, especially in monsoons when the debris could flow through Bhandera nala and damage the houses along its course (Fig. 27).

Fig. 27: Photograph depicting encroachment along the course of Bhandera nala.

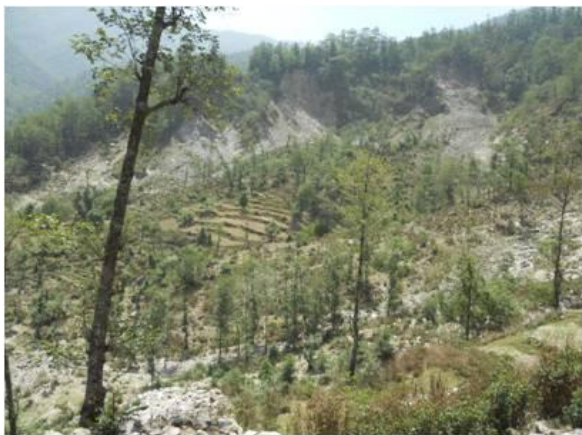
High flood in Laundhariya nala was observed to have damaged a number of agricultural fields at the eastern extremity of village (Fig. 28). The slide was observed to have occurred on the eastern slope of NW - SE trending ridge. General inclination of failure slope was observed to be 35° whereas the slope in the crown portion was more than 50° . The width of the failure slope was about 60 meters and its height was about 90 meters.

Fig. 28: View of the agricultural fields damaged at the eastern extremity of Gansi village.

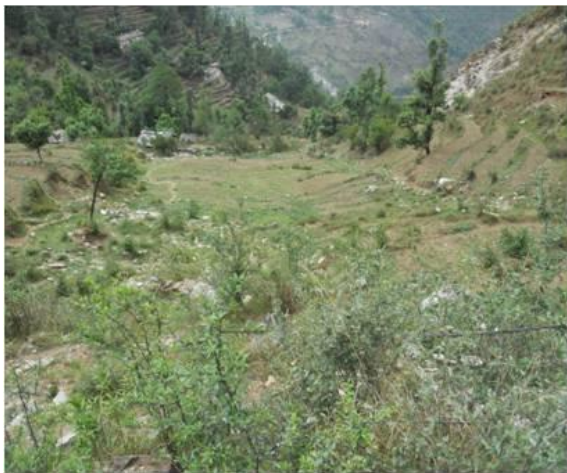
Fig. 30: View of the damaged agricultural fields.

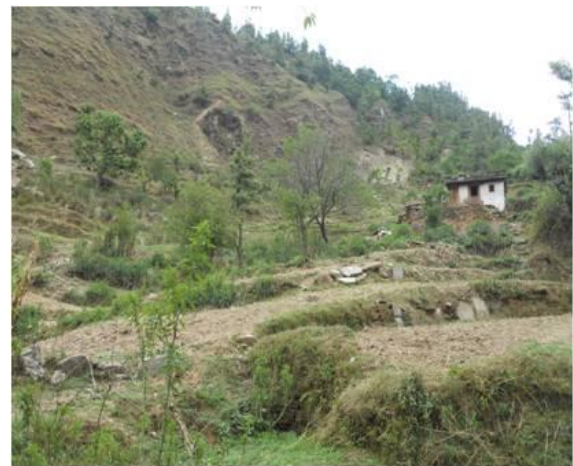
Two seasonal water courses flowing towards west in the upslope portion of the *tok* were deduced to have contributed to the instability of the area. In the western side of the *tok* one house was observed to be damaged by landslide (Fig. 31).

Fig. 31: Photograph depicting partially damaged house.

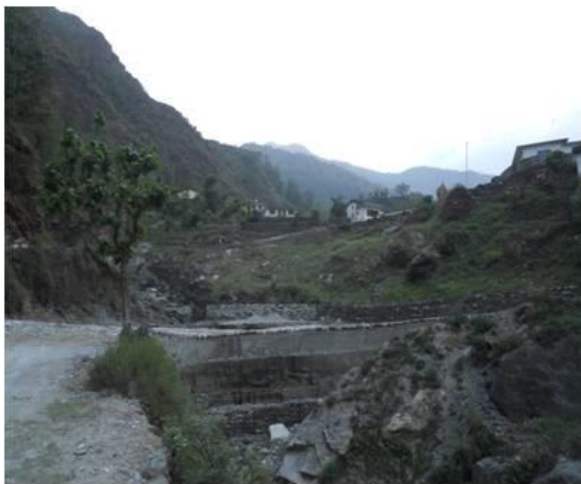
Fig. 32: View of slope failure around the tok.

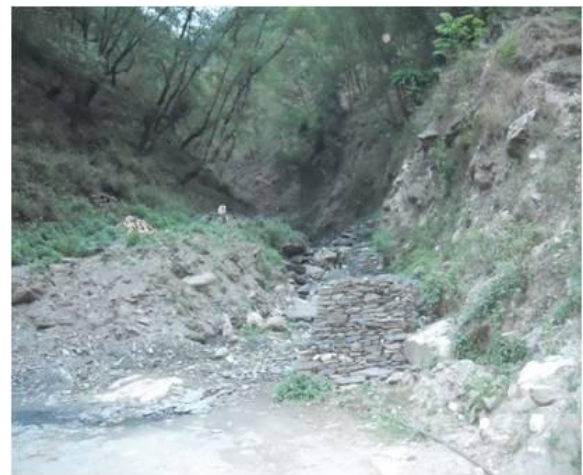
Fig. 33: Photograph depicting bank erosion by the seasonal nala.

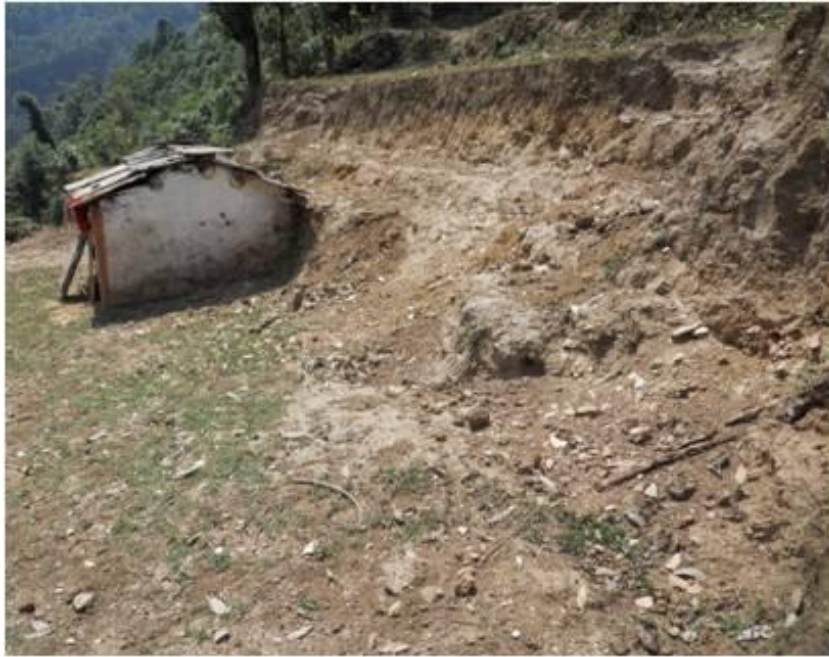
In the back slope area of an existing house quarrying was observed to have been undertaken on agricultural land and loose soil / quarried material was dumped in the area (Fig. 35).

Fig. 35: Quarrying at back slope of an existing house.

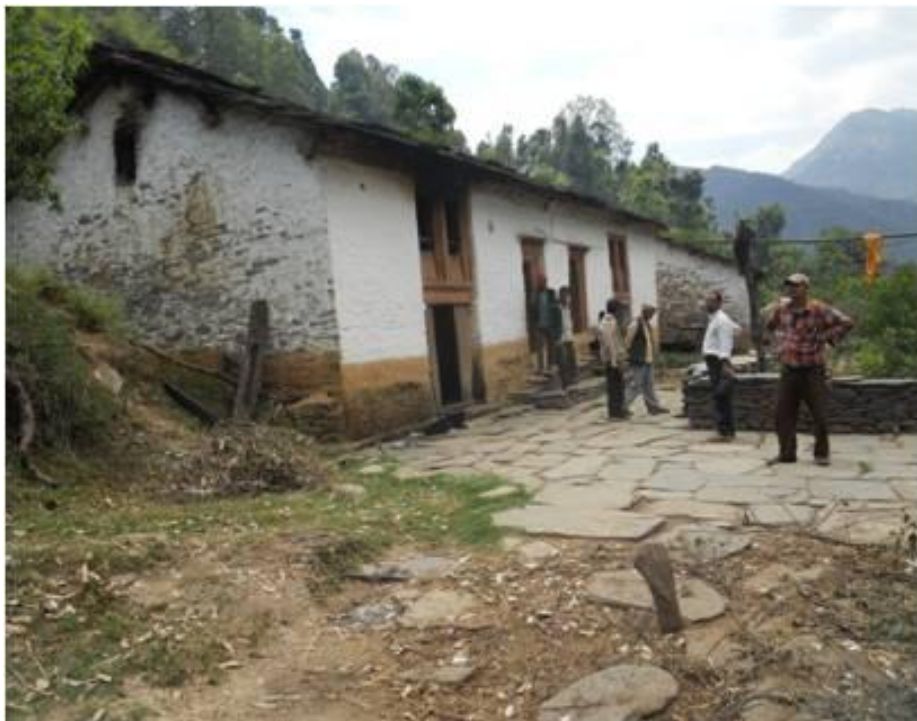
Fig. 36: View of the house in Thulkatyau *tok* showing evidence of local settlement.

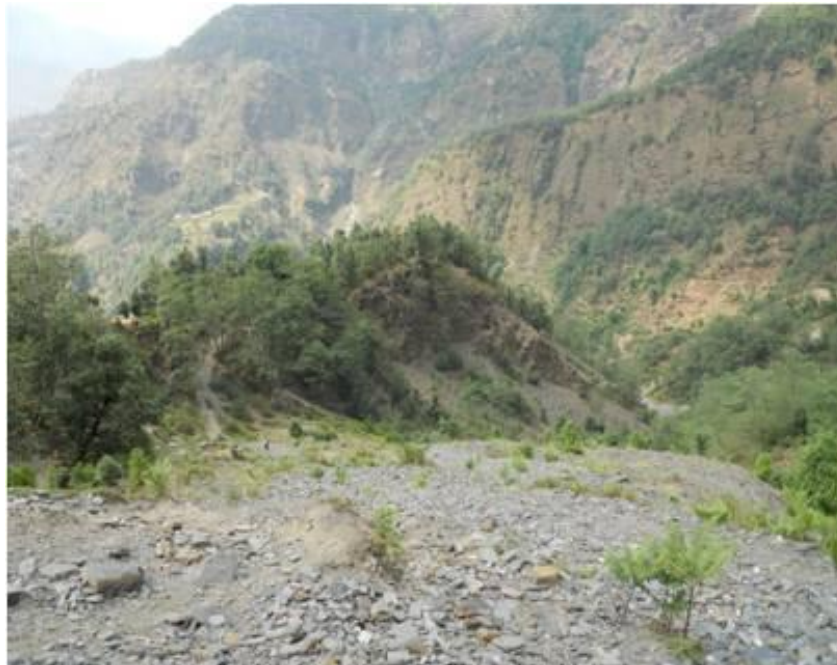
Fig. 37: View of the eroded rocky slope at the eastern end of Bhechana *tok*.

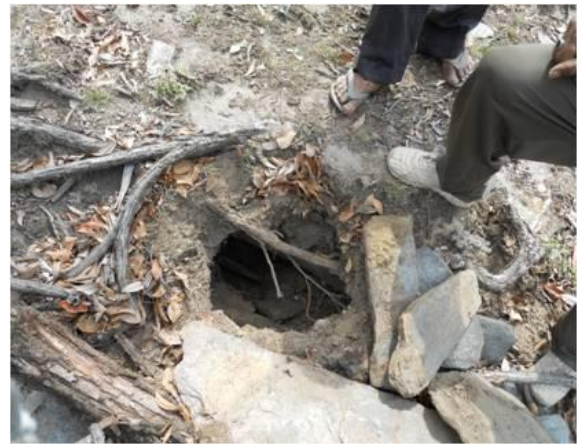
In the forest area up slope of the *tok* tension cracks and about 35 – 40 cm deep voids of were observed. This area was however fairly far from the *tok* (Fig. 39). On the left bank of the Shum gad the natural slope was observed to be parallel to the foliation planes. This might cause instability in the area. However, signs of such instability were not observed on the natural slopes of the area. Assessment of shallow instability and soil creep could however not be undertaken due to dense vegetation cover.

Fig. 39: Photograph depicting voids in the forest area.

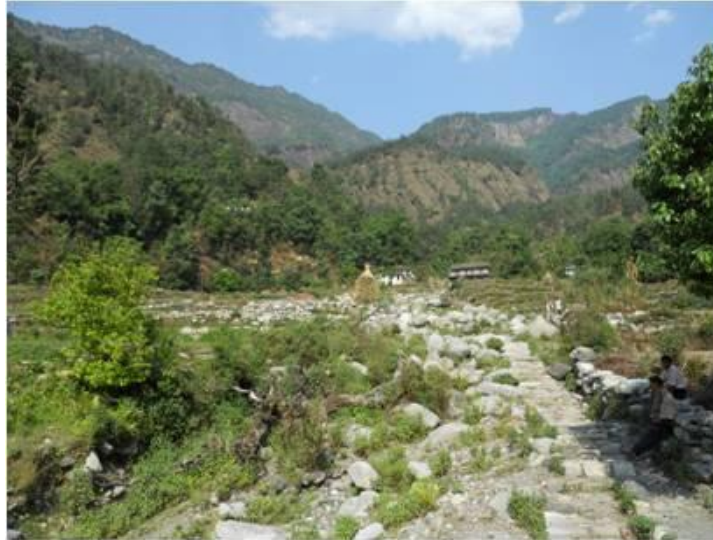
Shum gad was observed to be affected by bank erosion that was deduced to contribute to the instability of the area. In year 2010, the nala was reportedly diverted towards the *tok* and caused damage to a number of houses along its course (Fig. 40).

Fig. 40: Photograph showing the damage in Bhamal *tok* caused by flood in the nala.

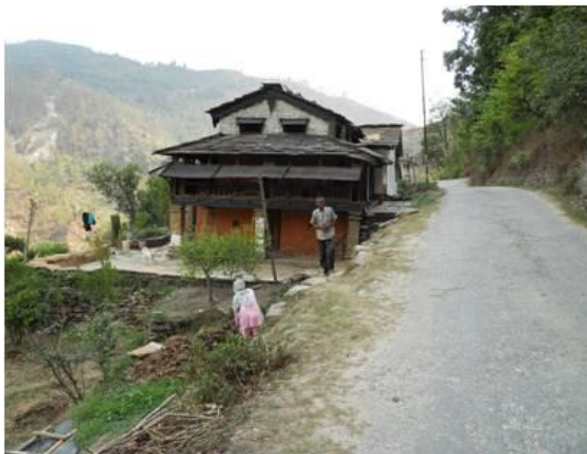
Fig. 41: Photograph depicting deformation in the houses.

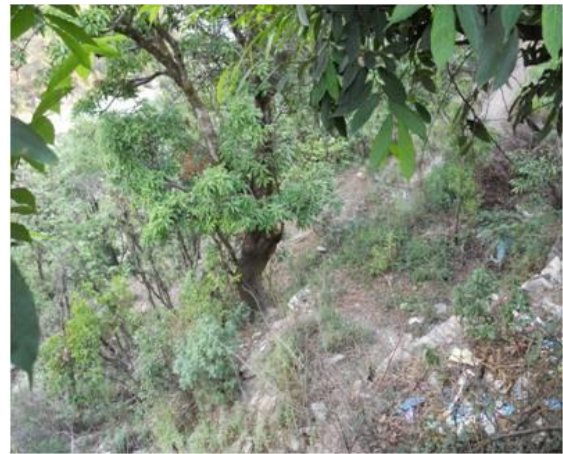
Voids and cracks were observed on the failure slope just below the *tok*. The failure slope was observed to have slope of around 45° and the slope direction was towards southeastern. Tilted and bent trees observed on the failure slope indicated creeping of tuffaceous debris material (Fig. 42).

Fig. 42: View of bent trees indicating creep movement.

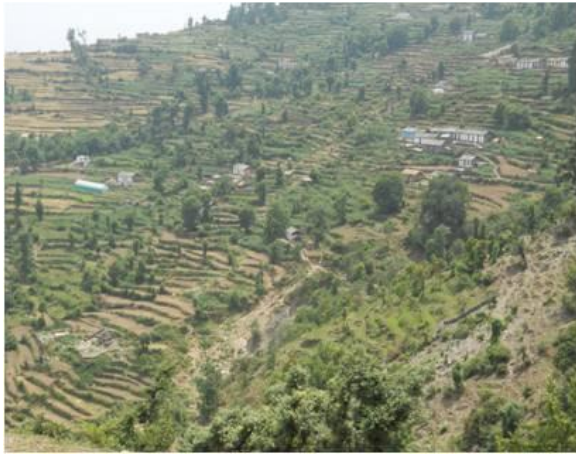
In the northern extremity of *tok* bank erosion by Gora gad was observed to have damaged a number of agricultural fields and affected many houses. About 12 houses were affected by both seasonal water course and perennial stream (Figs. 43, 44 and 45).

Fig. 43: Photograph showing agricultural fields damaged by bank erosion.

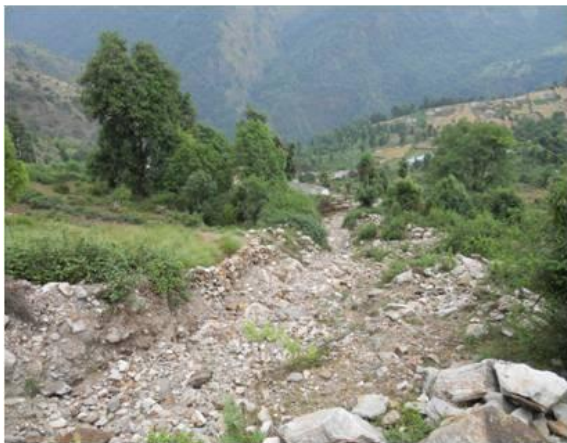
Slope material and debris in the area upslope of the *tok* was observed to pose threat to the Gora *tok*, especially during intense rainfall spells when the same is likely to be brought down by the seasonal nala (Fig. 46). Around 21 families were thus observed to be vulnerable to debris flow and bank erosion by Gora gad.

Fig. 45: View of the seasonal water course upslope of tok.

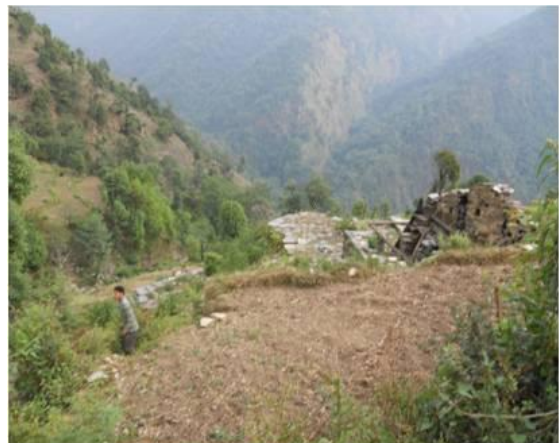
Fig. 46: Photograph depicting the house damaged by ground subsidence.

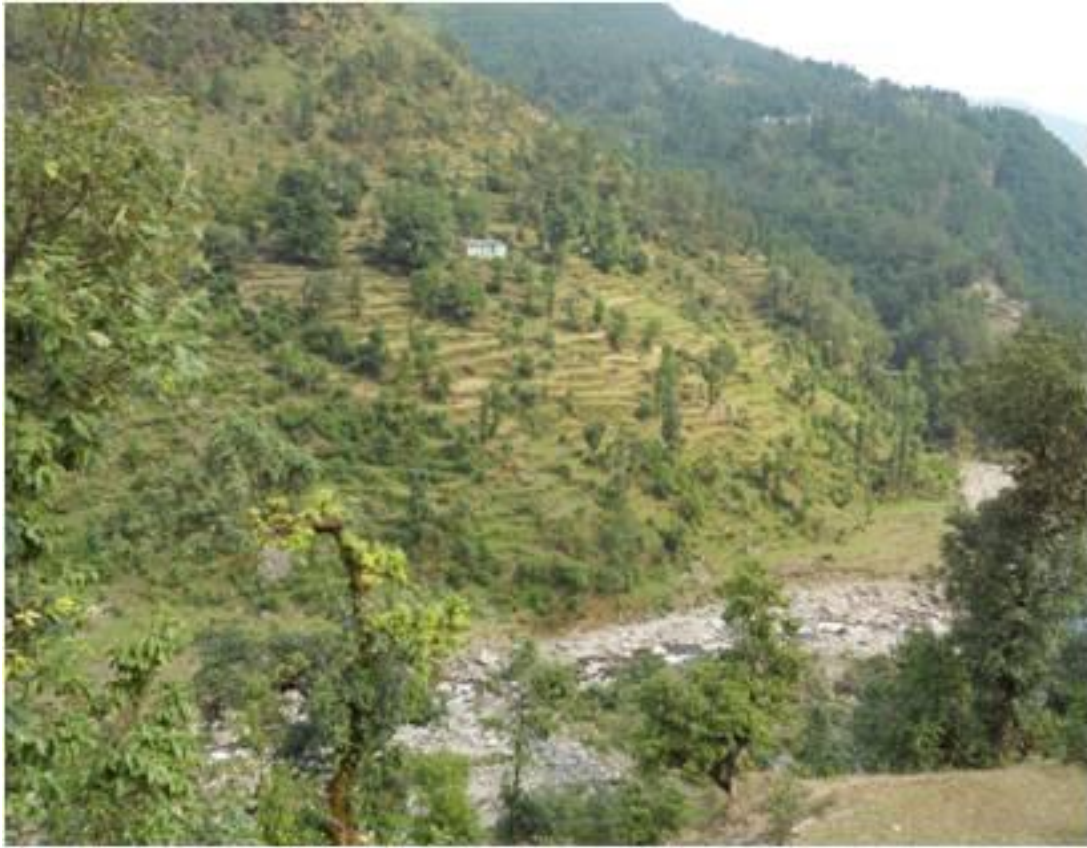
Bank erosion by Sarju river on its left bank was observed to pose threat to the stability of *tok*. Evidences of localized differential settlement were observed in some houses. However, no indication of the slope movement in agricultural land and in the area around *tok* was observed (Fig. 47).
