# **Sikkim Earthquake of 18<sup>th</sup> September, 2011**

## **A Report**

**Disaster Mitigation and Management Centre**

**January, 2012**

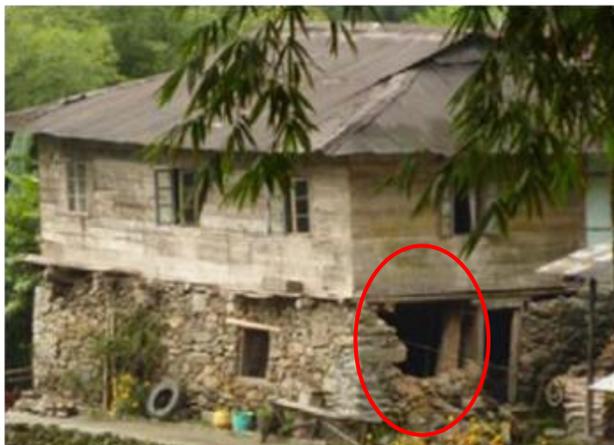
The damage is observed to be mainly limited to the random rubble masonry support walls of these structures.

*Fig. 6. Partial collapse of RR support wall.*

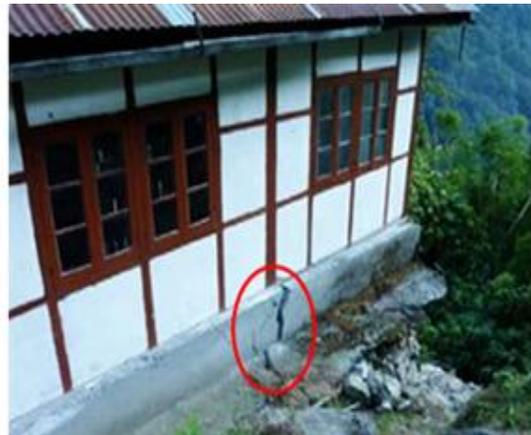
Damage is also observed in the foundation, mainly on hill slopes.

*Fig. 7. Damage to the foundation of Ekra house.*

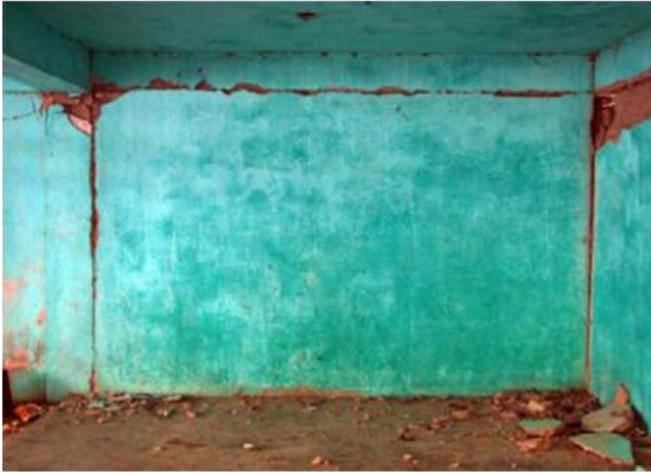
*Fig. 10. Cracks at the interface of RC columns/beams.*

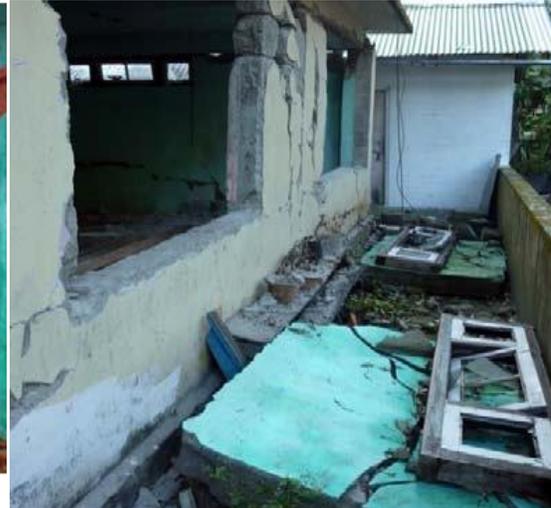
*Fig. 11. Damaged caused at the sill level*

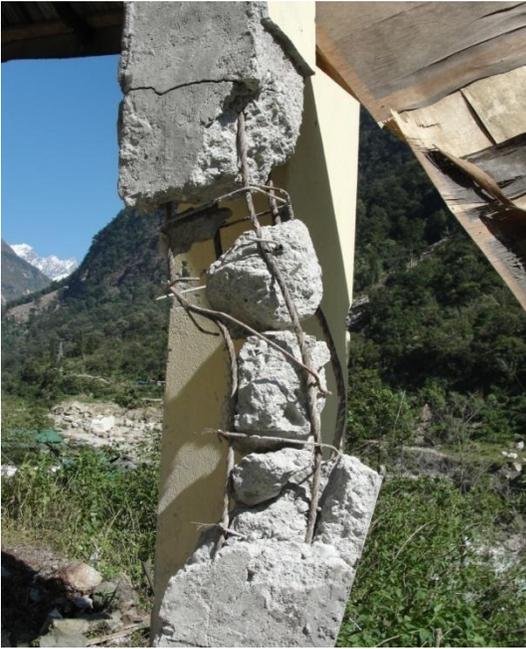
*Fig. 12. Buckling in column due to insufficient restraint in lateral direction.*

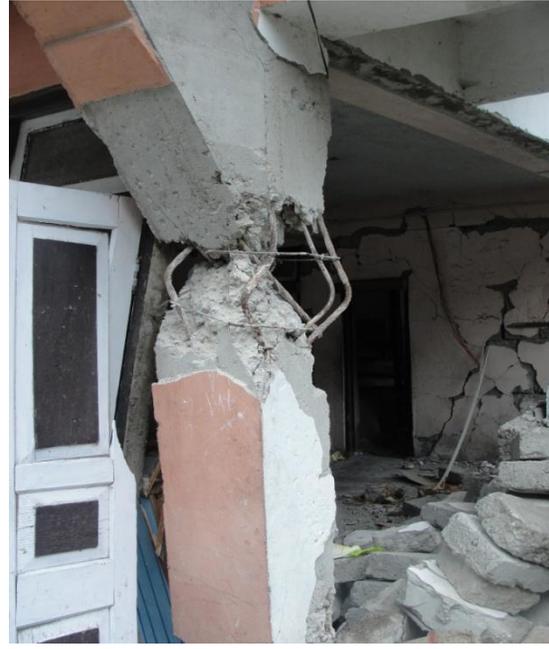
*Fig. 13. Failure of the column near the flaring.*

the beam-column joint. The stress intensity however increased in the lower portion of column ensuring damage at a lower point.

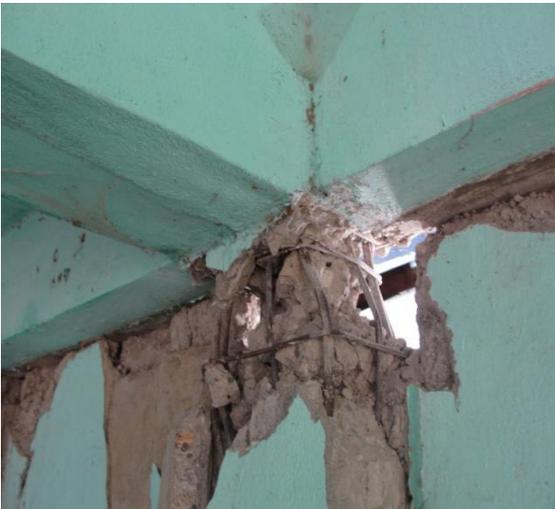
*Fig. 14. Cracking at the beam column joint.*

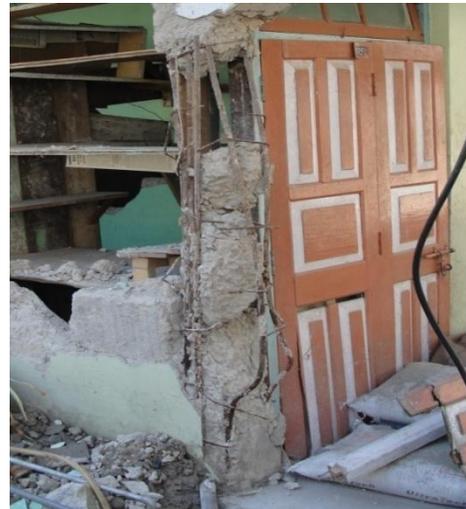
In some cases, it was found that the column faced damage due to the larger spacing of shear ties.

*Fig. 15. Failure showing larger spacing of shear ties.*

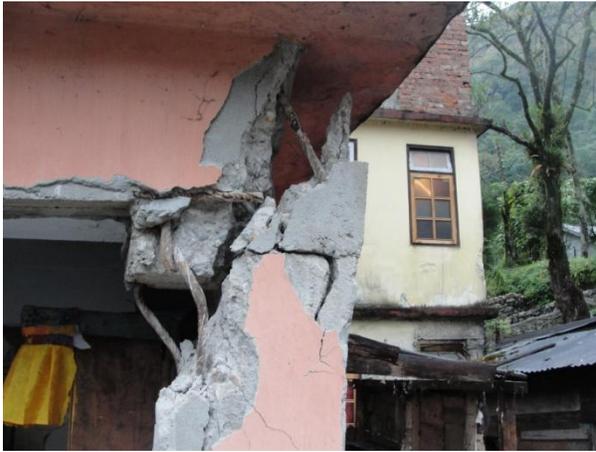
An interesting phenomenon observed during the field visit was that the beam-column joints that had flaring suffered relatively less damage as compared to the columns without flaring at

*Fig. 16. The joints without flaring.*

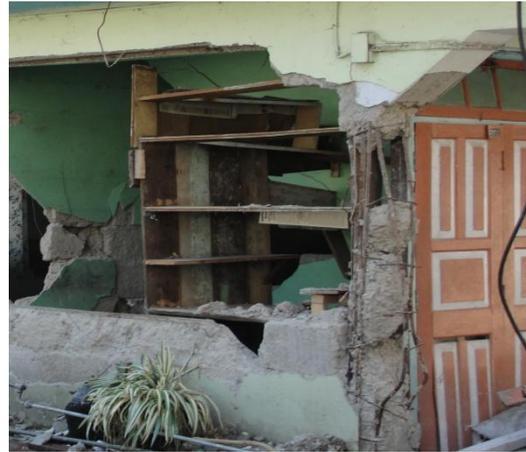
*Fig. 17. The joints with flaring.*

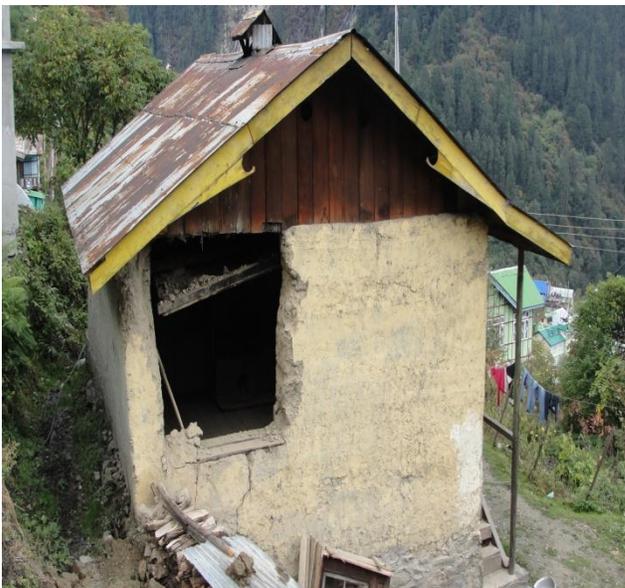
*Fig. 18. Partial collapse of earthen wall.*

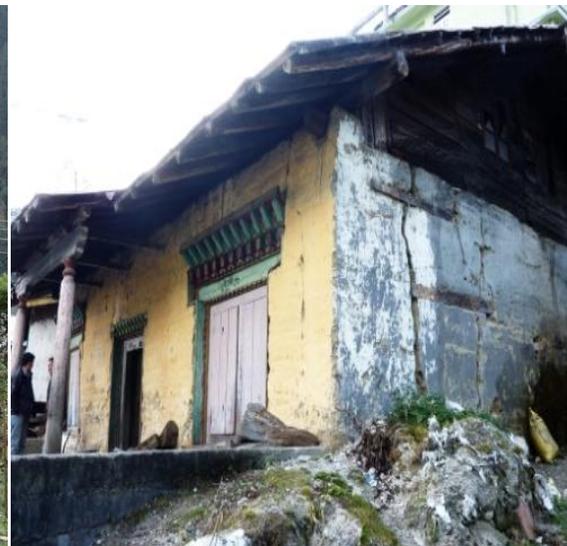
*Fig. 19. Cracking of earthen wall.*

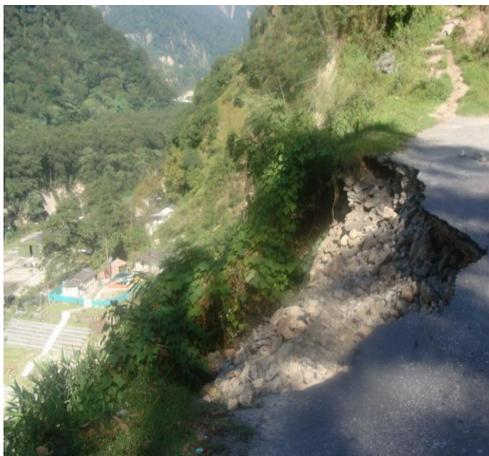
*Fig. 20. Damage to the edges of the road.*

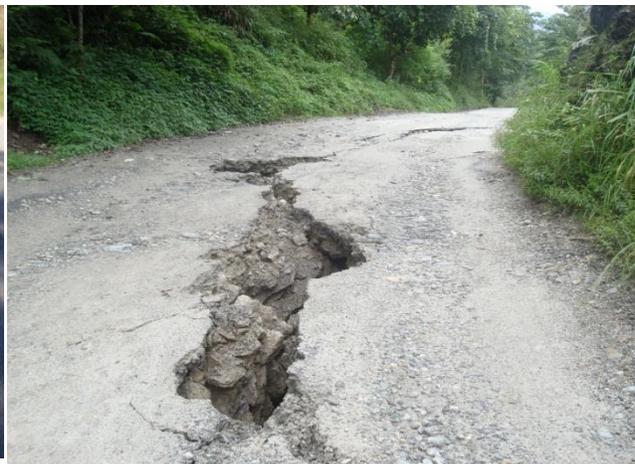
*Fig. 21. Wide cracks in the road.*

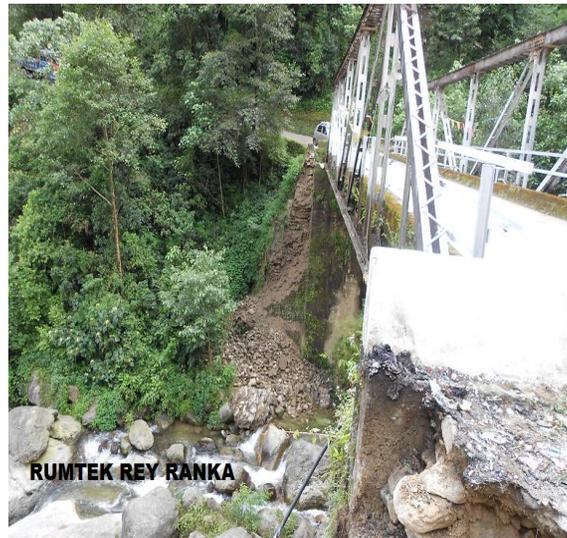
*Fig. 22. Damage to the bridge abutment.*

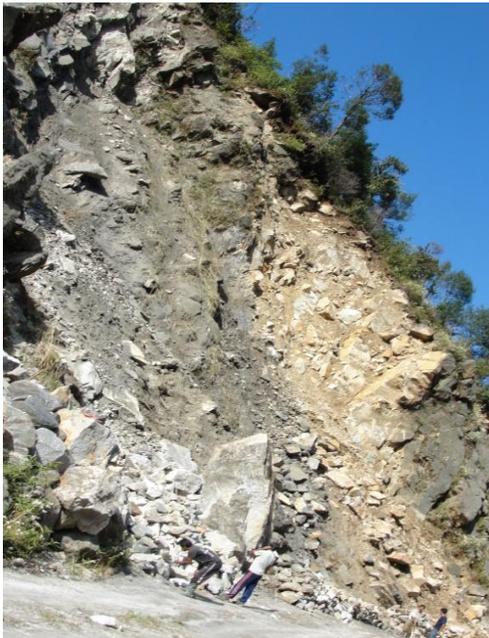
*Fig. 23. Reactivation of colluvial material along the slope.*

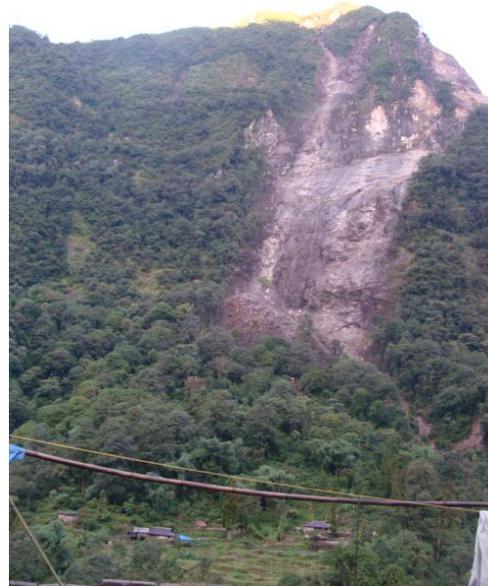
*Fig. 24. Rock fall along the steep valley face.*

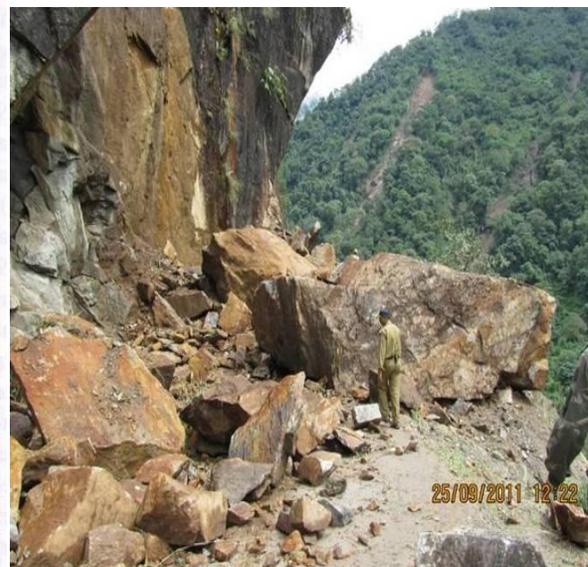
*Fig. 26. Rock fall along the steep valley face.*

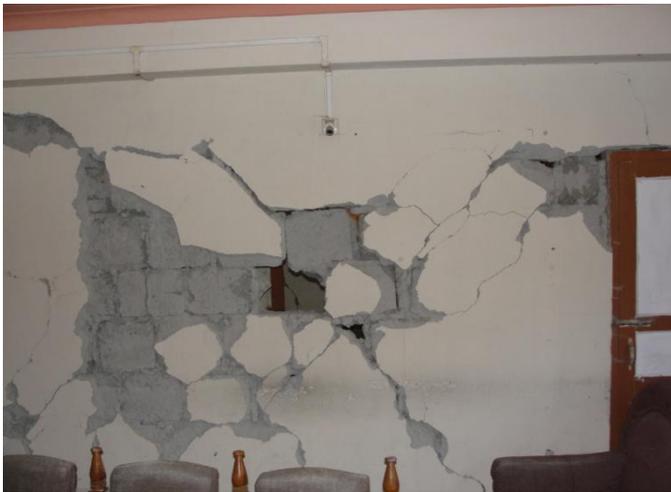
*Fig. 27. Damaged hollow blocks.*

- Walls are excessively thin. In case of hollow block masonry, the blocks are often placed vertically on their edge. This makes individual blocks unstable, and thus adversely affects the stability of the entire wall.
- In a large number of cases the exterior walls are observed to rest on the cantilever slab with no RC columns in between. This results in extremely long and hence, slender walls.
- Bond amongst the concrete blocks is observed to be poor on account of smooth surface of the blocks.

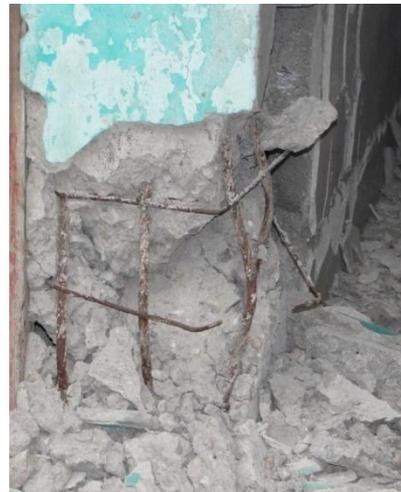
*Fig. 28. 90° tie hook opening up.*

- The columns were often observed to be too slender in relation to the overall height of the structure. The stirrups of the column were observed to have been bend at an angle of  $90^{\circ}$  instead of  $135^{\circ}$ . This is often responsible for the opening up of rings.

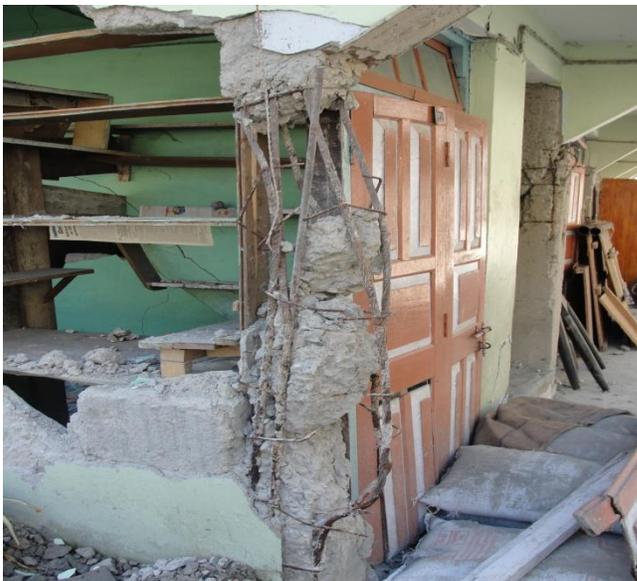
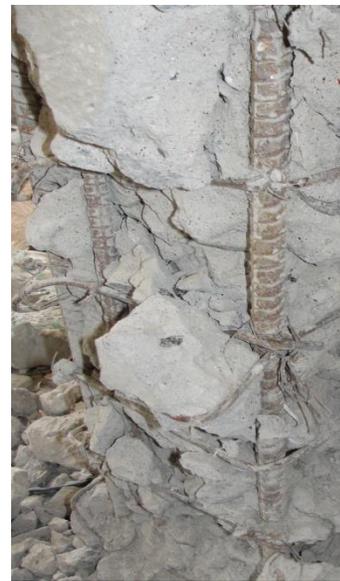
*Fig. 29 and 30. Column ring diameter lesser than 6 mm used in combination with 20 mm.*

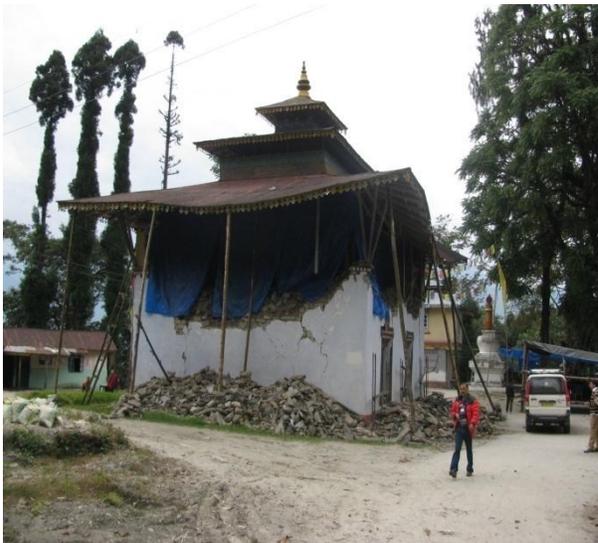
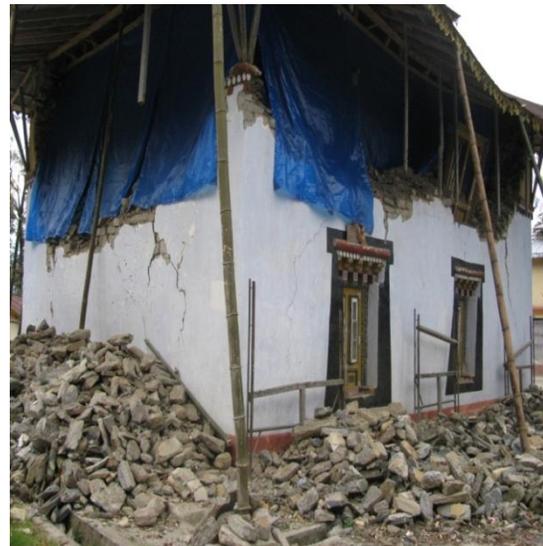
*Fig. 31 and 32. Rumghem Gompa*

- Poor interlocking among stones and among inside and outside wythes.
- Seismic forces.
- Absence of anchoring between the walls and the roofs.
