Disaster in Rudraprayag District of Uttarakhand Himalaya: A Special Emphasis on Geomorphic Changes and Slope Instability

Disaster Mitigation and Management Centre, Department of Disaster Management, Uttarakhand Secretariat, Dehradun-248001, Uttarakhand, India

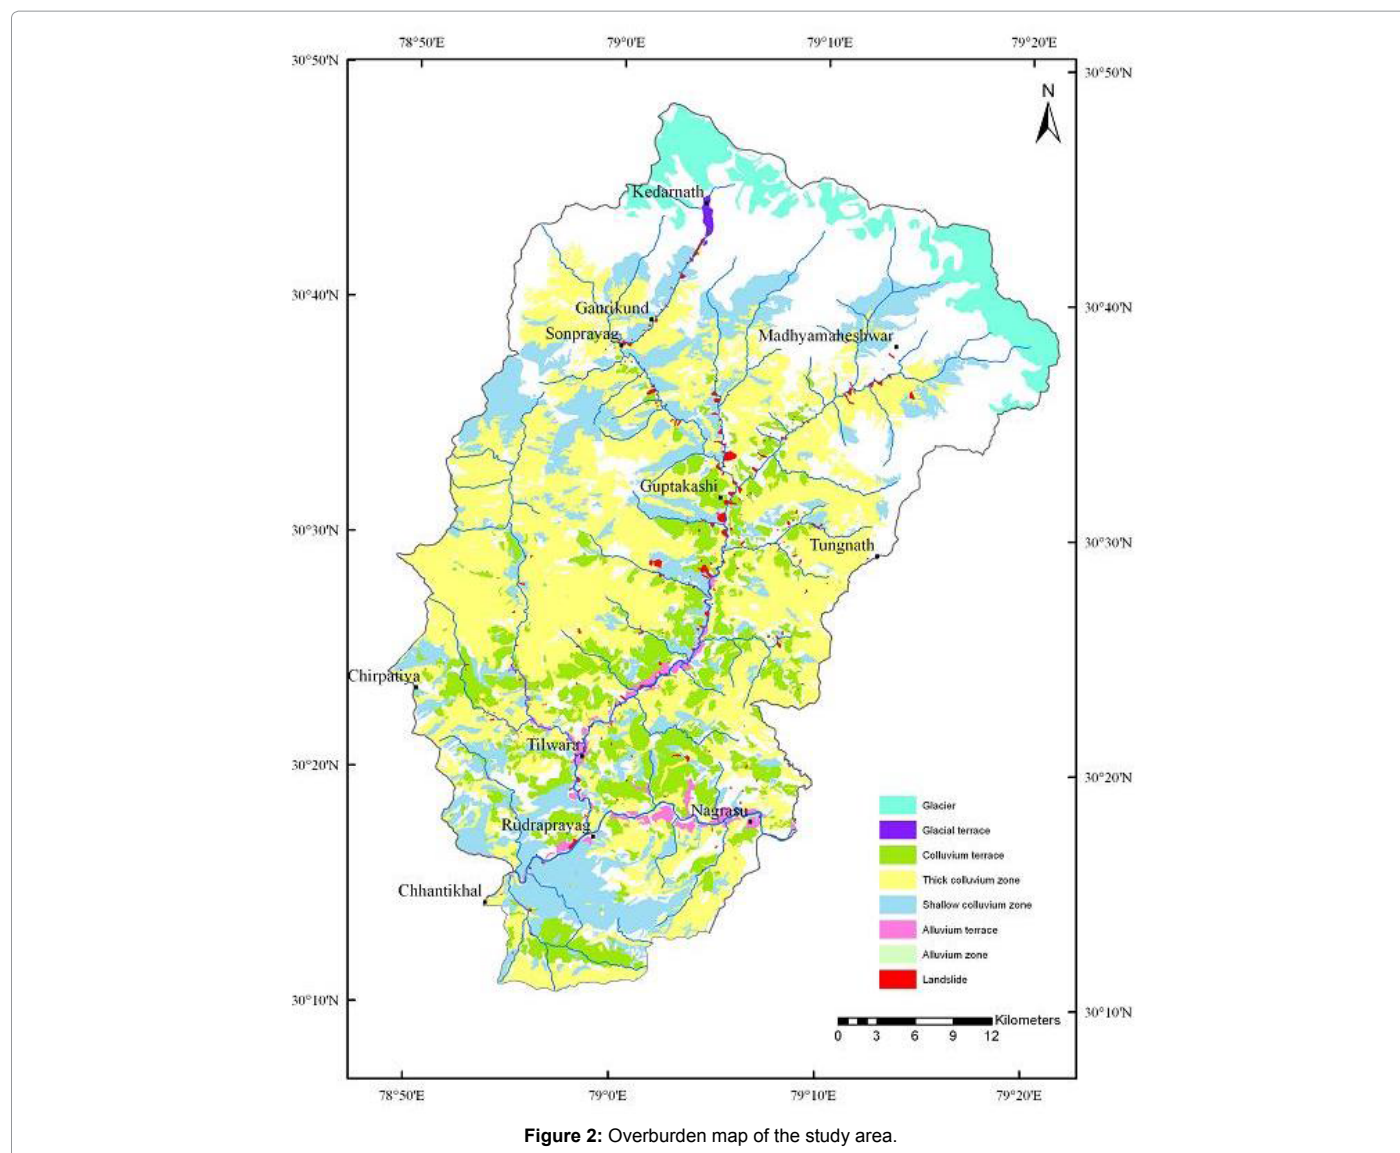
Figure 2: Overburden map of the study area.

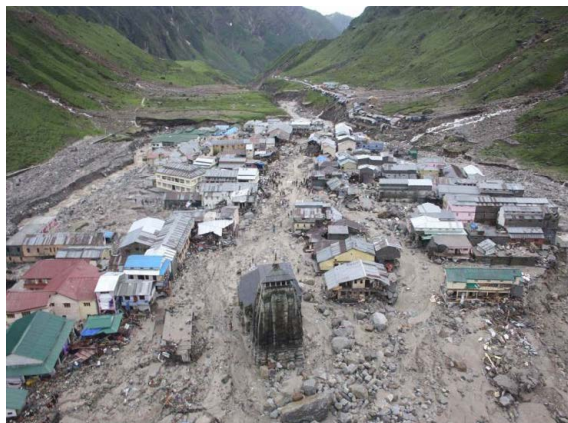
Figure 3: View of Kedarnath after the disaster of 16-17 June 2013.

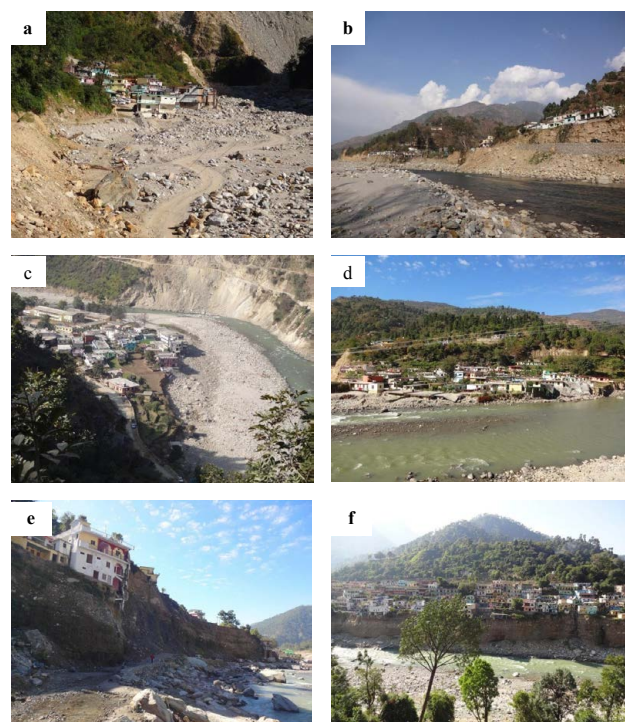
around Sonprayag, Chandrapuri, Tilaknagar, Ganganagar, Vijaynagar and Tilwara towns along the course of Mandakini river (Figure 4). These observations related to change and deposition are summarized in Table 1.

Figure 4: Deluge of June, 2013 events caused devastation in these towns; (a) Sonprayag, (b) Chandrapuri (c) Tilaknagar, (d) Ganganagar, (e) Vijaynagar, (f) Tilwara. All these towns situated over river borne materials (RBM) terraces along the banks of Mandakini river.

Most devastation has taken place on the river borne material terraces, particularly around Sonprayag, Chandrapuri, Tilaknagar, Ganganagar, Vijaynagar and Tilwara towns along the course of Mandakini river. It is therefore that some portions of these towns required to be relocated.

It is highly recommended that all the constructions in the townships located along the Mandakini river should maintain respectable distance from recent high flood level (HFL). Appropriately designed awareness drive is highly recommended for persuading people to maintain a respectable distance from streams and rivers when deciding to settle down. As a rule of thumb, message has to be sent across that the structures should be sited 50 to 100 meters from river bank. These however depend on the specific site conditions.

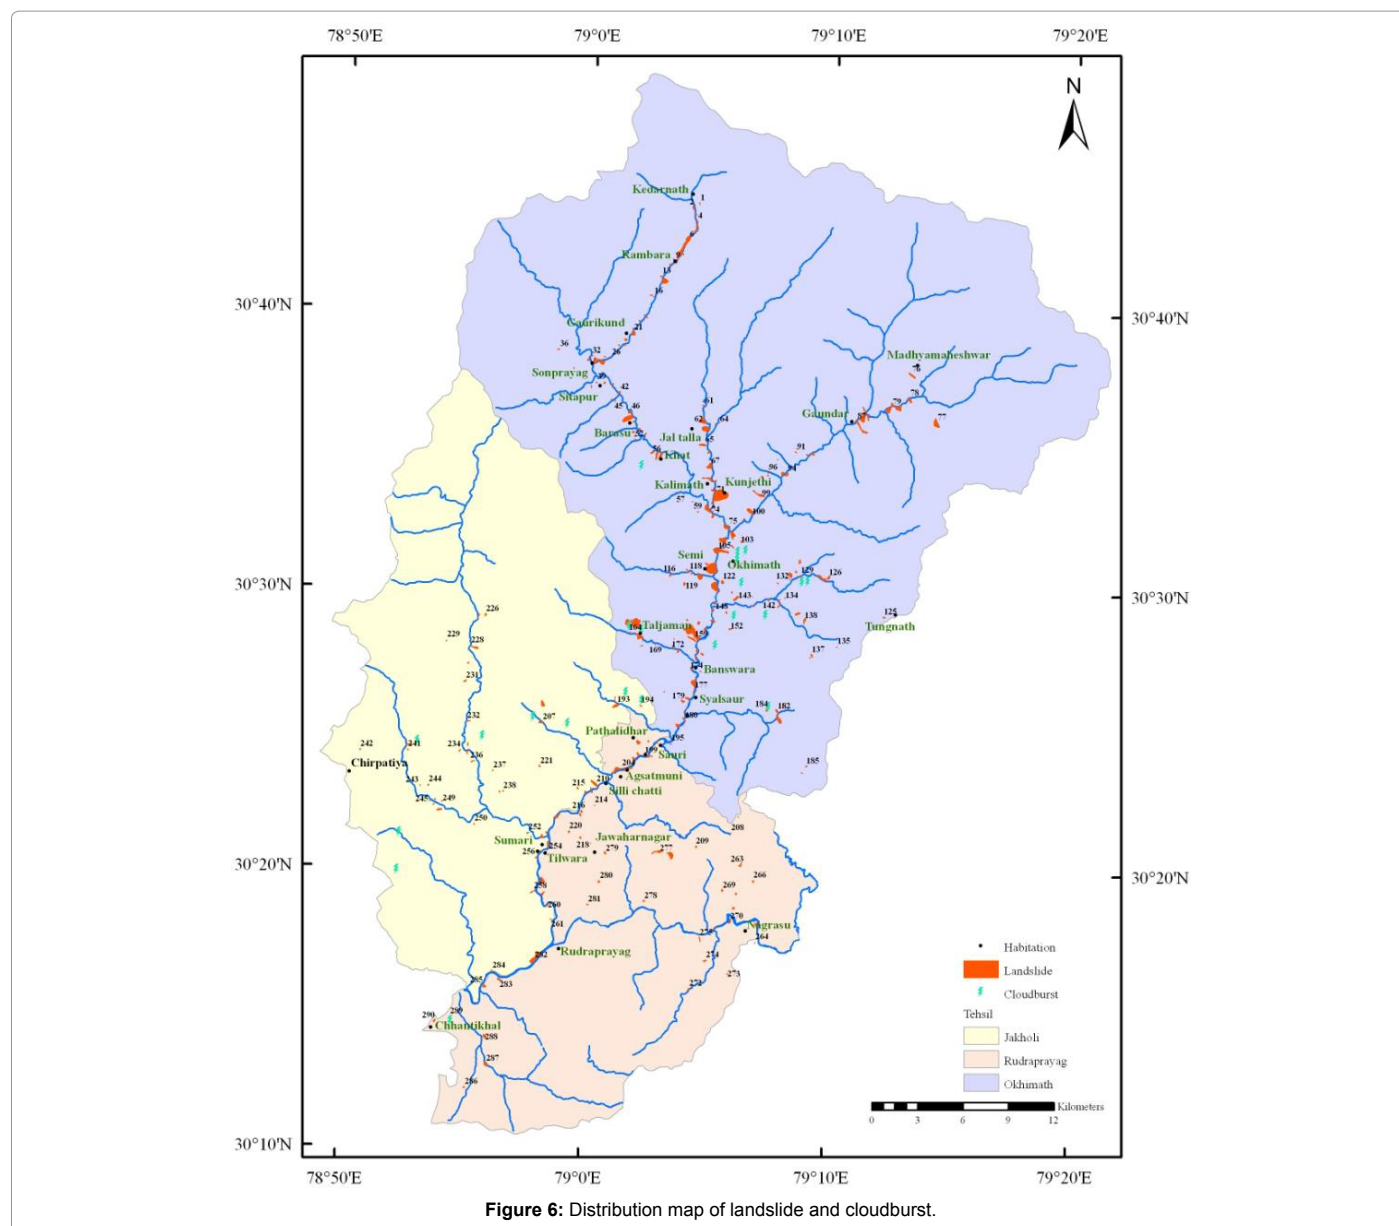
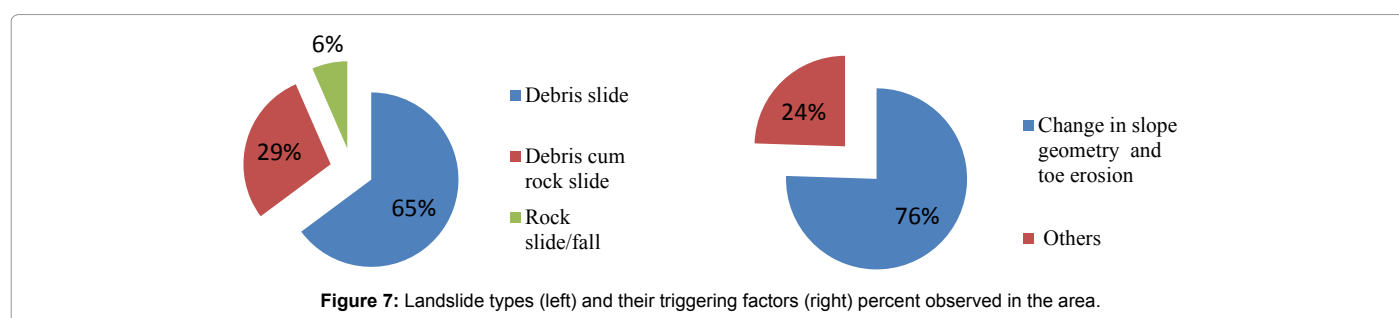
Analysis to data pertaining to the landslide observed in the field shows that the majority (65 percent) falls in the category of debris slide (Figure 7). This makes it amply clear that the overburden or debris material was saturated by prolonged heavy rainfall and the same was the responsible for the initiation of landslides.

Out of total landslide incidences recorded in entire district, 219 numbers are caused by change in slope geometry for infrastructural developments and toe erosion by stream. Another 71 numbers are however also caused by other factors that include heavy rainfall, lithological and structural condition of the bed rocks, surface and sub-surface water and deforestation. Majority of landslide incidences in this area largely (76 percent) are observed to be triggered either by change in slope geometry or toe erosion (Figure 7).

Landslide inventory map can be helpful in clear demarcation of relatively safe and unsafe zones. It is highly recommended that any constructional activities in the close proximity of landslides should necessarily be backed by appropriate geological-geotechnical assessments.
