Geological investigations in Rudraprayag district with special reference to mass instability

Disaster Mitigation and Management Centre

A Disaster Mitigation and Management Centre (DMMC) publication

2014

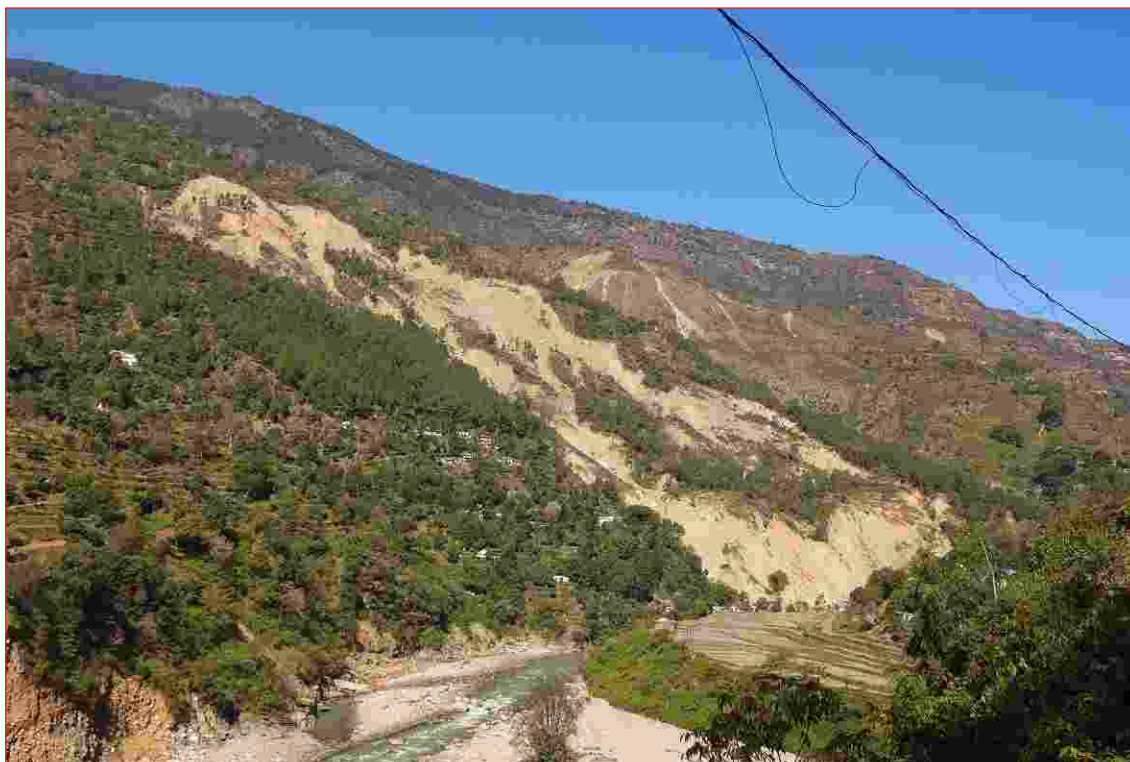
Fig. 17: Photograph of Nagjagai landslide.

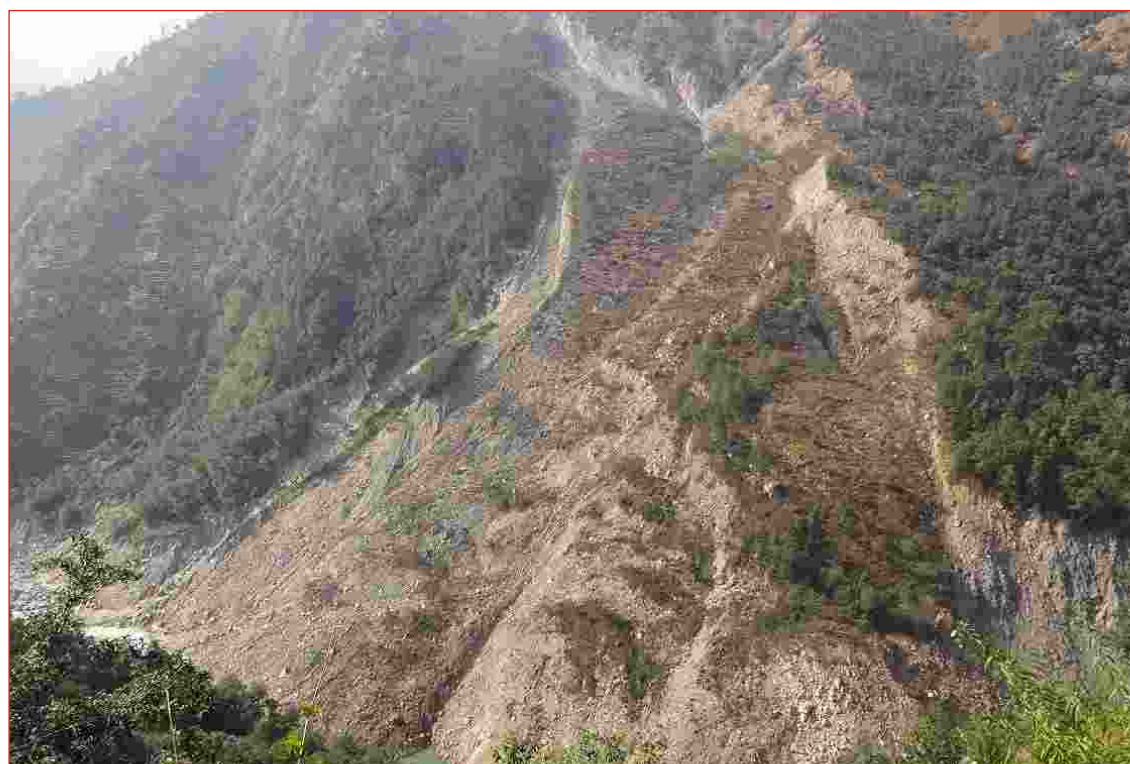
Lake formation is observed in the field around Jagi - Bedula slide zone. It is however in an initial stage but further downslope movement of debris and rock mass has the potential of posing a serious threat. The

Fig. 18: Lake formation due to Jagi-Bedula landslide.

landslides in this slide zone have huge amount of debris and debris laden water can easily erode loose portions of the slope causing further slope failure and consequently causing river blockade during monsoon period.

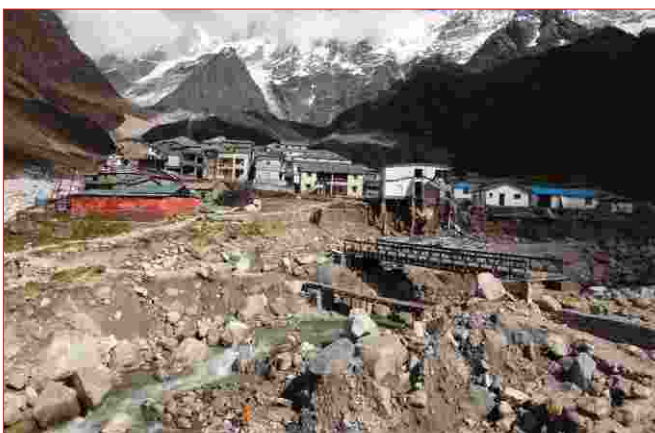
Fig. 19: Severely damaged structures over glacial outwash plain at Kedarnath.

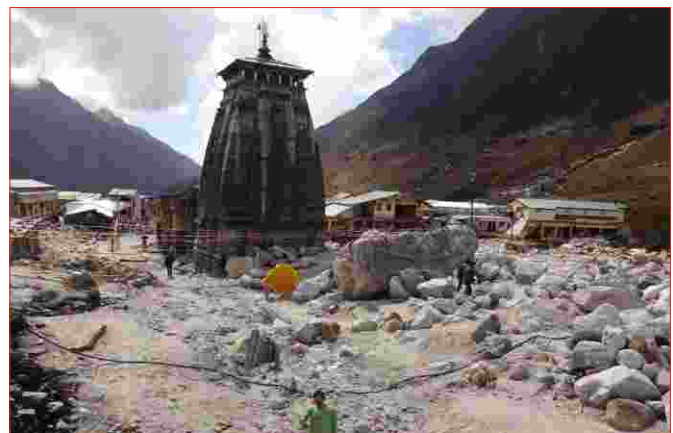
Fig. 20: Large boulders around the temple.

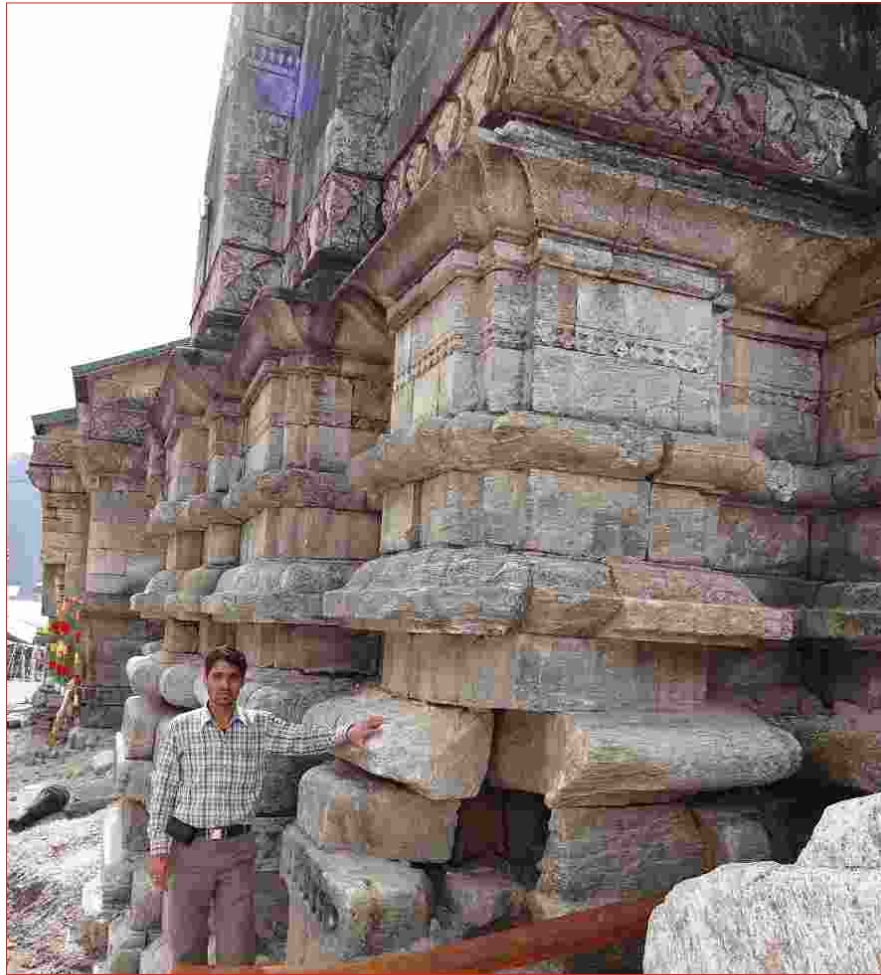
Heavy precipitation was received in upper Mandakini valley in June 2013. Thick pile of snow was present in the upper reaches of the area at that time. Breach of moraine dammed Chorabari Tal together with sudden melting of snow and heavy rainfall resulted in flash flood in the area. Huge volume of glacial debris along with large boulders was transported and re-deposited in this event that resulted in the activation of abandoned Saraswati channel to the east of the shrine. Due to this incidence around 1.0-2.0 meters thick pile of sediments with huge boulders got deposited on the valley floor (Figs. 19 and 20). A number of structures around the temple, particularly those to the north of it were ravaged in this incidence and the eastern wall of the temple as also many other structures were badly damaged (Fig. 21).

Fig. 21: Severely damaged eastern side corner wall of the main shrine at Kedarnath.

therefore be made to excavate the temple platform. This is likely to have adverse effect on the stability of the temple superstructure. Repair of the damaged portions of the temple should be carried out under personal supervision of experts.

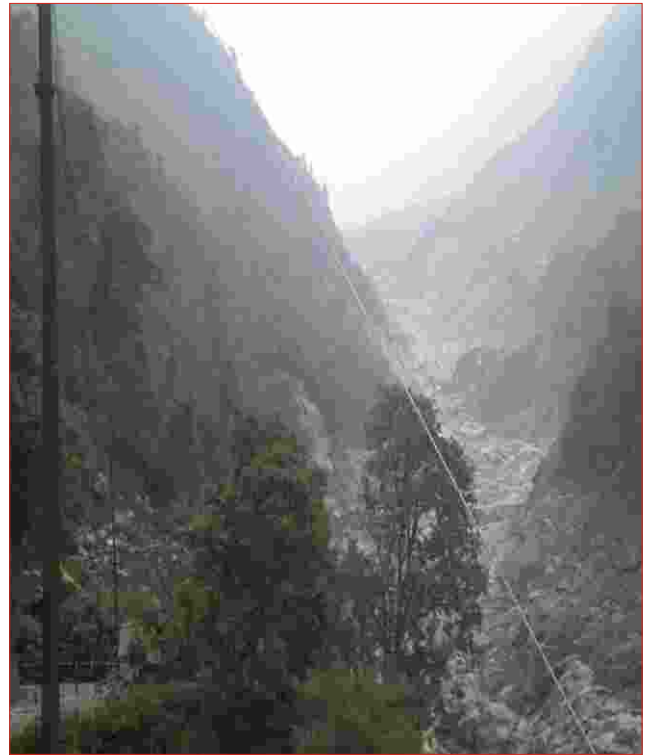
Rambara was located at a distance of 07 km from Gaurikund on the right bank of Mandakini. The place has been totally washed off in June, 2013 disaster (Fig. 22 and 23) and what exists is an active slide zone with glacial moraines visible on the scar below the in situ rock face.

Figs. 22 and 23: View of Rambara before (left) and after (right) the disaster. Camera looking south along the course of Mandakini.

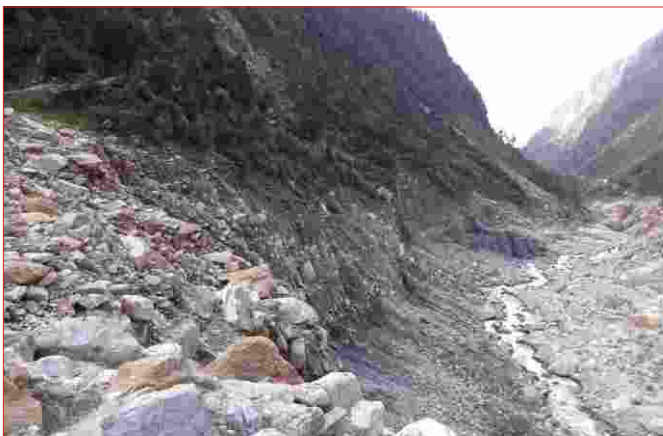
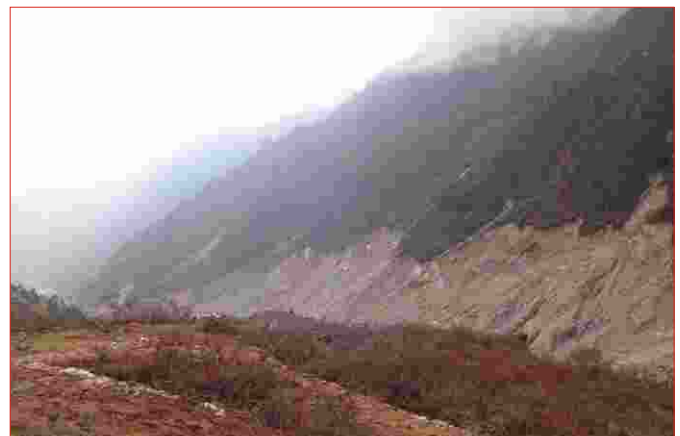
Figs. 24 and 25: Rambara town (left) and RCC footpath (right) were completely washed off due to flash flood.

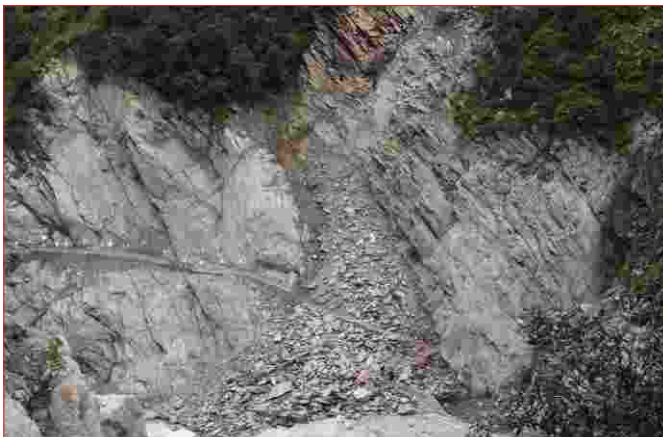
Fig. 28: Photograph shows damaged RCC footpath just upstream to town.

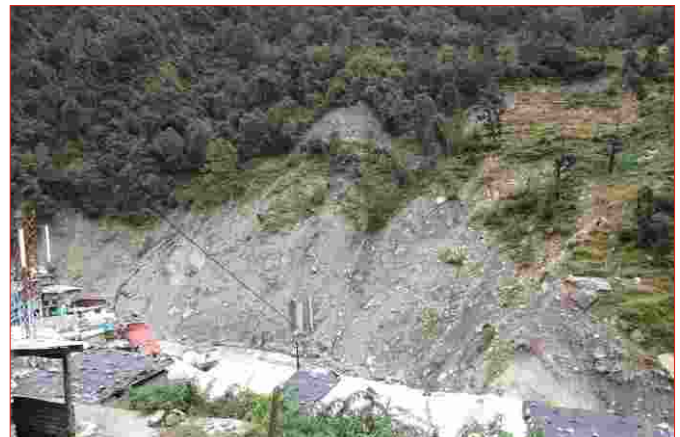
Landslides are also observed on the opposite side of the market area (Fig. 29). The landslide debris has the potential of damming the river during monsoon. Bank erosion by river on its left bank has damaged a number of agricultural fields.

Fig. 29: View of damaged agricultural land opposite side of the market.

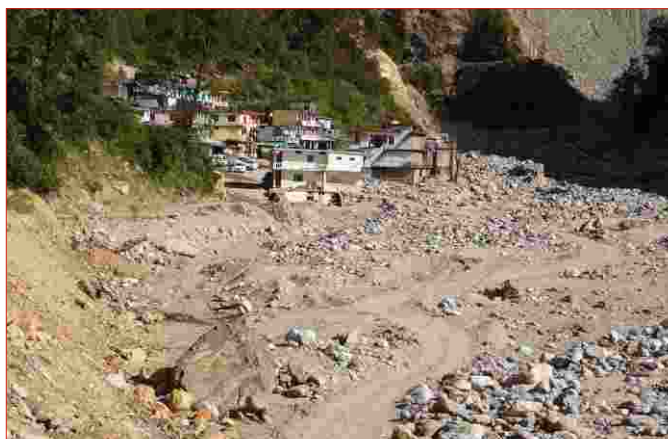
Fig. 30: View of damaged structures at Sonprayag town.

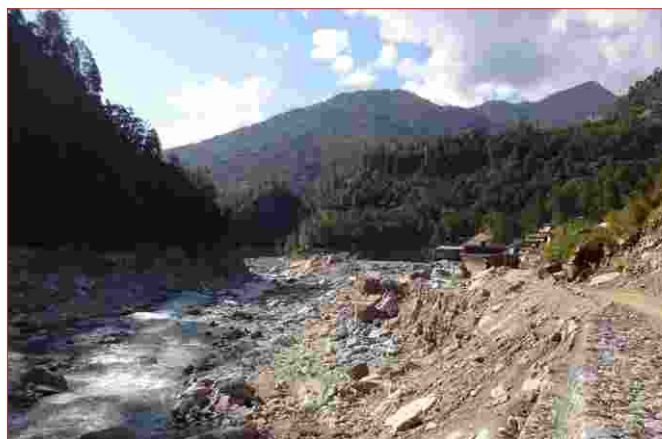
Fig. 31: View of damaged road and deposition of sediments around Sonprayag.

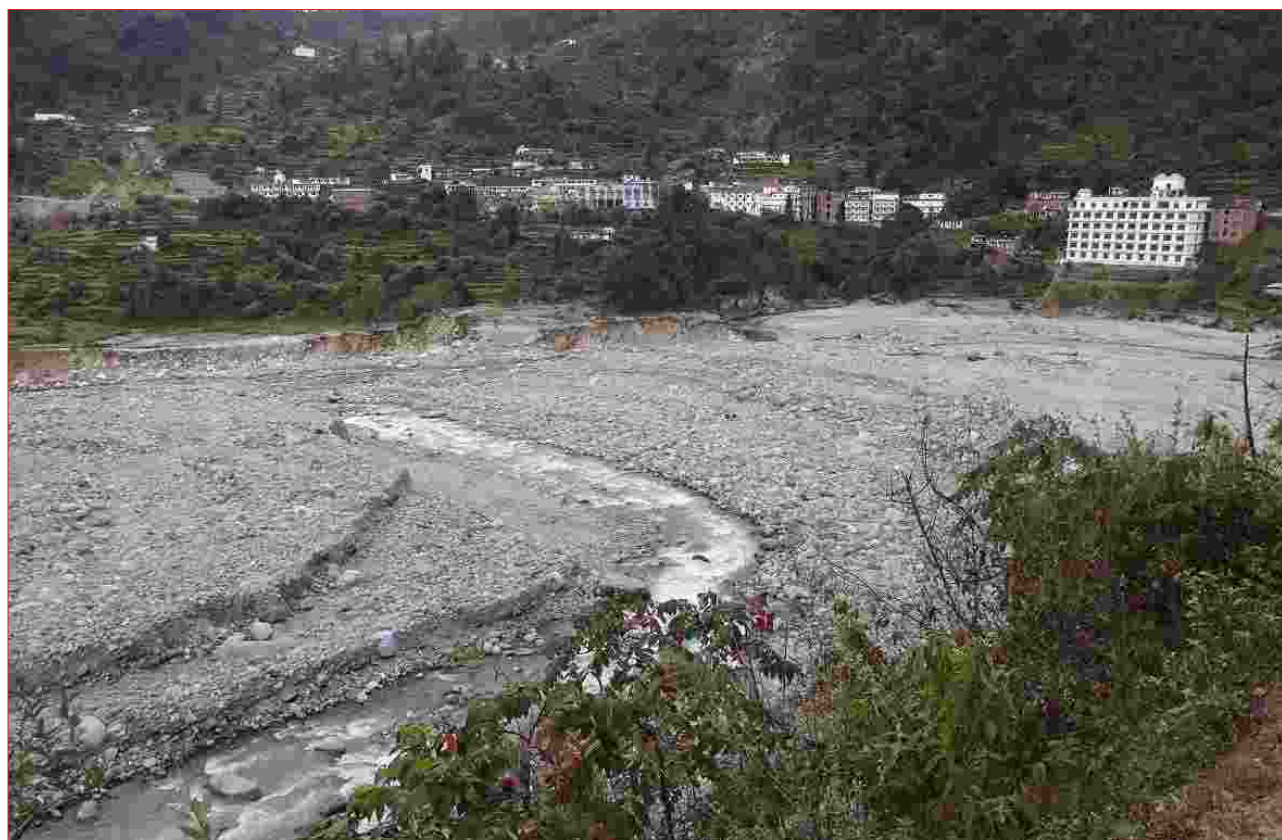
Fig. 32: View of deposited sediments at Sitapur on river bed.

For the safety of settlements, erection of suitably designed flood protection walls on the river bed along the

right bank of Mandakini river is recommended.

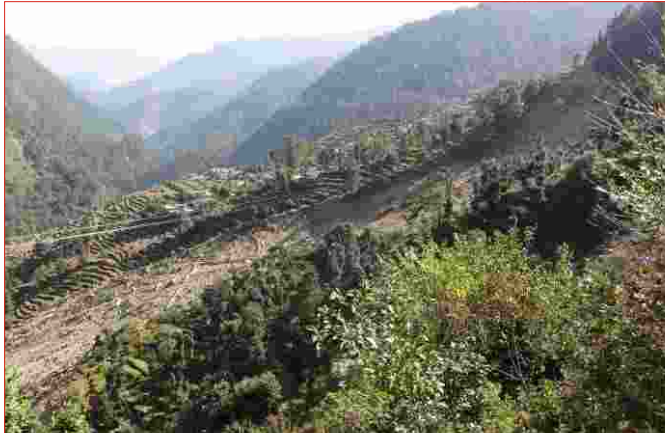
The inclination of failure slope is observed to be around 25° - 35° and the slope direction is towards northeast. The width of failure slope is about 200 meters and vertical height of the slide is about 150 meters (Figs. 33 and 34).

Fig. 33: Panoramic view of Barasu landslide.

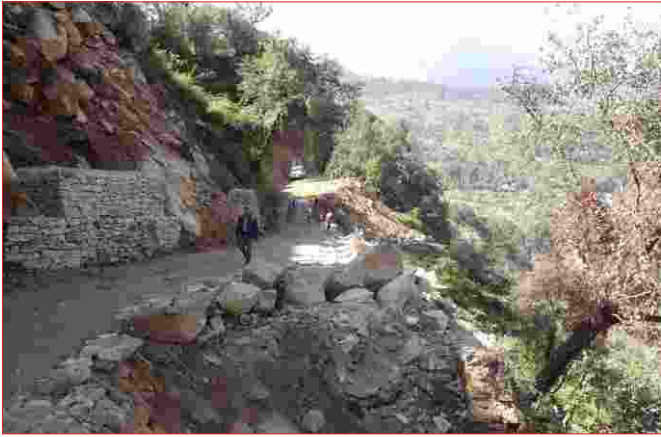
Bank erosion due to floods has introduced instability in the slopes around the road below Khat village. Due to this a number of trees have been uprooted and around 100 meters long stretch of road has been damaged (Fig. 35). Primary School structures located around the crown of this slide zone have been damaged by landslide induced ground fissures (Fig. 36).

Fig. 35: View of National Highway - 109 damaged around Khat village due to landslide.

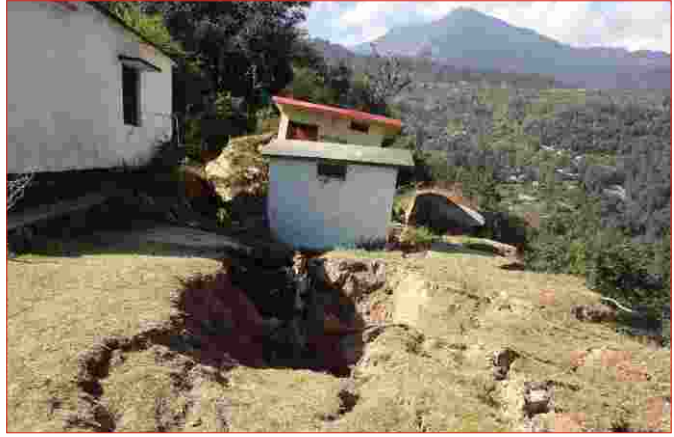
Fig. 36: View of the Primary School at Khat damaged by landslide induced fissures.

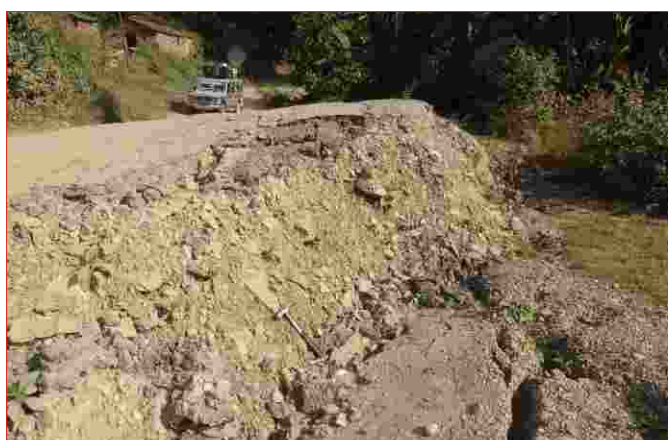
Slope failure is observed to have occurred on the eastern slope. The width of the failure slope is around 250 to 300 meters along the south flowing Mandakini river while the height of the slide from river bed to the crown is about 200-240 meters. The inclination of failure slope is observed to be around 25°. Entire Semi village is under high risk due to multi-level rotational slope movements and subsidence. This has damaged the National Highway and settlements (Figs. 37 and 38).

Fig. 37: View of subsidence of National Highway - 109 around Semi village.

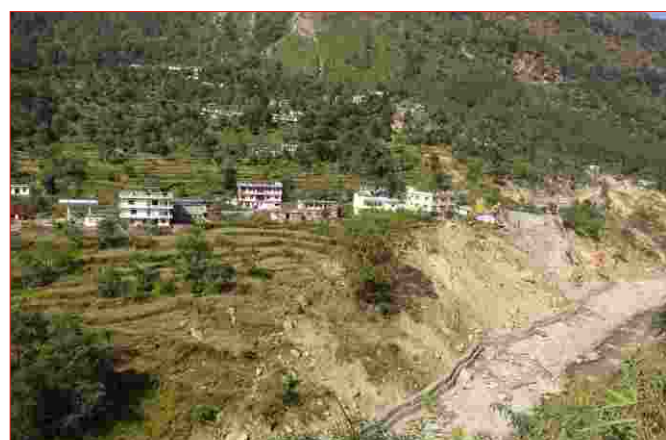
Fig. 38: Photograph depicting semi landslide induced by bank erosion by Mandakini river.

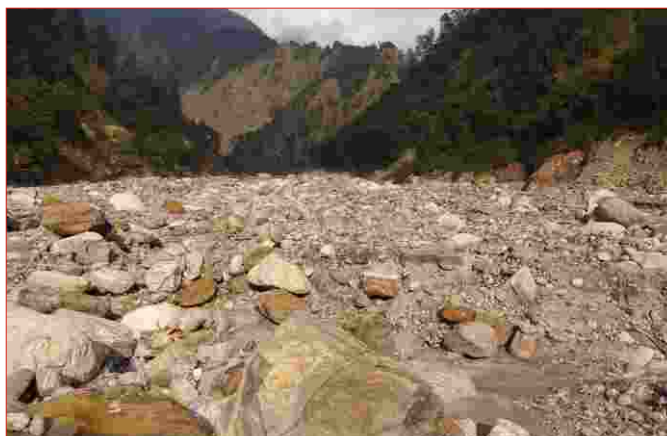
Fig. 39: Sediments deposited by Madhyameheshwar Ganga just upstream of Gaundar.

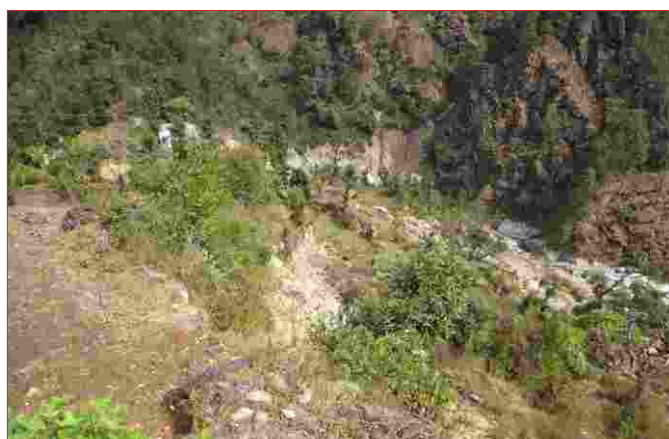
Landslides are observed to occur uncontrollably over the entire stretch of the agricultural lands below the village. These pose threat to the houses located on the subsided portion where road has also been damaged.

Fig. 41: Slope failure around Jal Talla village.

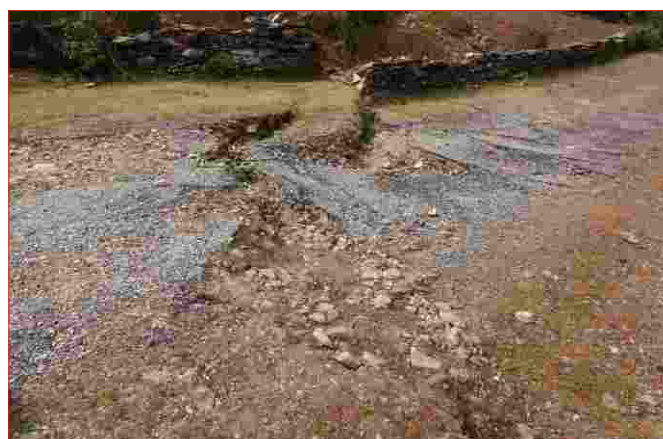
Fig. 42: Photograph showing cracks on the road.

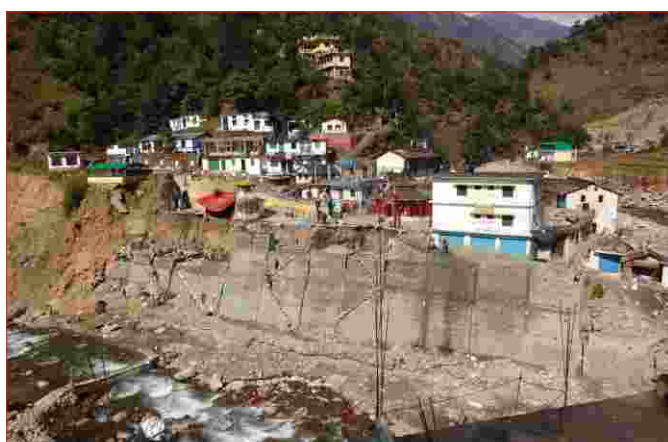
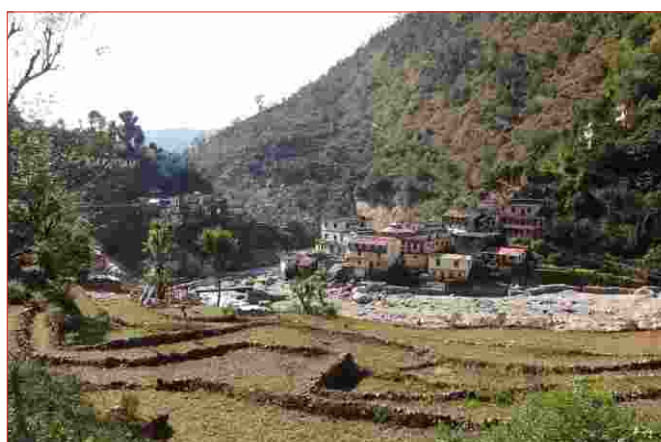
Terraces are observed to have been cut vertically by Kali Ganga. An eroded terrace with vertical cut of around 6.0 meters is observed on the left bank of the river just below the temple. Foundation of the temple is observed to be severely damaged by toe / bank erosion of Kali Ganga on both northern and southern extremities (Figs. 43 and 44).

Figs. 43 and 44: View of severely damaged Kali temple and other structures around Kalimath.

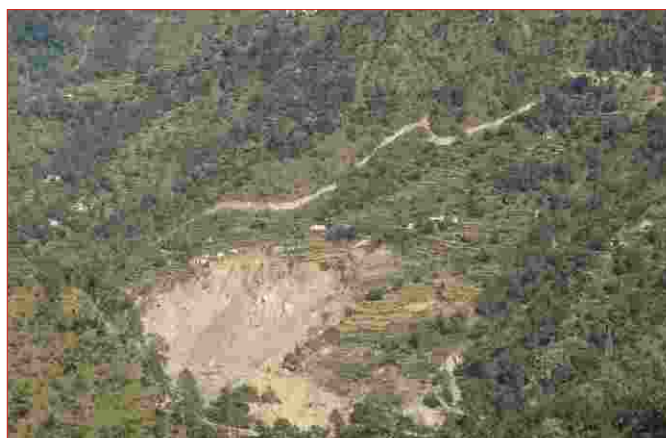
Fig. 45: Photograph showing road and habitation damaged by landslides at Kunjethi.

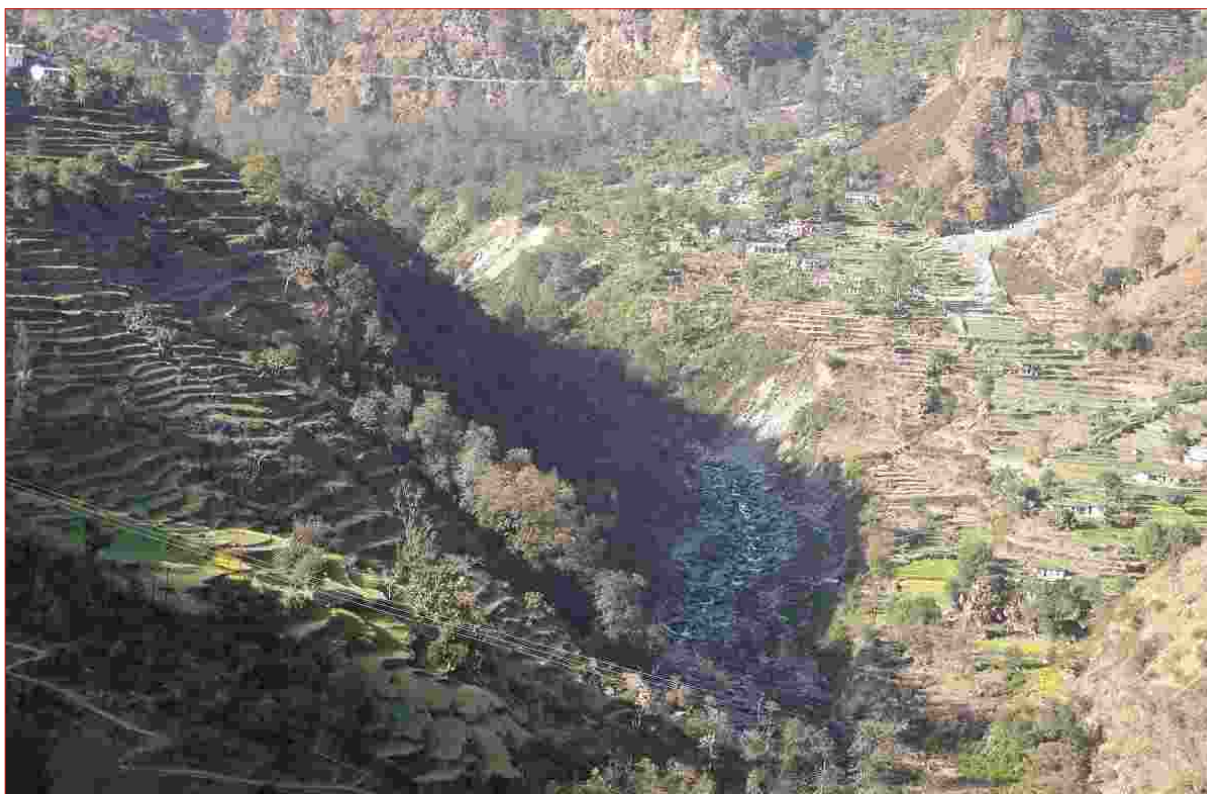
Fig. 47: View of terrace eroded by Damar Gad around Taljaman village.

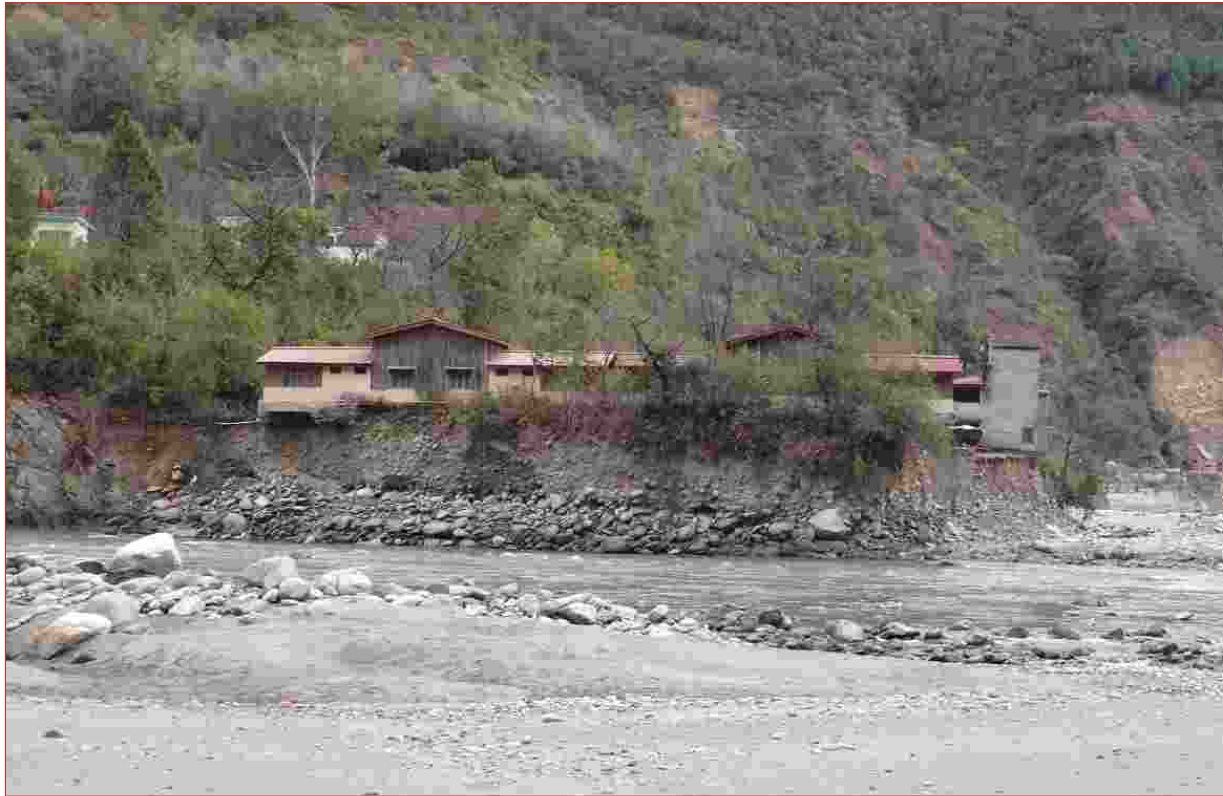
Fig. 48: View of damaged structures over eroded terrace at Banswara.

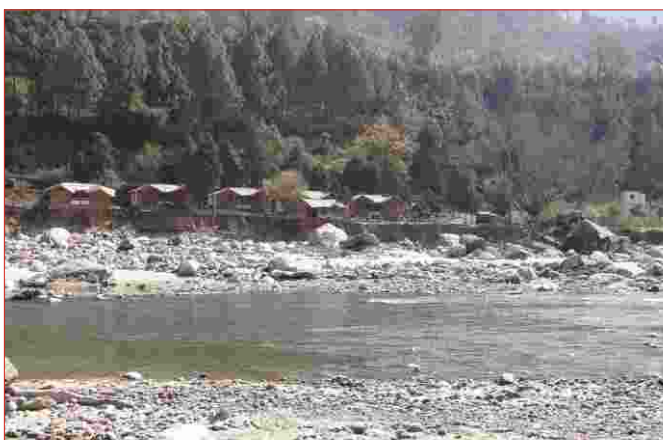
Fig. 49: View of damage GMVN cottages on the left bank of Mandakini river.

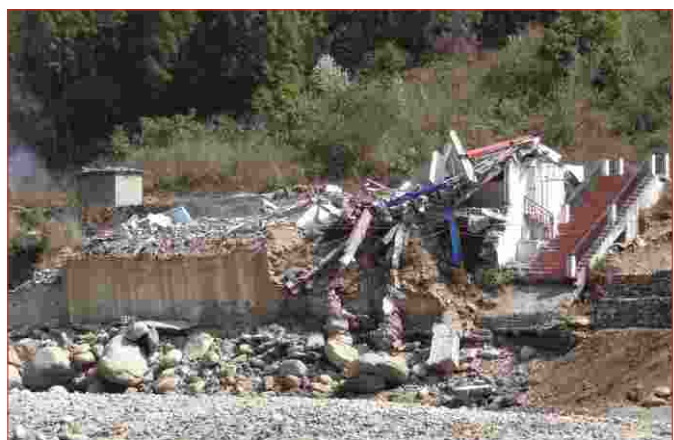
Fig. 50: View of damaged Prince Hotel just below the National Highway.

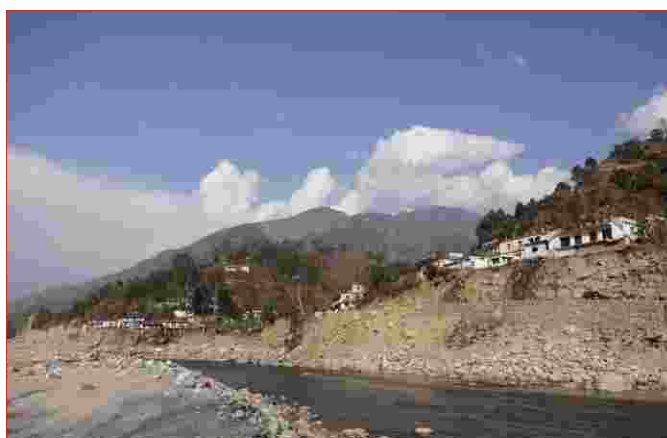
Fig. 51: View of the damaged settlements and road.

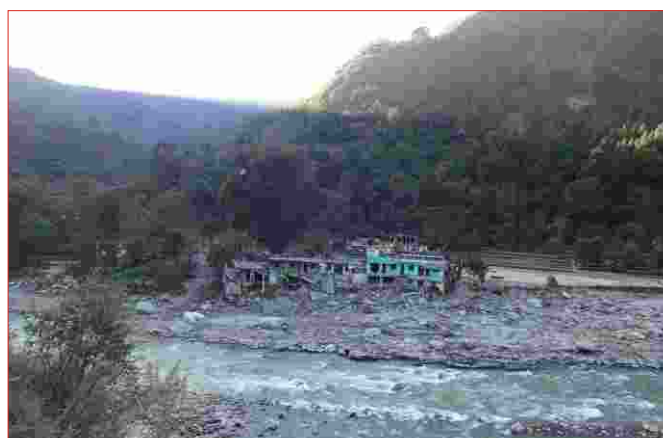
Fig. 52: View of flood affected Chandrapuri village on the right bank of Mandakini river.

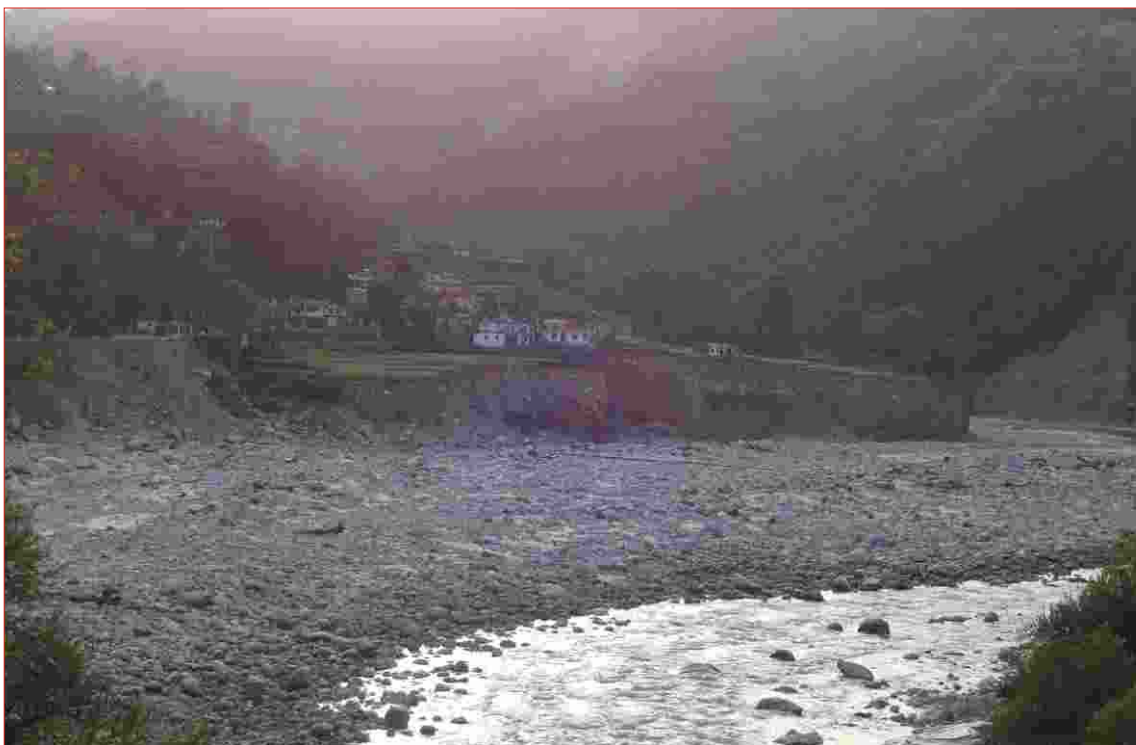
Fig. 53: Photograph depicting critical state houses on eroded terrace.

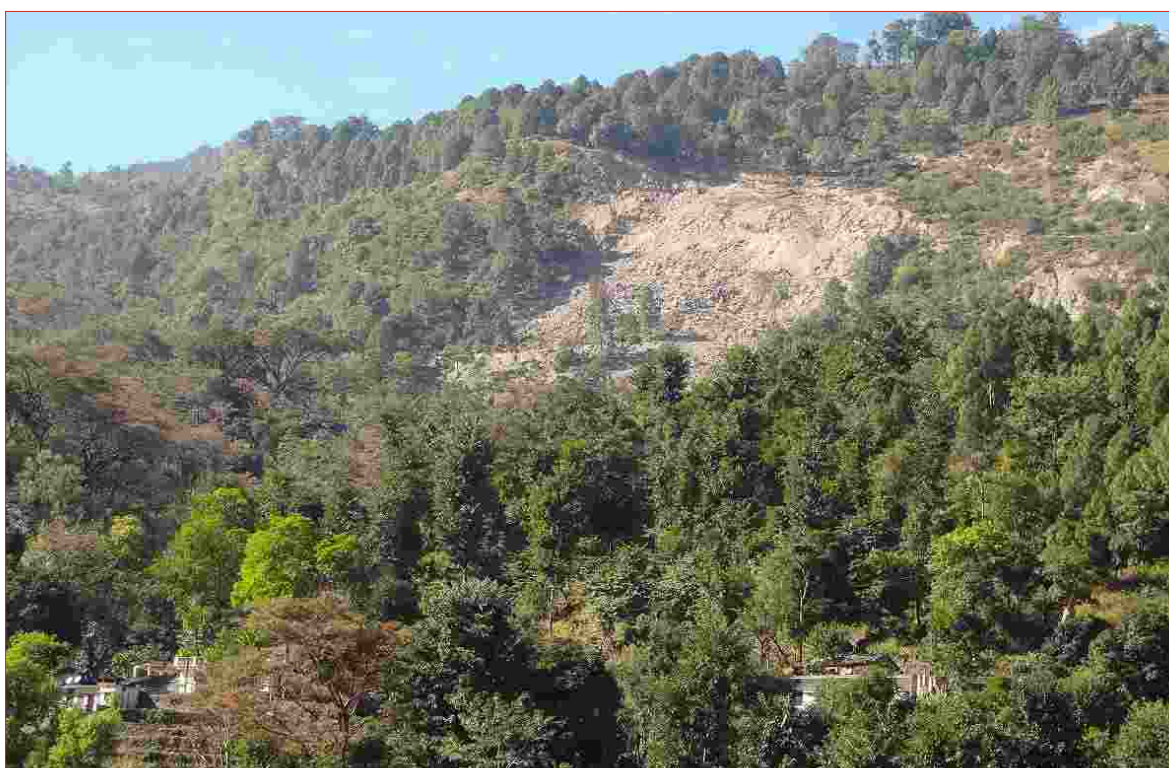
Fig. 54: Panoramic view of Pathalidhar landslide.

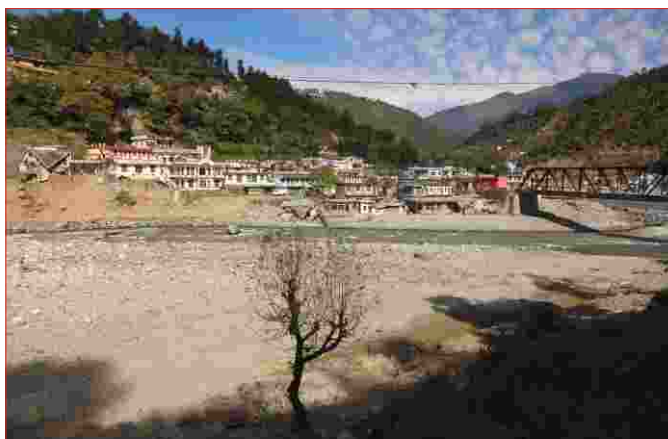
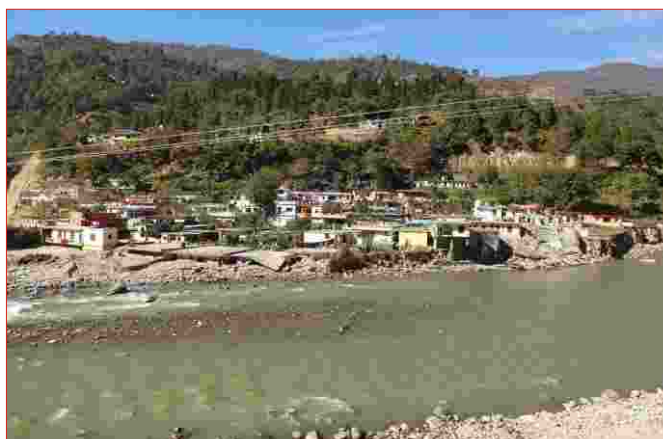
Figs. 55 and 56: Photographs shows damaged structures around Ganganagar.

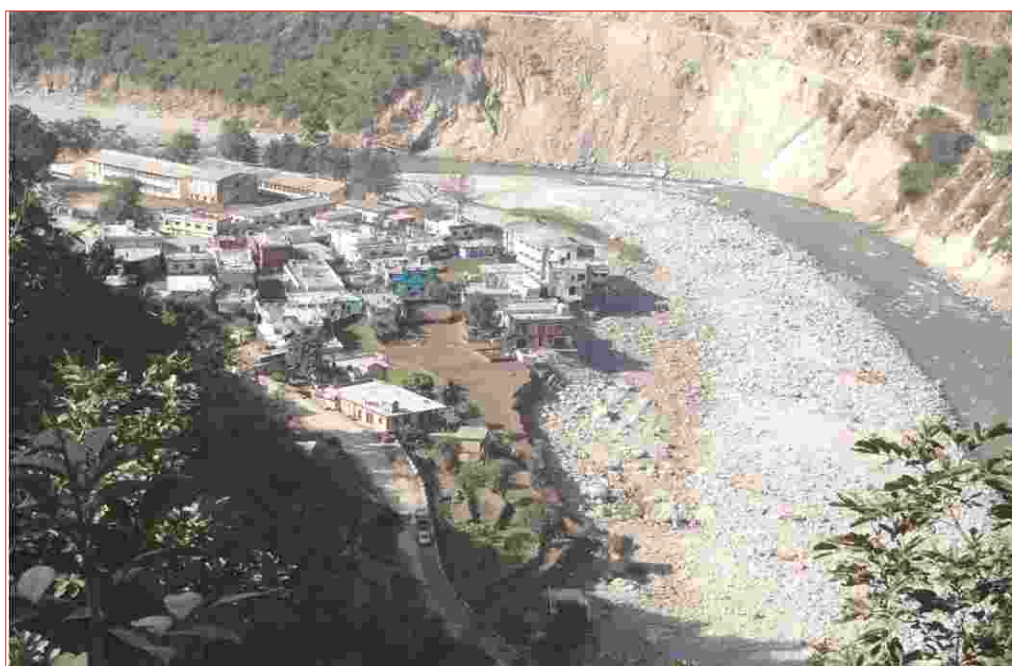
Fig. 57: Photograph depicting damaged structures and agricultural fields

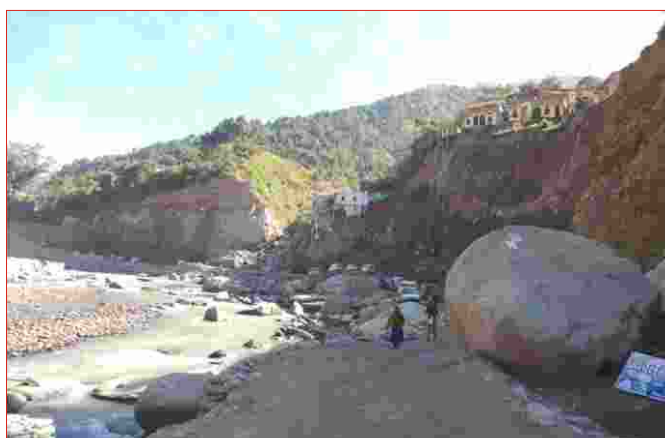
Fig. 58: Photograph depicting eroded terrace and temporary road at Vijaynagar.

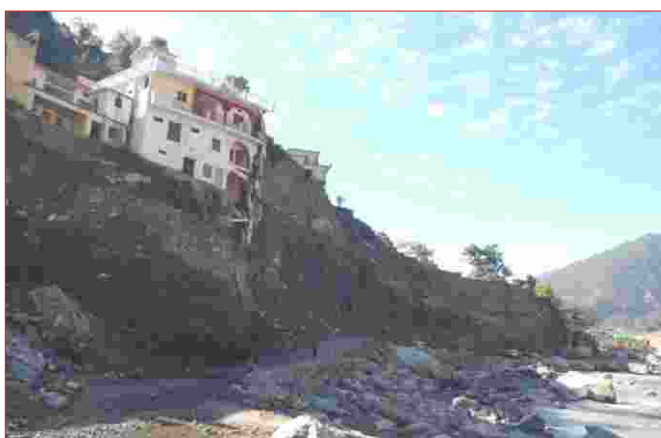
Fig. 59: Close view of damaged houses located over the edge of eroded terrace.

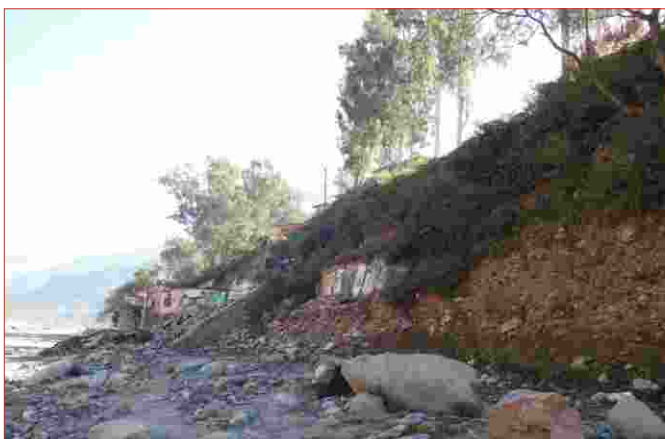
Fig. 60: View of eroded terrace of Ramleela Ground.

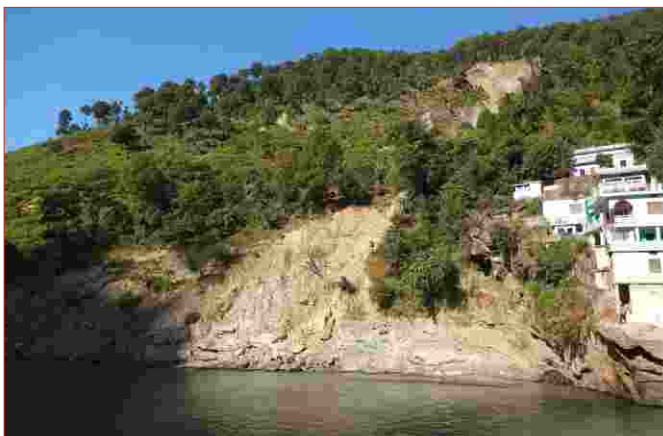
Fig. 62: View of gully erosion on the right bank of Mandakini.

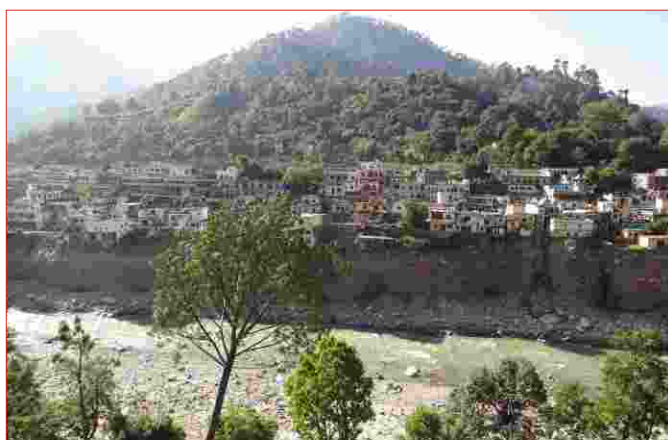
Fig. 64: View of damaged structures over eroded terrace at Sumari.

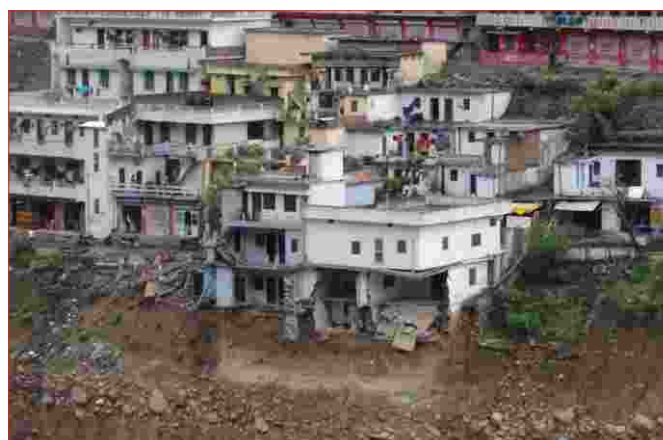
Fig. 65: Close view of damaged structures over eroded terrace.

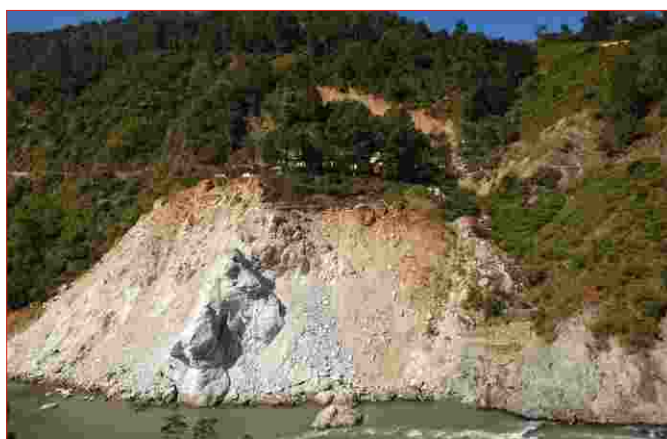
Fig. 66: Slope failure around Government Inter Collage, Tilaknagar.

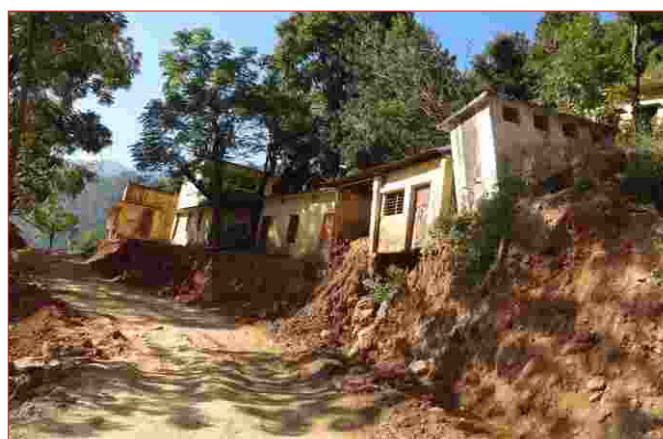
Fig. 67: Damaged school buildings due to slope failure.

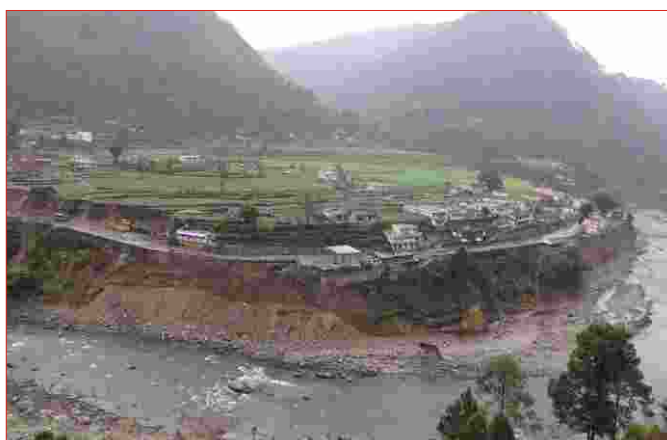
Fig. 68: Panoramic view of eroded terrace at Tilwara.

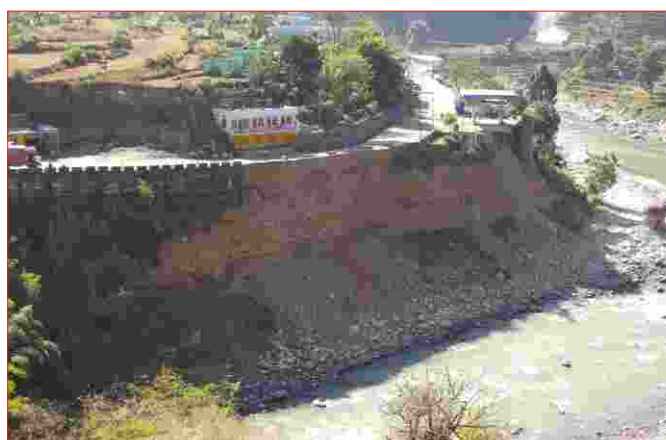
Fig. 69: Close view of damaged road and petrol pump.

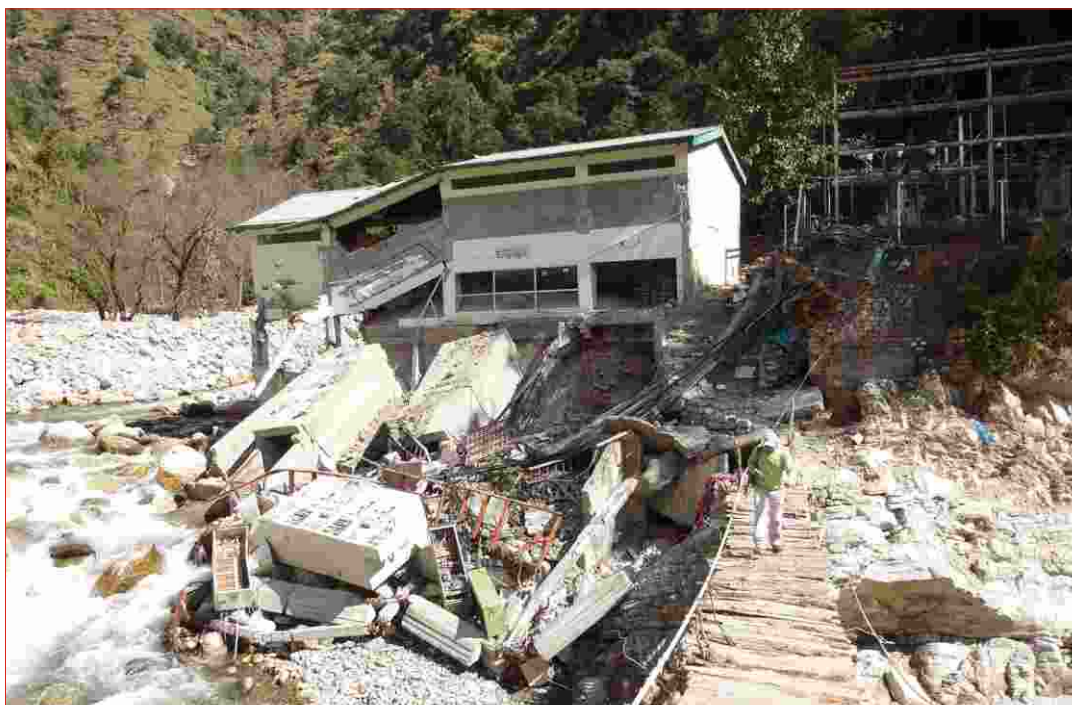
Fig. 70: View of ruined powerhouse of Son hydroelectric project at Sonprayag.

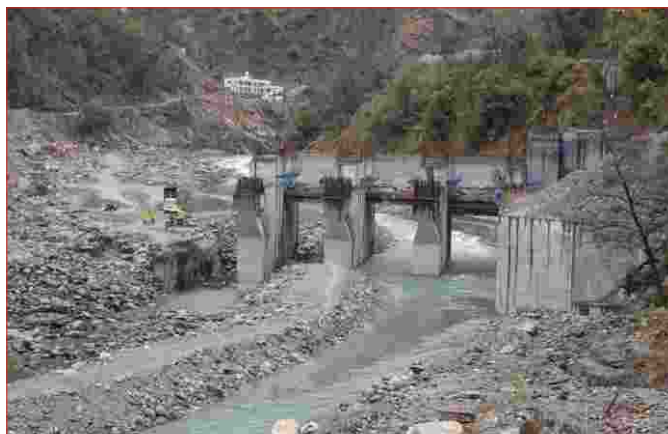
Fig. 71: View of severely damaged Barrage of Singroli - Bhatwari hydroelectric project at Kund.

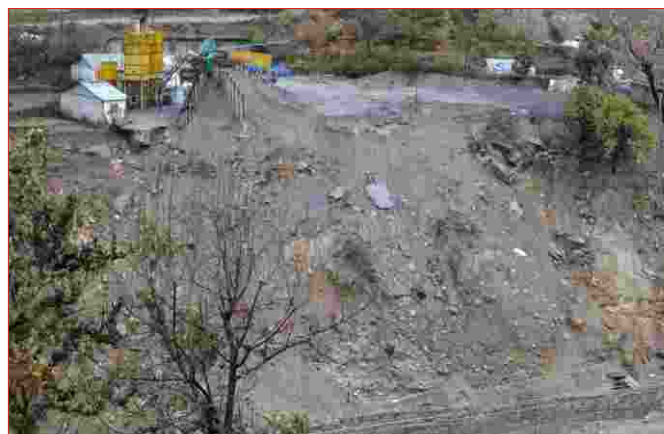
Fig. 72: Photograph depicting damaged crasher plant at Semi.

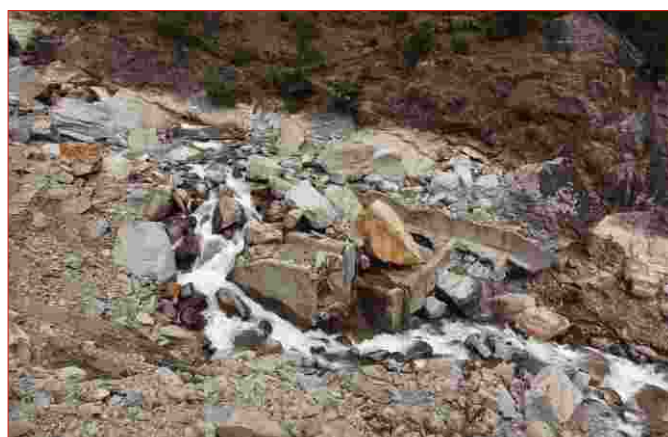
Fig. 73: Photograph of completely damaged Weir of Kali Ganga Stage - I hydroelectric project.

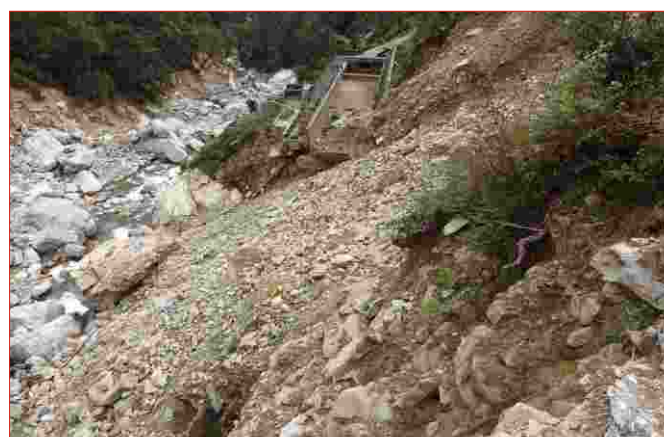
Fig. 74: View of damaged diversion canal of Kali Ganga Stage - I hydroelectric project.
