Geological investigations in Rudraprayag district with special reference to mass instability

Disaster Mitigation and Management Centre

A Disaster Mitigation and Management Centre (DMMC) publication

2014

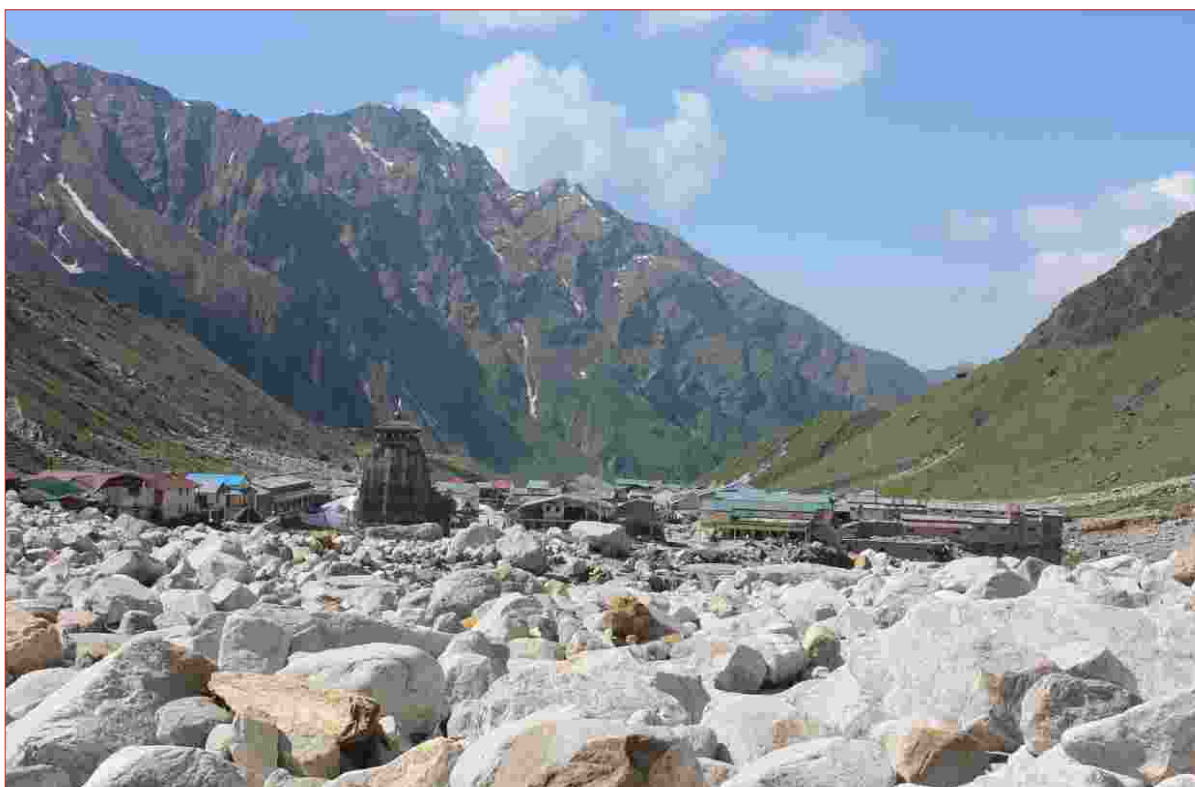
Fig. 75: View of large boulders stacked haphazardly to the north of the temple.

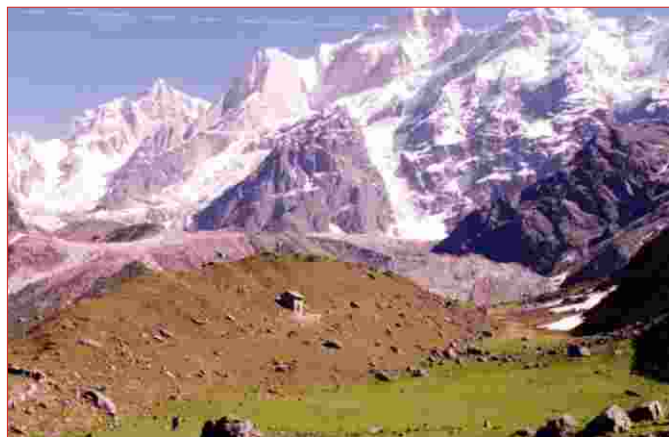
Fig. 77: Depression between the left lateral morainic ridge and the valley wall to the east of the helipad at Kedarnath.
