Geological observations on the devastation around Srinagar in Pauri Garhwal district of Uttarakhand on the aftermath of June 2013 floods

A Preliminary Report

January, 2014

Piyoosh Rautela, Sushil Khanduri and Ashish Rawat

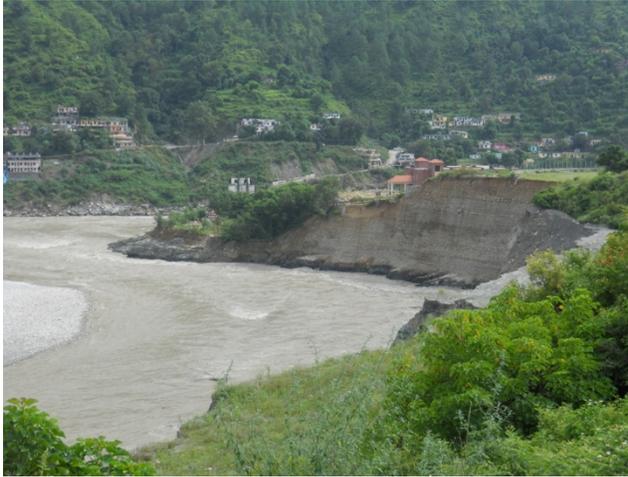
The stadium is observed to be severely damaged by bank erosion by Alaknanda river. In this area the river directly hits the base of the Stadium resulting in continuous undercutting and erosion of the same.

Chauras stadium was eroded by about 07 meters due to bank erosion by flood waters (Fig. 2). Just outside of the stadium approximately 30 meters stretch of road connecting Srinagar to Chauras was completely washed off (Fig. 3).

Fig. 2. Photograph showing severely damaged Chauras stadium due to bank erosion by Alaknanda river.

Mitigation measures: Appropriately designed and anchored concrete curtain wall may be considered for safe execution at this sensitive location. This would help in protecting the affected site as well as bank of Alaknanda river from stream erosion.

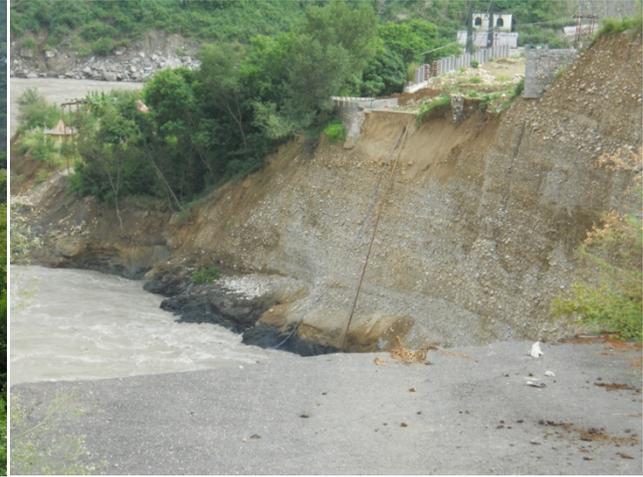
Fig. 3. Photograph depicting completely damaged road outside the stadium.

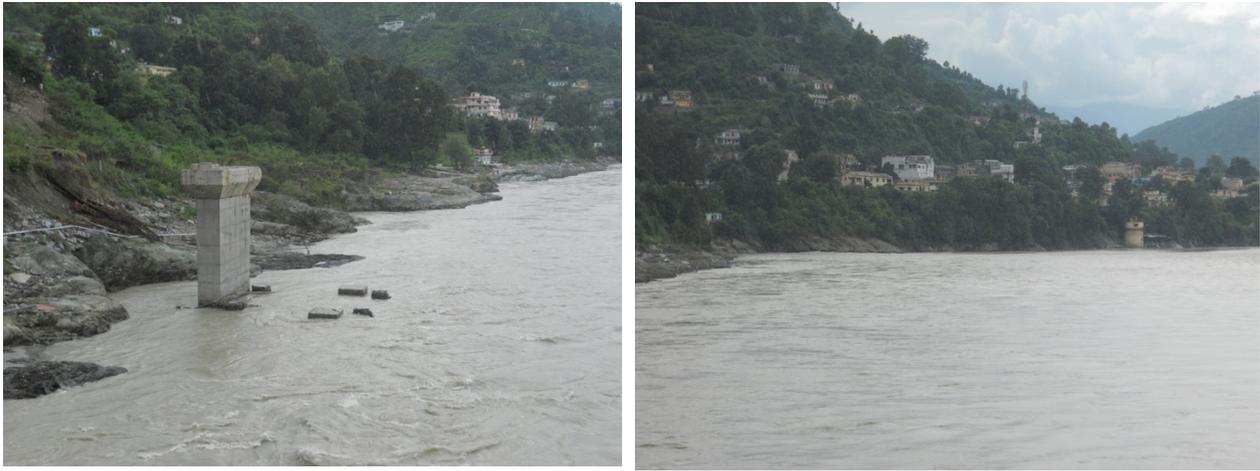
Phyllites are observed to be exposed from Chauras bridge to Ma Durga Mandir (Ganga Ghat) in Upper Bazar area on the left bank of Alaknanda river. The rock outcrops in this stretch protect the river bank as also the upslope area. So, at present there is no need of any structural / non – structural intervention for protection of river bank in this stretch (Figs. 4 and 5).

Figs. 4 and 5. View of the area from Chauras bridge to Agency Mohalla with phyllites exposed on the left bank of Alaknanda river.

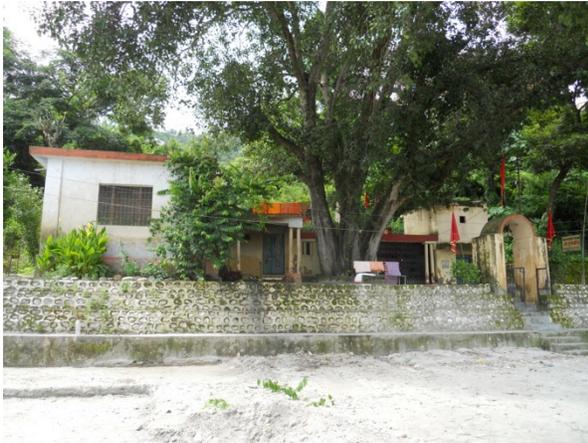
Reconnaissance geological-geotechnical assessment: Ma Durga Mandir was reportedly filled with silt and sand brought by the flood waters of Alaknanda river. At the time of the field investigations silt and sand material had been safely removed from the temple and nearby area. Ma Durga Mandir is observed to be safe and no damages were recorded (Fig. 6).

Fig. 6. Photograph depicting the situation around Ma Durga Mandir.

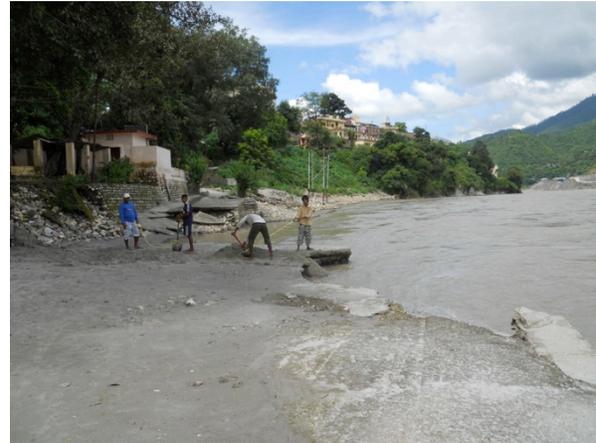
Ganga Ghat area and the pathway are also observed to be partially damaged by flood waters (Fig. 7).

Fig. 7. Photograph showing partially damaged Ganga Ghat area and the pathway.

Mitigation measures: Damaged structures at Ganga Ghat area are required to be repaired with suitable design and deep foundation.

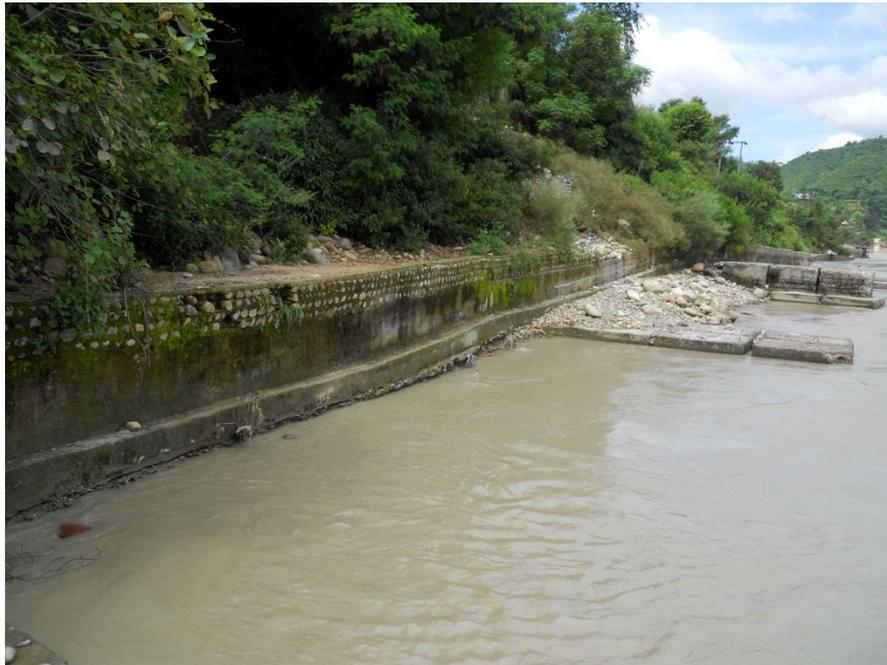
Around Jain Mandir area the river bank is observed to be protected by retaining structures and oblique RCC cubs/blocks that are observed to be tilted and partially damaged at some places (Fig. 8).

Fig. 8. Photograph depicting tilted and partially damaged retaining structures and RCC cubs / slabs near the river bed.

Mitigation measures: It is advised that repair of tilted and damaged retaining wall and oblique RCC cubs/slabs be undertaken by filling core stone and concrete where ever required.

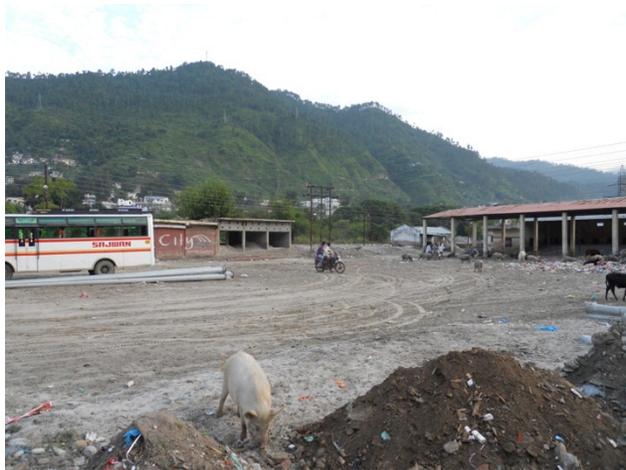
Reconnaissance geological-geotechnical assessment: It is reported that the houses, Rainbasera, cremation shed, temple, Police Station and other structures around New Bus Stand were filled by silt and sand materials due to the high floods during monsoon (Fig. 9). From indoors of the buildings silt, sand and other materials are observed to have been removed. No major structural damage is observed in this area.

Fig. 9. View of houses and other infrastructures overwhelmed by silt and sand due to flood waters near New Bus Stand area.

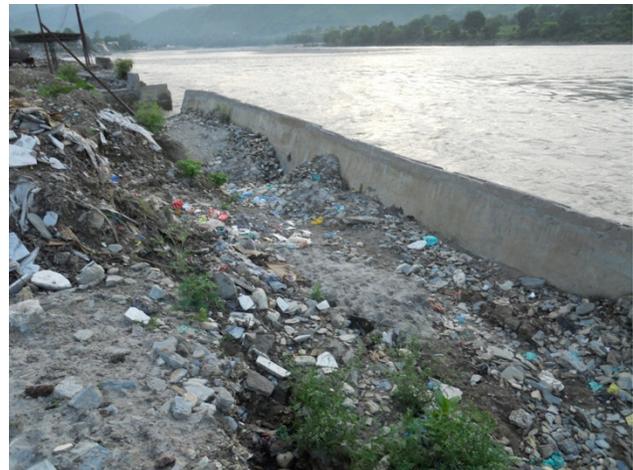
River side retaining wall near the Bus Stand is observed to be tilted due to high flood water during monsoons (Fig. 10).

Fig. 10. View of tilted retaining structure near New Bus Stand on the left bank of river Alaknanda.

Mitigation measures: It is advised that repair/reconstruction of river side tilted retaining structures be undertaken for ensuring safety of the Bus Stand as also the river bank.

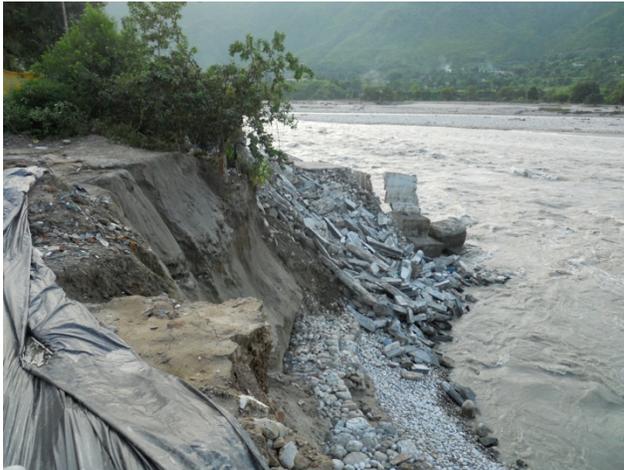
Reconnaissance geological-geotechnical assessment: Keshav Math temple that was constructed in close proximity of Alaknanda river is observed to be completely destroyed (Fig. 11).

Fig. 11. Photograph depicting completely destroyed Keshav Math temple.

Mitigation measures: It is advised that construction of retaining wall/gravity wall with boulder pitching with suitably placed oblique RCC cubs/slabs as per site requirement be constructed from new Bus Stand to Nagraja Mohalla area. Area both upstream and downstream of Keshav Math temple, is required to be protected by appropriately designed RCC retaining structures with desired height.

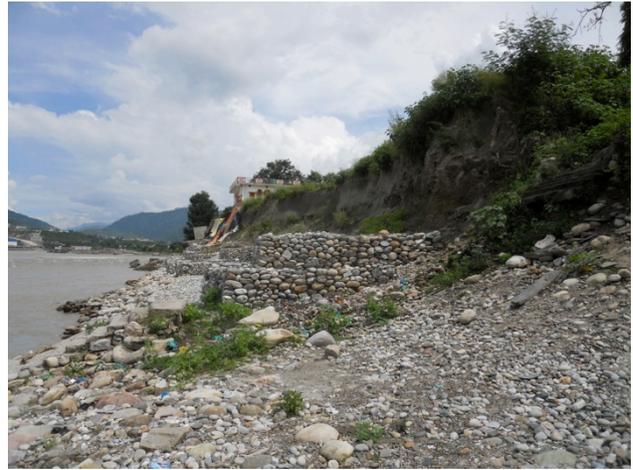
Bank erosion by Alaknanda river has brought some houses in Nagraja Mohalla area to the edge of vertical cut. High risk is posed to these houses (Fig. 12).

Fig. 12. Photograph showing vertical cut slope and a house close to edge of vertical cut.

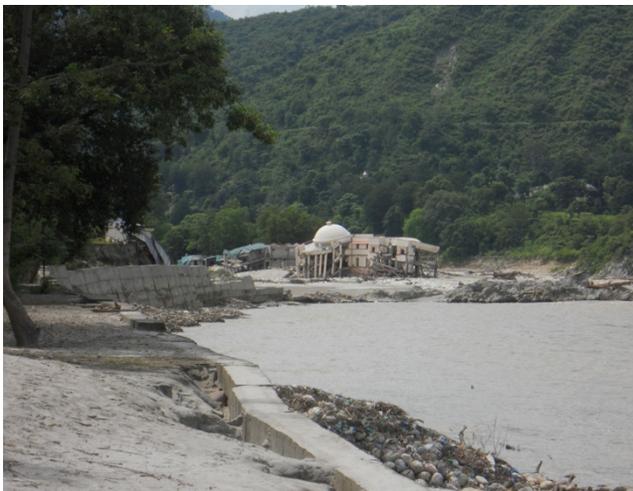
Reconnaissance geological-geotechnical assessment: Sashastra Seema Bal (SSB) Academy building is observed to be severely damaged (Fig. 13). A number of tin sheds are also observed to be severely damaged and some structures are observed to be filled with silt and sand (Fig. 14). All the structures that have suffered losses are observed to be constructed close to course of Alaknanda river. At this location river has meandering course and during the high flood the flow of river was diverted towards SSB Academy that was directly hit by floodwaters.

Fig.13. Photograph depicting severely damaged SSB Academy building.

Suggested measures: Severely damaged SSB Academy building is required to be demolished. This area should be kept free of construction activities. Silt and sand from some of the buildings on the upslope area should be safely cleared.

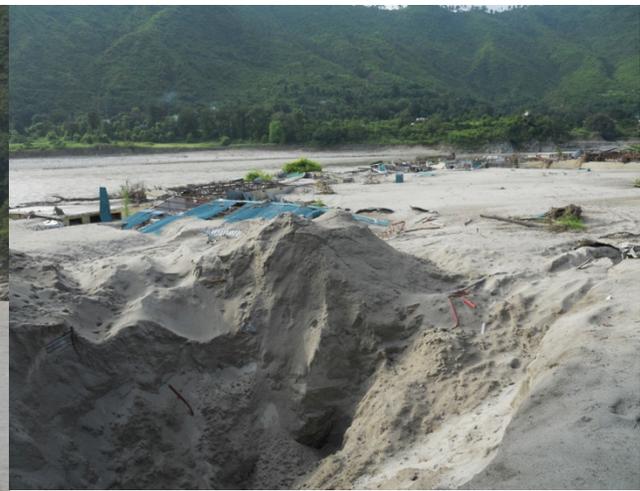
Fig.14. Photograph depicting severely damaged SSB tin shed structures that are completely filled with silt and sand brought by high floods.

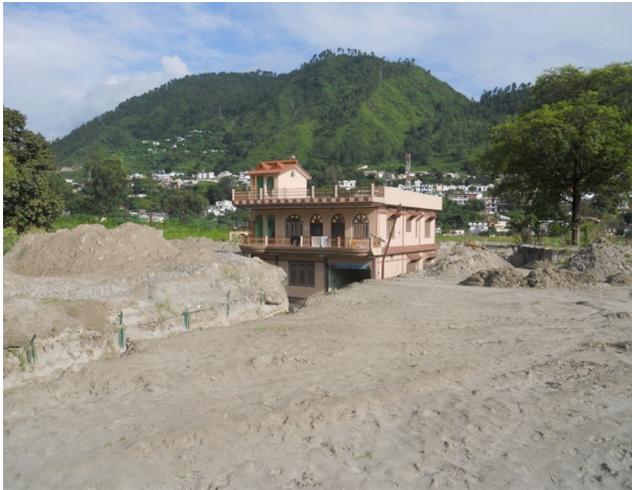
Reconnaissance geological-geotechnical assessment: Area around Sakti Vihar some houses are observed to have suffered losses and filled with silt and sand due to floodwaters of Alaknanda river (Fig. 15).

Fig.15. View of double storied house in which ground floor was filled with silt and sand.

Mitigation measures: Silt and sand deposited in the structures and over nearby lands is required to be cleared so that the same could be put on productive usage.

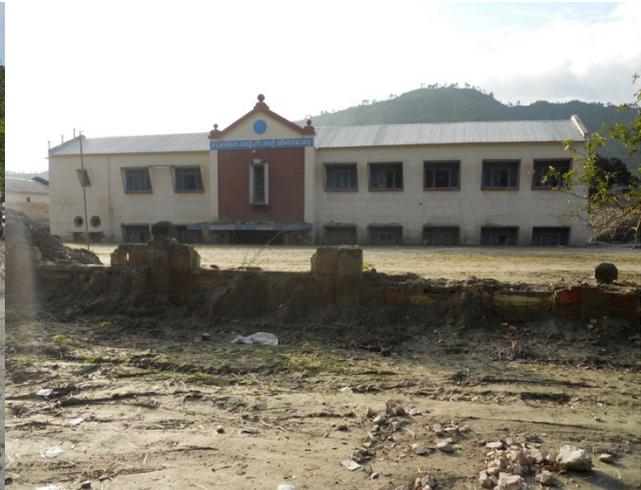
Most buildings of the Industrial Training Institute (ITI) are observed to have suffered losses and filled with silt and sand. The silt and sand is observed to be piled up for around 2.0 to 3.0 meters (Fig. 16).

Fig. 16. Ground floor and the frontal area of the ITI building has as much as two meters thick pile of silt and sand.

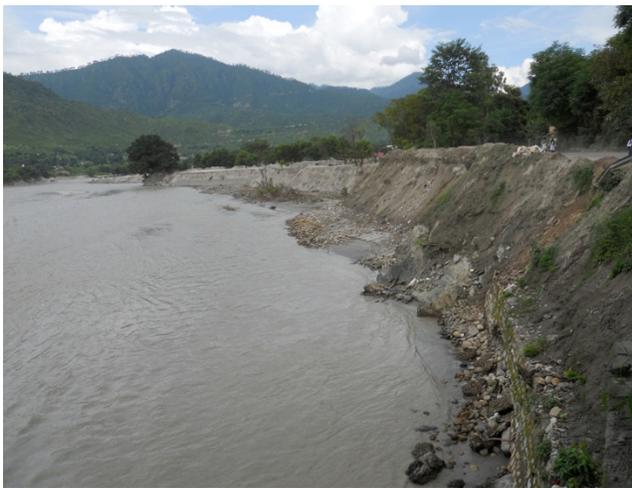
Area along the river bank to the downstream of ITI (Fig. 17) and upstream of Uphalda (Fig. 18) is observed to be damaged due to the floodwaters.

Fig. 17. Photograph depicting bank erosion in the area downstream of ITI.

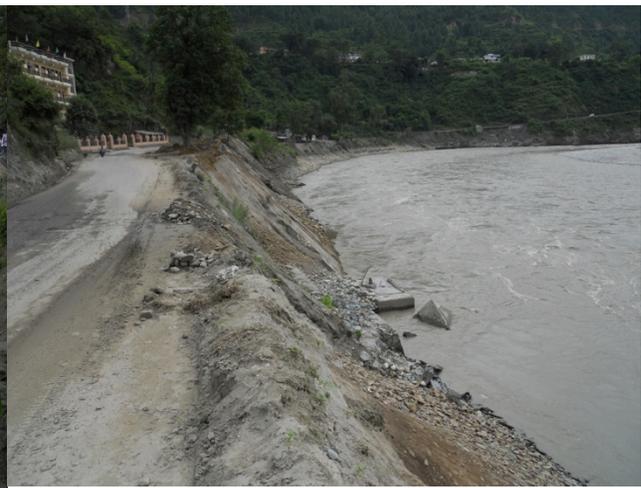
Fig. 18. Photograph depicting bank erosion in the area upstream of Uphalda.

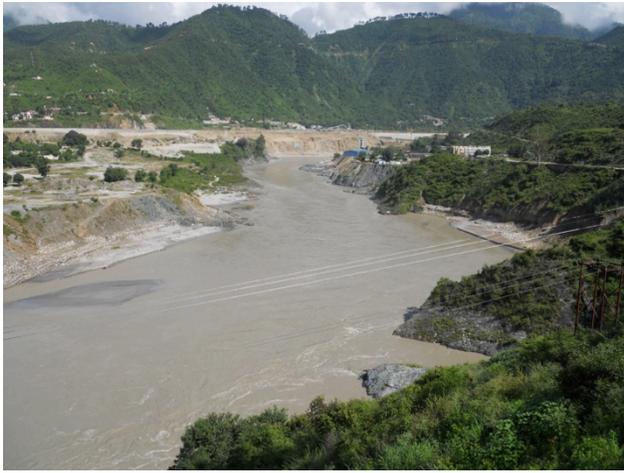
Reconnaissance geological-geotechnical assessment: On the opposite side of Chandreshwar Mahadev temple area excavated muck was washed off due to flooding. Upstream of confluence of Swit Gad and Alaknanda river undercutting by river is also observed below the road level (Fig. 19).

Fig. 19. View of the dumped muck on the right bank and road (NH- 58) being undercut on the left bank of Alaknanda river.

Mitigation measures: It is advised that wire crate gabion walls be constructed at the tow of muck dumping site located at river bank area. Construction of masonry retaining structures is also recommended below the National Highway along the river bank. This would protect the affected site and reduce bank erosion by the river.

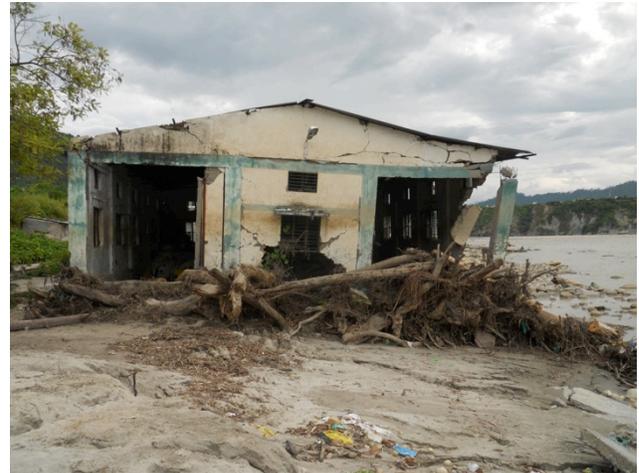
Downstream of Chandreshwar Mahadev temple a Plastic Factory was severely damaged by high flood. The building is observed to be filled with silt and sand (Fig. 20).

Fig. 20. Photograph depicting severely damaged plastic recycling plant building.

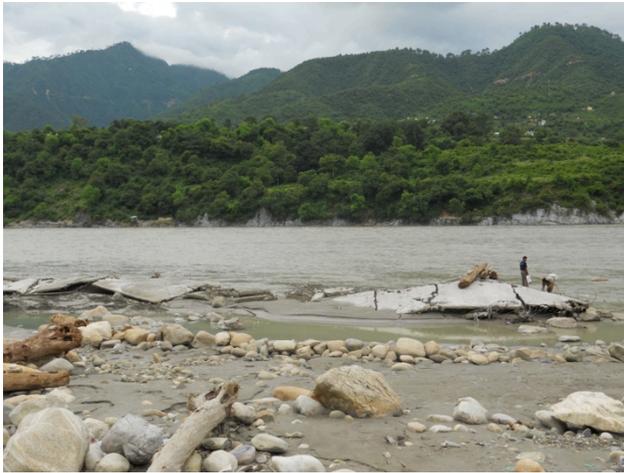
Double storied building of IRIS school, located just downstream of the Plastic Factory, is observed to be completely destroyed by floodwaters (Fig. 21) together with some class rooms that have been damaged and filled with 1.5 m to 2.0 meter thick pile of silt and sand materials. Just downstream of IRIS school, Mahila Milan Kendra buildings are also observed to be damaged and filled with silt and sand (Fig. 22). All these structures were built and located in close proximity of the river and within its high flood level.

Fig. 21. Photograph depicting completely destroyed IRIS school office building.

IRIS school that falls within high flood level should however be kept free of anthropogenic activities of any kind.

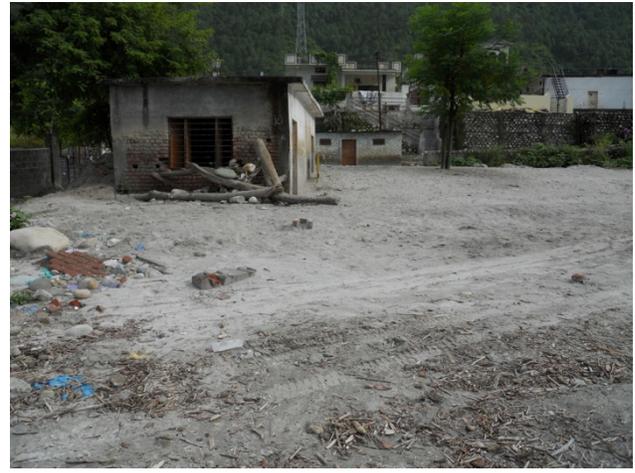
Fig. 22. Photograph depicting Mahila Milan Kendra filled with silt and sand materials.

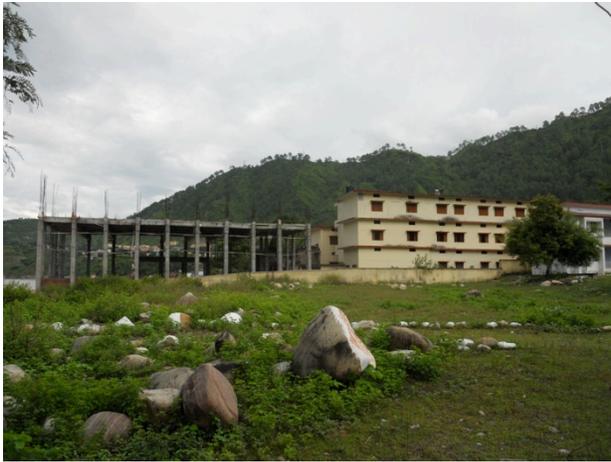
Reconnaissance geological-geotechnical assessment: Sarasvati Vidhya Mandir is observed to be a new construction in close proximity of the river bed. The structure, though filled with silt and sand (Fig. 23) has not suffered structural damage of any kind.

Fig. 23. Photograph depicting new constructions of Sarasvati Vidhya Mandir in close proximity of river bed.

Mitigation measures: Sarasvati Vidhya Mandir area falls in high flood zone and should be kept free of any anthropogenic activity. Masonry retaining structures would however be required below Government Senior Secondary School for reducing further under cutting and erosion.

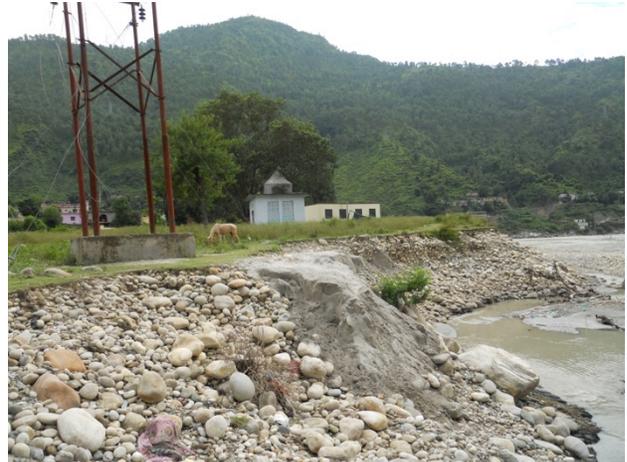
Government Senior Secondary School area is located on the terrace comprising of river borne material. Below the school the terrace is observed to be eroded by river (Fig. 24).

Fig. 24. Photograph depicting bank erosion near Government Senior Secondary School.

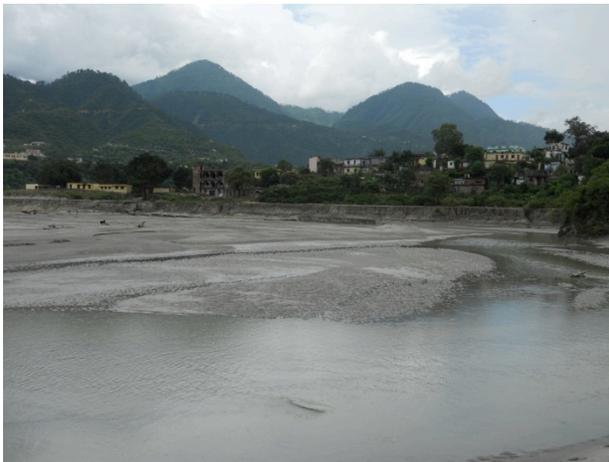
Downstream of Government Senior Secondary School area bank erosion is observed around New Basti area (Fig. 24). This area is observed to be filled with 3.0 meters thick pile of silt and sand.

Fig. 24. Photograph depicting bank erosion between Government Senior Secondary School and Petrol Pump colony.

Mitigation measures: Constructions of adequately designed RCC retaining structure and oblique concrete slabs is recommended along the river bed between Government Senior Secondary School and New Basti area.

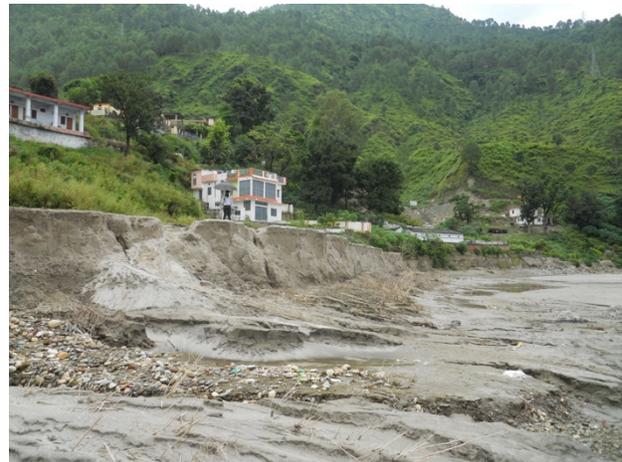
Gas Godown area is also observed to be filled with 2.5 meters thick pile of silt and sand (Fig. 25). Slight undercutting is also observed at this location.

Fig. 25. View of freshly deposited sand and silt near Gas Godown.

Masonry retaining structures along the river bank for reducing further under cutting and erosion are recommended around Gas Godown area.
