Disastrous Events on Kelash-Mansarowar Route, Dharchula Tehsil in Pithoragarh District, Uttarakhand in India

Sushil Khanduri*, Sajwan KS and Ashish Rawat

Department of Disaster Management, Disaster Mitigation and Management Centre, Uttarakhand Secretariat, Dehradun, Uttarakhand, India

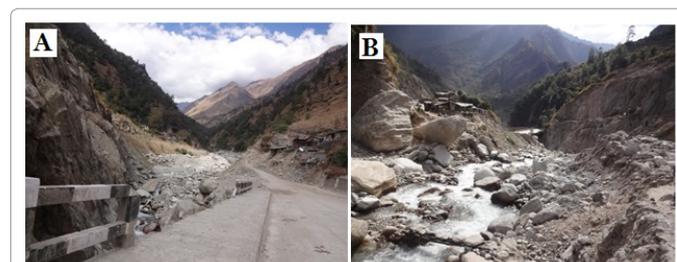
Going to the Border Post Army persons were camped near Mangti area on the left bank of Simkhola Gad on 13 August, 2017. They were also parked their vehicles on the road and bridge at the same place. According to the local people, at early morning (2:30 am) high flash flood discharge of the Simkhola Gad contributed to the instability of the hill slopes of the Mangti area. The course of this gad was temporary blocked and water saturated debris overran the bridge, road and other structures. Around 50 meters road was washed off while barricading of bridge was also damaged in this incidence (Figure 2a). A number of places upstream to bridge around 2-3 meters thick pile of sediments were deposited on the right bank of Simkhola Gad (Figure 2b). The deposited sediments were observed to comprise of debris consisting of grey, fine grained silty matrix with rare boulders and fragments of schist and gneiss. As many as 9 persons were killed in this incidence. Of these bodies of 08 could not be recovered. Total of 3 Army tents and 2 vehicles were damaged and 51 cattle were lost. Because of loose soils/overburden and low level, damage or destruction mostly occurred along the left bank. Besides flash flood, landslides are also observed on the downhill and uphill side to devastated area along the road section.

Figure 2: (a) Damaged barricading of bridge together with eroded road at Mangti area due to stream erosion by Simkhola Gad, (b) Accumulated sediments on the right bank of the Simkhola Gad.

- It is suggested that appropriately designed bank protection walls should be constructed along the Simkhola Gad at Mangti area where road was washed off by stream. This practice will protect the road as well as bank of Simkhola Gad from stream erosion. Besides, damaged barricading of exist bridge should also be repaired.
- In the future, existing bridge of Mangti also needs to be relocated to upstream. This would protect the road along with left abutment of Bridge from the threat of flash flood.
- It is suggested that reconstruction of washed off pedestrian trek and bridge around the Malpa area. Alternative connectivity options, such as rope-ways would be better suited for the hills.
- In future recurrence of extreme rainfall events cannot be ruled out and therefore development like temporary camps, tourist camps and realignments of hazardous routes should be needed in safer location.

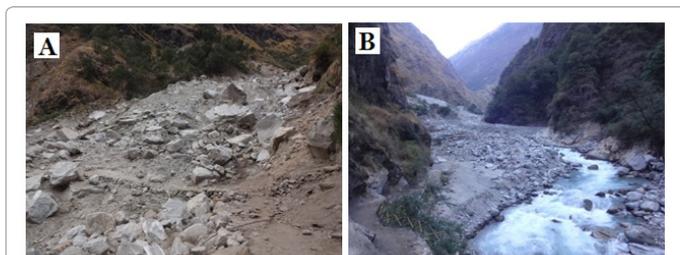
On the same day, flash flood incidence took place at Malpa area in Pithoragarh district. Some of the habitation was situated over the old landslide mass and close to Malpa Gad at bottom of the hill slope. The excessive stream water eroded the old landslide mass on the left bank. The vertical height of the eroded cut is around 8-10 meters and

width along the gad is around 120 meters. The overburden materials were observed to comprise of debris consisting of grey, fine grained silty matrix with rare boulders and fragments of quartzites. The pedestrian route leads to Kailash-Mansarover together with bridge were washed off in this incidence. Gully erosion is to be largely responsible for the devastation in the area (Figure 3a). As many as 8 persons were died and 10 persons went missing while 4 shops were damaged due to water saturated debris flow in the eastern side to Malpa gad area. As also, due to fast pace of stream water, sediments have been dumped at various places along the Kali river banks just downstream to affected area (Figure 3b).

Figure 3: (a) Gully erosion in the old landslide mass on the left bank of Malpa Gad, (b) accumulated sediments along the Kali river banks in the area round Malpa.

- Although it is difficult to forecast abnormally high precipitation and associated flash flood events, dense network of rain gauges is required for better understanding of this phenomenon.
- In view of the flash flood threat local population as well as other peoples are advised to stay away from loose soils/overburden materials and way of abandoned channels, particularly during monsoon.
