# Traditional inputs in disaster management: the case of Amparav, North India

PIYOOSH RAUTELA\* AND R. K. PANDE

Disaster Mitigation and Management Centre, Department of Disaster Management, Government of Uttaranchal, Uttaranchal Secretariat, Rajpur Road, Dehradun – 248 001, (Uttaranchal), India

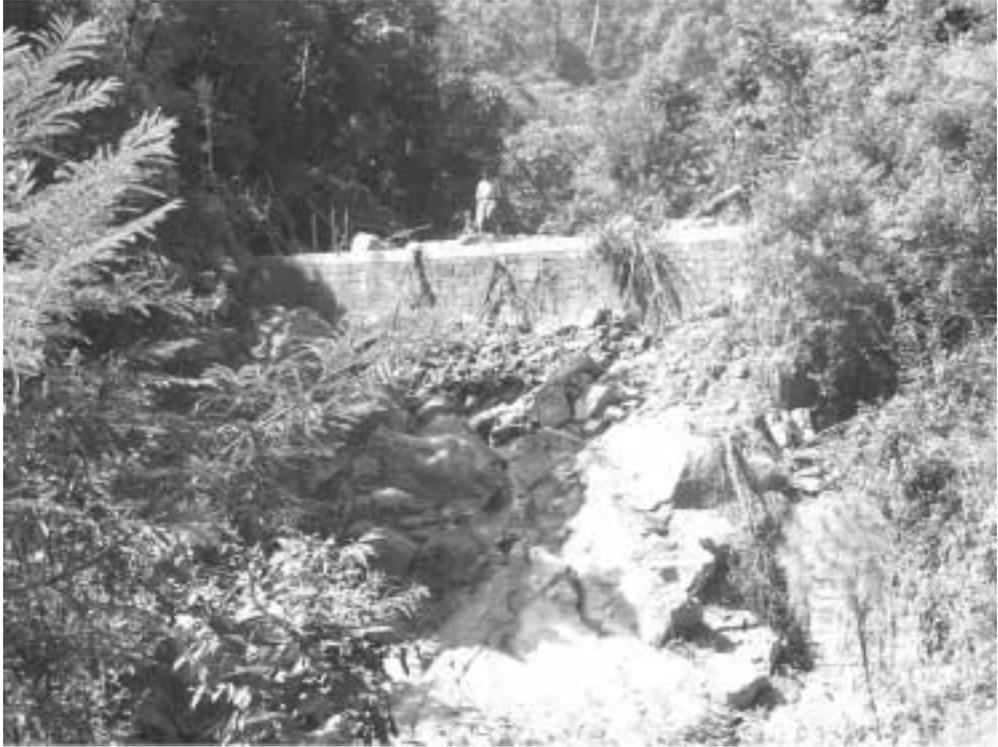
Figure 3. Still intact; upstream view of the structure erected for diverting discharge of the seasonal stream flowing through Amparav to China Gadhera (at (A) in Fig. 2). The structure became silted up and the water overran the structure.

- (2) The stream draining through Amparav flowed over loose unconsolidated old slide material and would have caused severe mass wastage during the monsoon season. It was therefore diverted to China Gadhera by a massive stone masonry structure (figure 3).

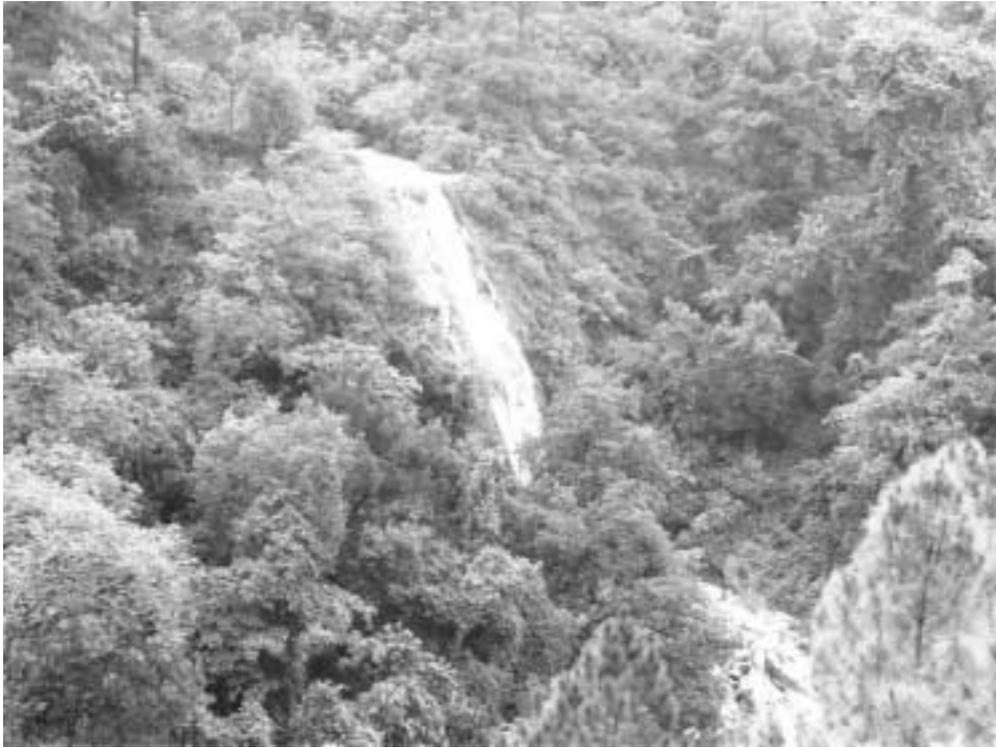
- (5) China Gadhera cuts across the sandstone shale sequence and falls into Nalena Gadhera over a cliff. Enhanced discharge along this stream resulting from stream diversion could enhance the rates of head-ward erosion. The old landslide managers seemed to be aware of the probability of enhanced erosion along the course of the China Gadhera and therefore implemented adequate safety measures. The stream course was converted into a number of small rapids by erecting retention walls at regular intervals. The last in the series is more than 150 feet high and forms a spectacular waterfall (figure 4). This

Figure 4. View of the waterfall over the retaining wall erected along the cliff (at (B) in figure 2). This retaining wall is preceded by the concrete lined course of China Gadhera.

massive stone masonry structure that is intact even today rules out the probability of head-ward erosion initiating from this steep drop in gradient. To be doubly sure of success, the entire streambed was lined with concrete. All these structural interventions are still intact and functional.
