Seismic retrofitting of lifeline structures in Uttarakhand

A report

Disaster Mitigation and Management Centre
(An Autonomous Institute of Disaster Management, Government of Uttarakhand)
Uttarakhand Secretariat, Dehradun-248001
Uttarakhand, India

November, 2012

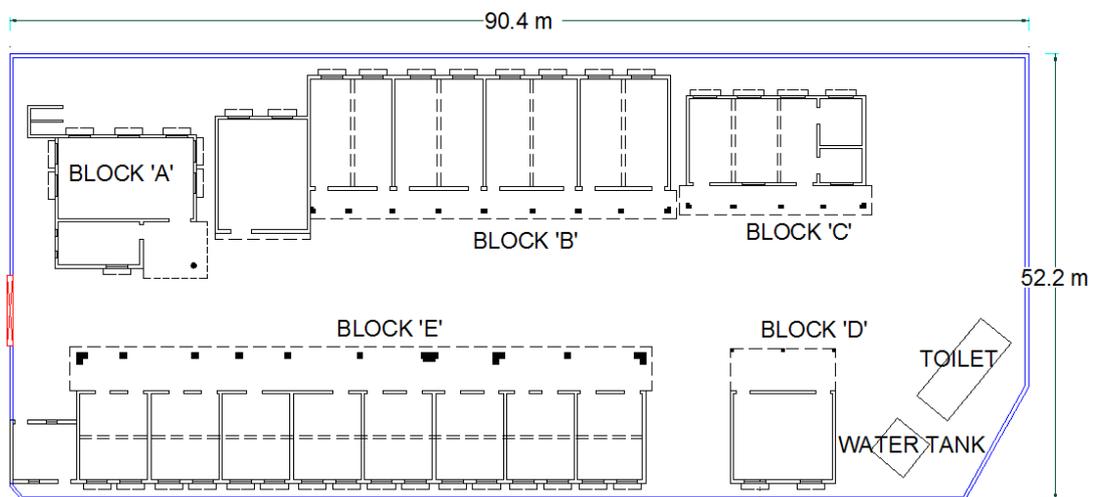
Fig. 8: Layout of the school building at Ranipokhari, Uttarakhand.

Building Details: The school is situated at Ranipokhari that is situated at a distance of 25 km from Dehradun on Dehradun – Rishikesh highway. The school was observed to have been constructed in many stages with the oldest part being constructed around 55 years ago. There are five blocks in the school designated A, B, C, D and E respectively. The school has 20 rooms including the kitchen, computer room and office. All the blocks are single storeyed and Figure 8 shows the layout of the school building.

The school is constructed on a uniform plane with all the blocks being situated at the same elevation. Being a single storey structure it has a unique centre of mass and centre of stiffness through which the design eccentricity is calculated.

Except for C and D blocks that have a height of 3.7 meters all other blocks have a height of 3.0 meters. With increase in the height of the structure its seismic vulnerability is generally enhanced as the building height is proportional to the amount of forces it has to resist during an earthquake. Figures 9 and 10 depict the state of the school building before retrofitting.

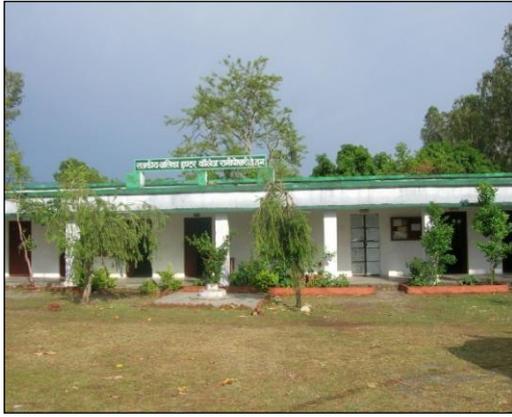
Fig. 9: Photograph of the school building block 'B' at Ranipokhri, Uttarakhand

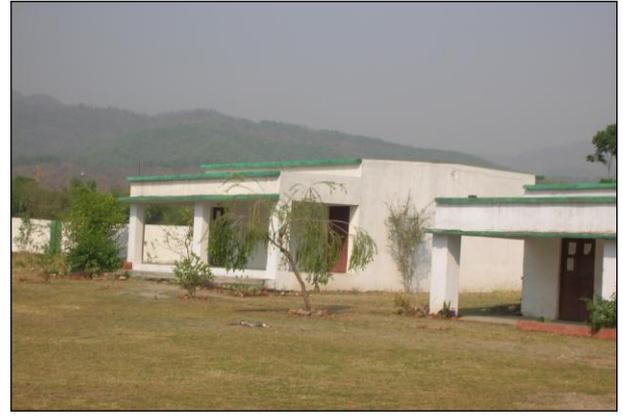
Fig. 10: Photograph of the school building Block 'A' at Ranipokhri, Uttarakhand.

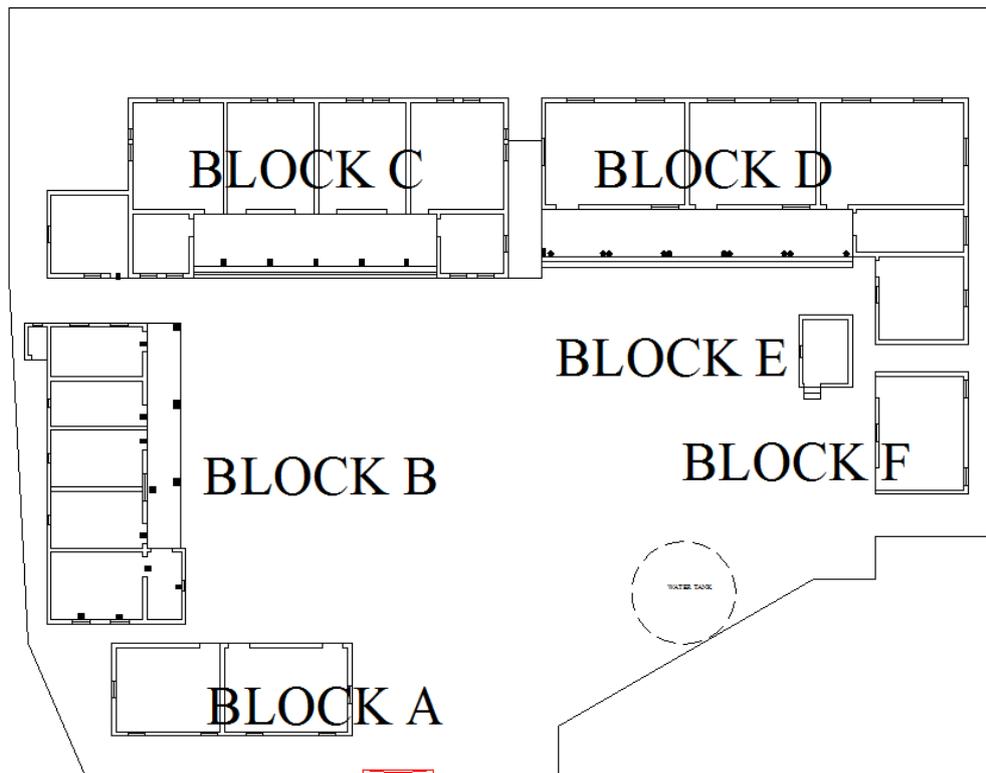
Fig. 11: Layout of the school building at Dobhalwala in Dehradun city.

Building Details: The school is situated in Dehradun city at a place called Dobhalwala. The school was observed to have been constructed in many stages and its oldest portion was constructed about 45 years ago. There are six blocks in the school designated A, B, C, D, E and F. All the blocks are single storeyed. Figure 11 shows the layout of school building.

The school is constructed on a uniform ground with all the blocks being located at the same elevation. Being a single storey structure the building has a unique centre of mass and centre of stiffness through which the design eccentricity is calculated. Except for C and D blocks that have height of 3.7 and 4.2 meters respectively all other blocks have a constant height of 3.0 meters.

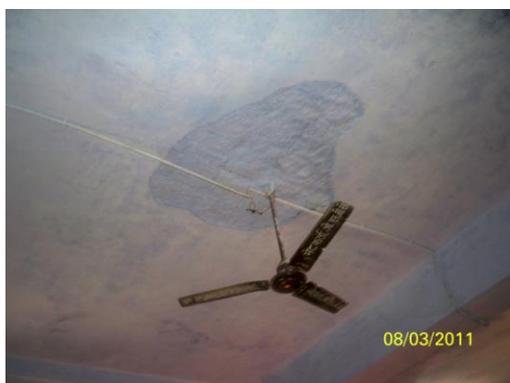
Some parts of B and C blocks were observed to be wrecked. Honeycombing was clearly visible in the roof in some parts (Fig. 12). Honeycombing refers to voids in concrete that are caused by the mortar not filling the spaces between the coarse aggregate particles. It is an aesthetic problem but depending on the depth and extent it may reduce durability, performance and structural strength of concrete.

Fig. 12: View of oneycombing in the roof of the structure.

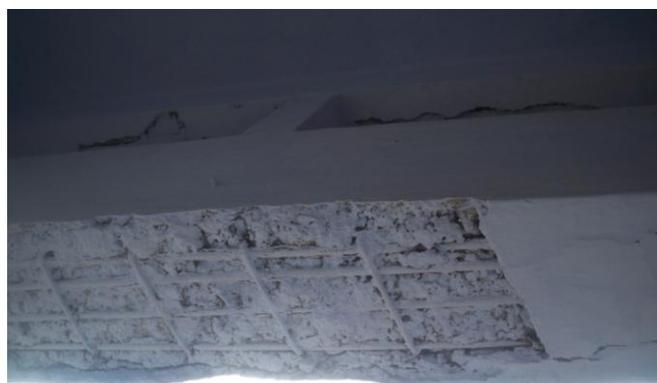
Fig. 13: Exposed steel reinforcement of the roof.

A part of the A block was observed to have been constructed using random rubble (RR) masonry of 230 mm thickness while the rest was constructed using brick masonry. The roofs of most of the blocks were not in good condition. This is owed to i) honeycombing of concrete, and ii) exposure of steel reinforcement (Fig. 13). The exposed reinforcement is prone to corrosion and the corroded steel reinforcement is often not able to bear the imposed loads properly.

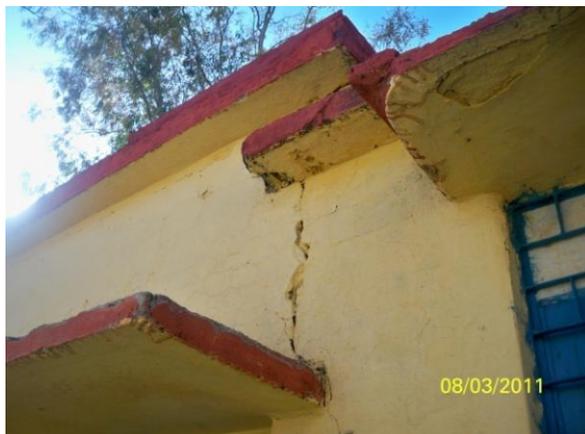
Cracks of several kinds were clearly visible in the building (Figs. 14 and 15). These include structural cracks, shear and diagonal cracks, lack of regular maintenance and construction cracks due to joining of two different structures.

Fig. 14: Joint crack observed in the school building at Dobhalwala.

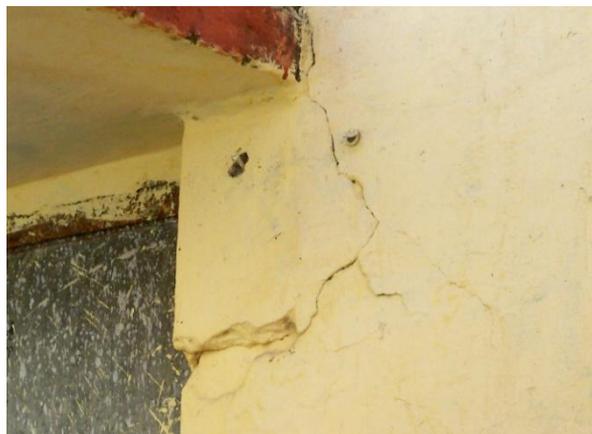
Fig. 15: Shear / diagonal crack observed in the school building at Dobhalwala.

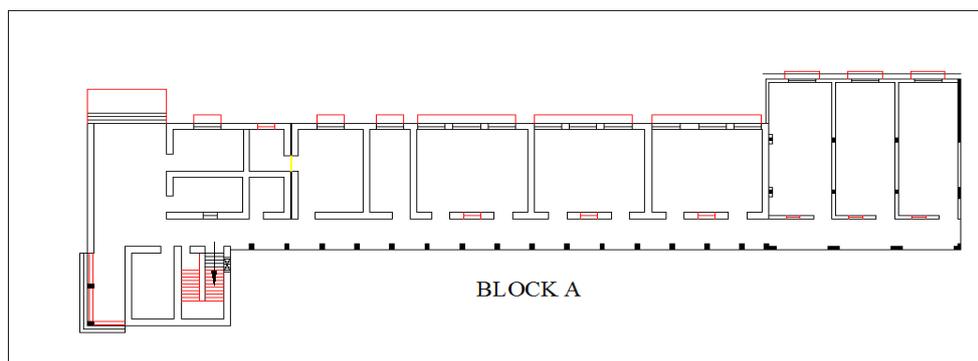
Fig. 18: Layout of the school building at Nainbagh in Tehri Garhwal district.

Only one block was considered for retrofitting (Fig. 18). This block had a constant height of 3.8 meters for ground floor and 3.2 meters for the first floor.

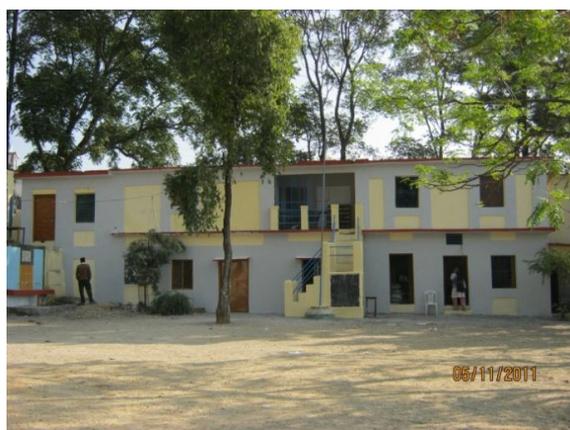
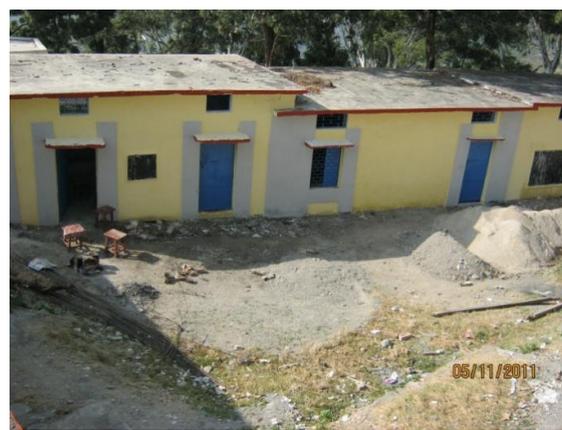
Figs. 19 and 20: Government Inter college Fakot, Tehri Garhwal.

Building details: The school is situated at Fakot (near Agrakhal) on Rishikesh – Gangotri National Highway. The construction of the school was observed to have been done in many stages (Figs. 19 and 20).

The oldest part of the school was constructed about 25 years ago. There are five blocks in the school designated A, B, C, D and E (Fig. 21). Of these A block is double storeyed while the rest are single storeyed. The school has 21 rooms including the kitchen, computer room and school office. The school is constructed on an uneven plane with A block being located at the highest elevation. Ground floor of this block had a height of 3.08 meters while the first floor had a height of 2.5 meters.

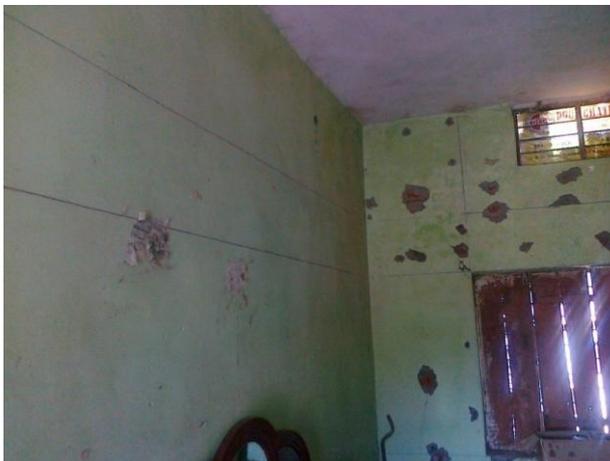
Fig. 22: Markings being done using blue colour and thread.

The marking for the seismic bands proposed to be provided at various levels of the structure is the first step of the retrofitting exercise. Markings are done on the surface of the wall using colour and thread (Fig. 22). These markings are intended to guide the stone cutting machine operators in chipping the plaster.

For making the marks first dip the thread in the coloured dye. Hold both ends of the thread at places across which marking is to be made. Stretch the thread and finally leave it. A straight line would thus inscribed across the surface of the wall at the desired location.

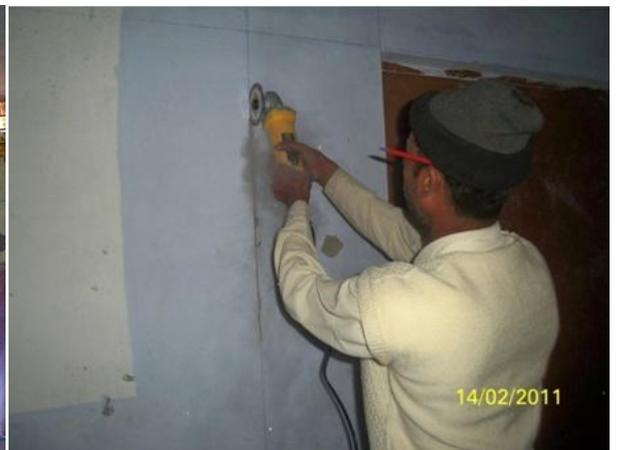
Fig. 23: Mason using stone cutting machine to chip off at markings.

Rotary stone cutter is used to cut through the layer of the wall plaster along the markings done previously (Fig. 23). This facilitates removal of the wall plaster from the desired location, i.e. the surface of the wall between the markings. The wall plaster from the desired area is subsequently removed using chisel and hammer (Figs. 24, 25 and 26).

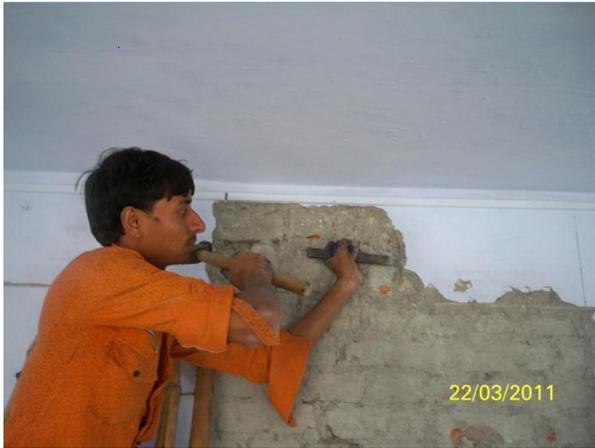
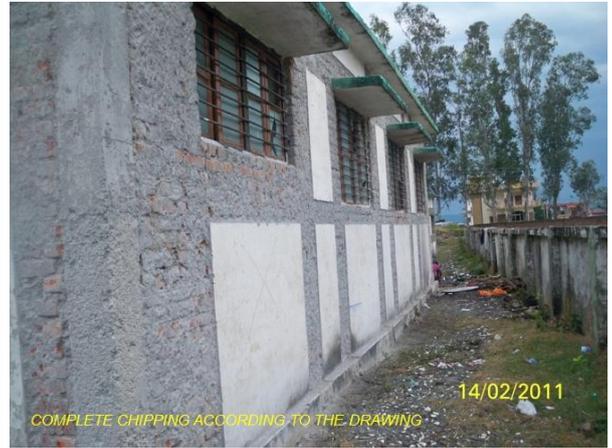
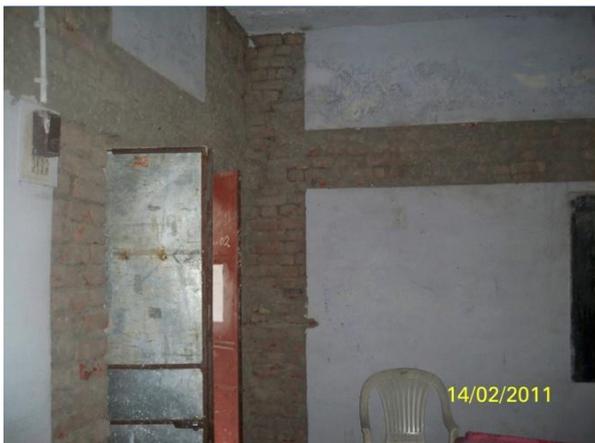
Fig. 24: Mason using chisel and hammer to chip off the plaster.

Fig. 25: Figure showing complete chipping according to the drawing.

Fig. 26: Figure showing complete chipping of plaster inside the room.

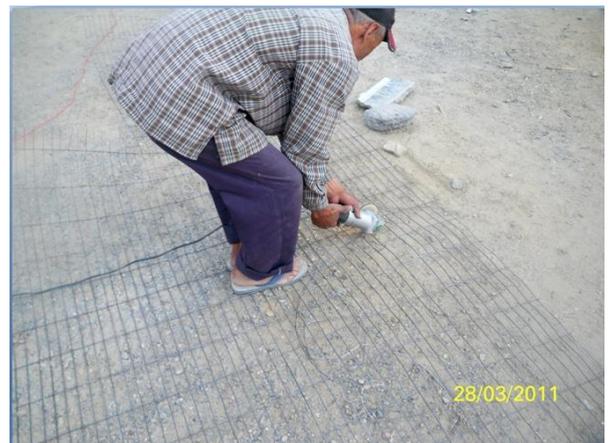
Fig. 27: Mason using rotating cutter to cut wire mesh.

In accordance with the specifications given in the retrofitting design the wire mesh (1'' x 6'') is cut to the desired dimension using a cutter (Fig. 27). In case cutter is not available at the site the mesh is cut using hammer and chisel (Fig. 28).

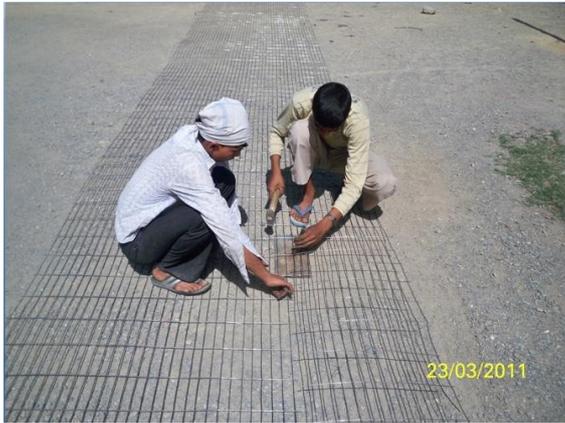
Fig. 28: Masons using chisel and hammer to cut wire mesh.

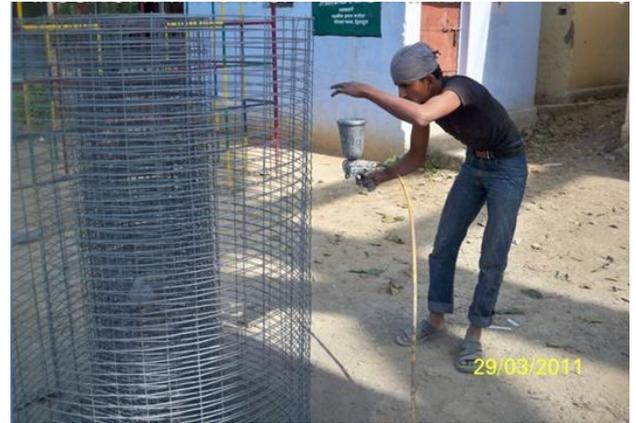
Fig. 29: Figure 4(a): Mason applying epoxy primer using spray.

Epoxy zinc primer is then applied to the wire mesh (Fig. 29). It works as an anti corrosion coating on the steel reinforcement or steel surface. This resists corrosion within the confines of the repair location and avoids the generation of incipient anodes in immediately adjacent locations.

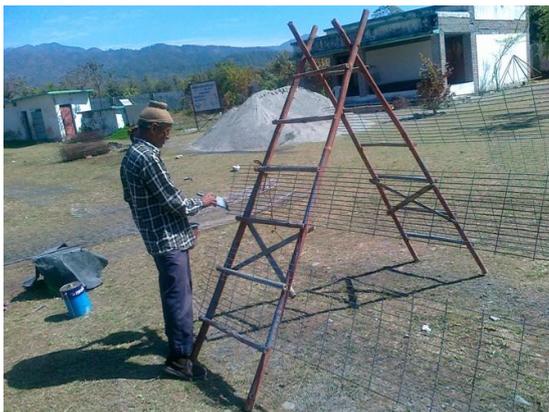
Fig. 30: Mason applying epoxy primer using paint brush.

If spray is not available epoxy zinc primer can be applied using a brush (Fig. 30). Use of spray however saves time and labour.

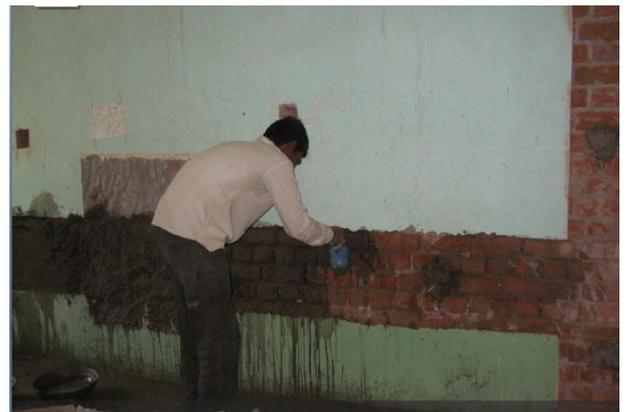
Fig. 31: Mason applying cement slurry on wall.

Acrylic bonding agent is used as i) a bonding agent for both new and old substrates and ii) cement mortar modifier as it provides strong bonds between old and new concrete and improves tensile and flexural strength of concrete and increases the durability of the structure.

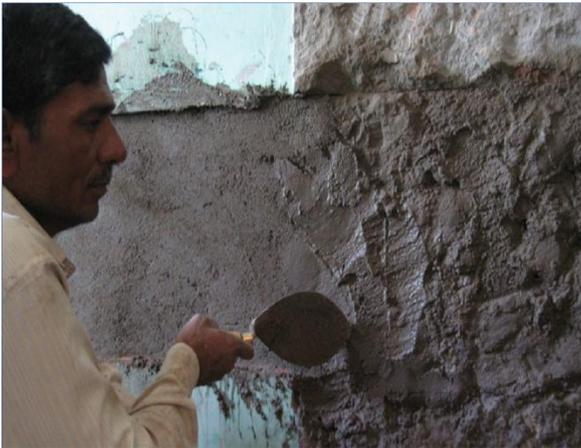
Fig. 32: Mason applying first layer of cement mortar.

Liquid integral waterproofing compound is used as an additive for cement concrete / mortar / plaster as its plasticizing properties make concrete cohesive and prevent segregation. It improves the waterproofing properties of cement concrete and plaster after curing.

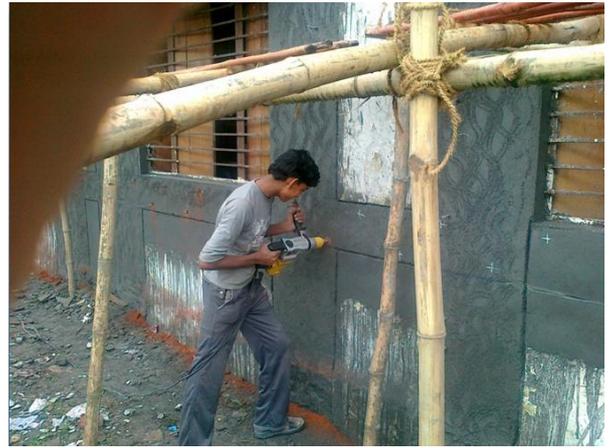
Fig. 33: Mason drilling holes into the wall.

Holes of 8 mm diameter are subsequently drilled through the wall (Fig. 33). The centre to centre distance of 45 cm is maintained between two consecutive holes. 6 mm steel bars are then passed across the wall through these holes.

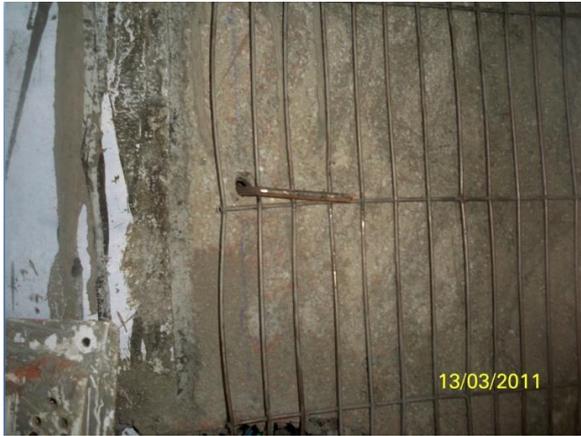
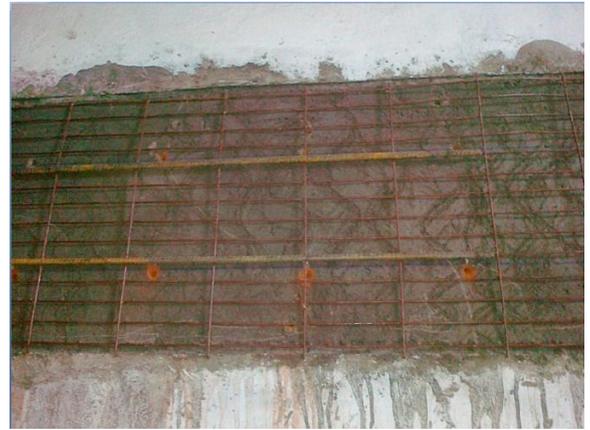
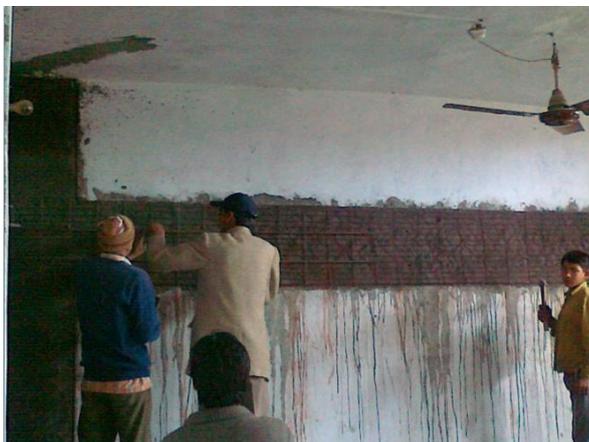
Fig. 34: Wire mesh being held in position using 6 mm steel bars.

Fig. 35: Figure showing fitting of wire mesh and reinforcement bars.

Fig. 36: Masons fitting the wire mesh and reinforcement bars.

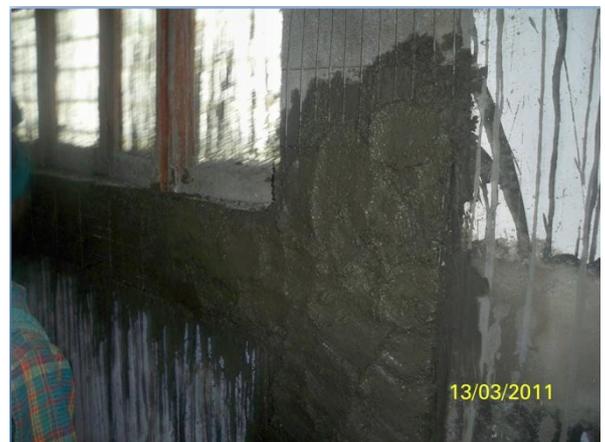
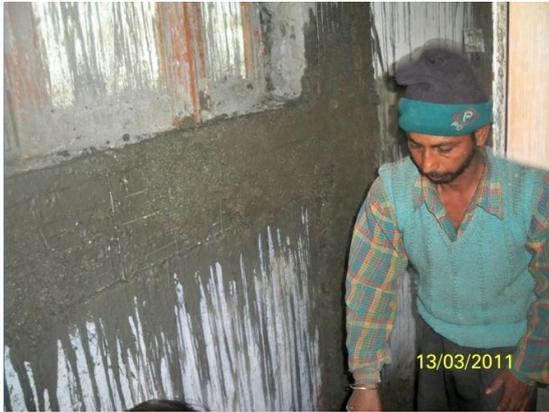
Fig. 37: View of the second layer of micro-concreting.

Fig. 28: Mason applying second layer of micro-concrete.

After fitting the wire mesh on the wall second layer of micro - concrete is applied (Figs. 37 and 38).

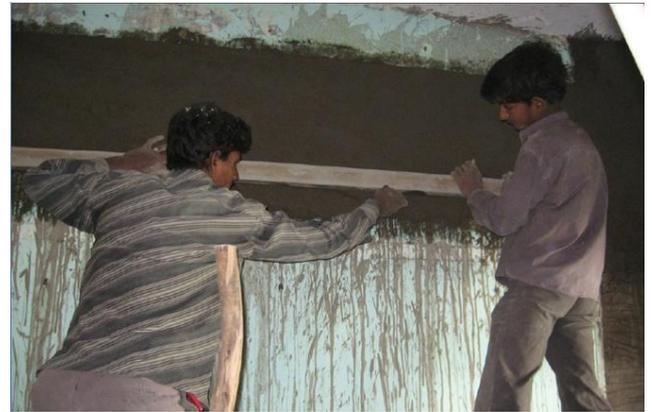
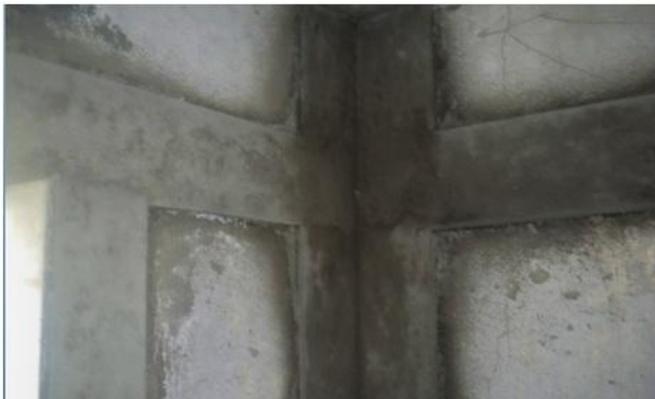
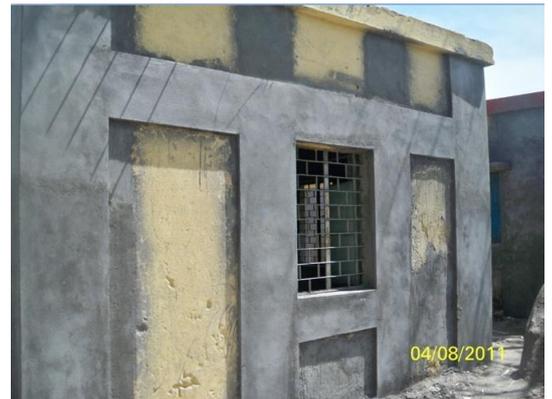
Fig. 29: Mason applying third and the final layer of plaster.

Fig. 40: The final finished look of the wall after plastering.

Fig. 41: The final finished look of the wall after plastering.

After applying second layer of micro-concrete third layer of cement mortar is applied so as to give final finish to the wall. The concrete layer after the previous step is rough and slightly uneven. Henceforth to make the surface smooth proper finishing is done by the masons by plastering with cement mortar (Figs. 39, 40 and 41).

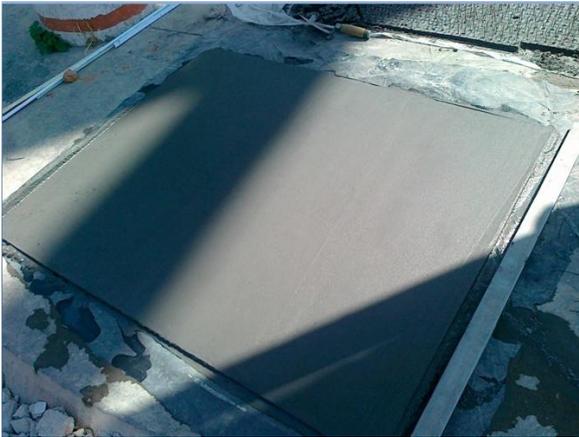
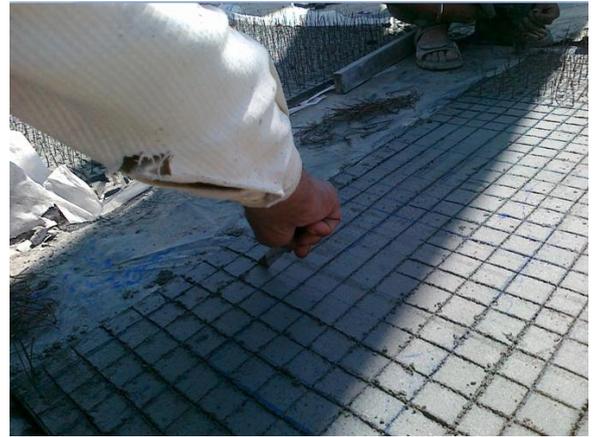
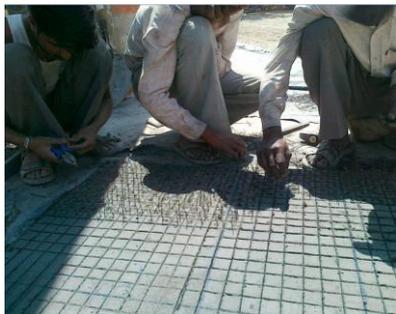
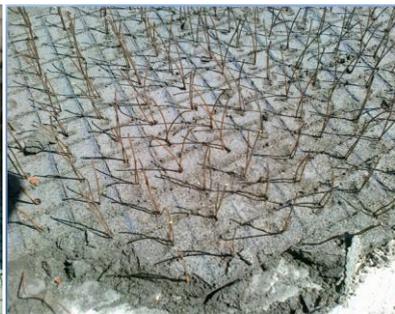
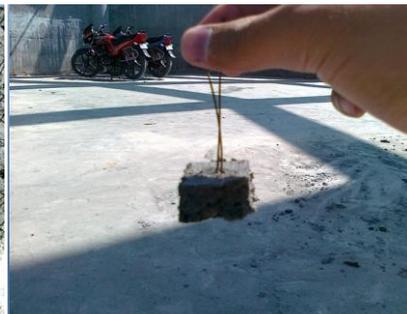
Fig. 42: Figure showing the base from which spacer is made; the base is 15 mm thick.

Fig. 43: Figure showing cutting of spacers (2" x 2").

Fig. 44: Binding wire being inserted into the spacers.

Fig. 45: Spacers prepared.

Fig. 46: An individual spacer.

cement mortar and binding wire (Figs. 42 – 46). These are used to maintain certain gap between the wall and the wire mesh. Spacers of 15 mm thickness are used in the present case.

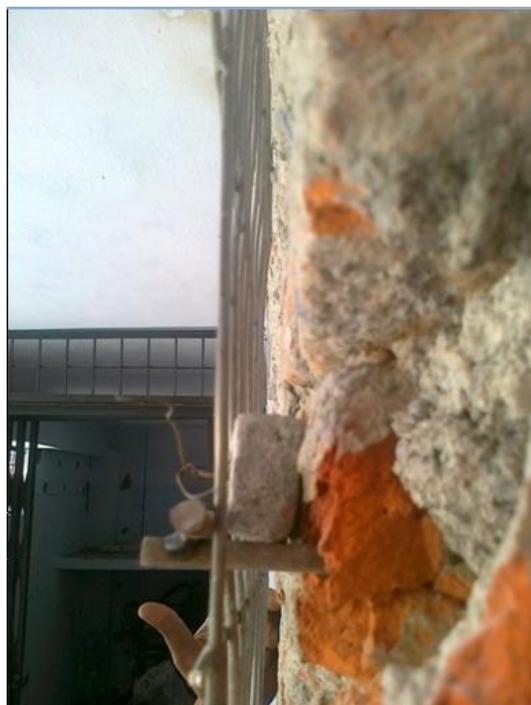
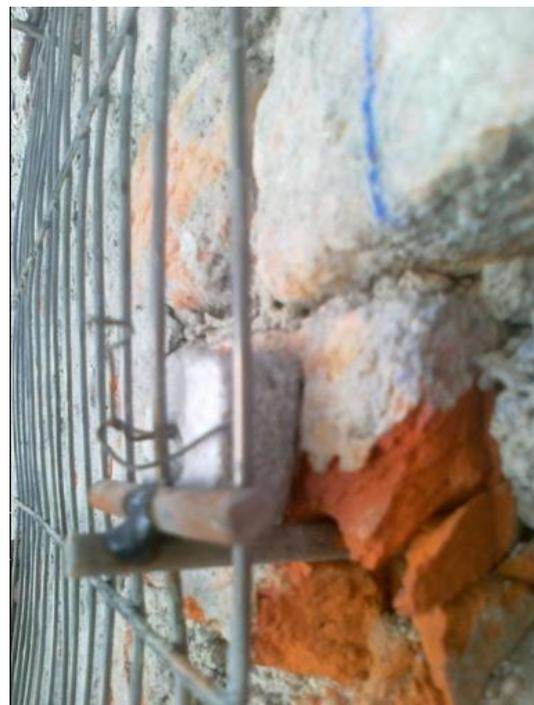
Fig. 47: A spacer tied between the wall and the mesh.

Fig. 48: A spacer tied between the wall and the mesh.

The spacers are fixed between the wire mesh and the wall and tied with the binding wire so that their position remains intact and these do not get displaced while guniting (Figs. 47 and 48).

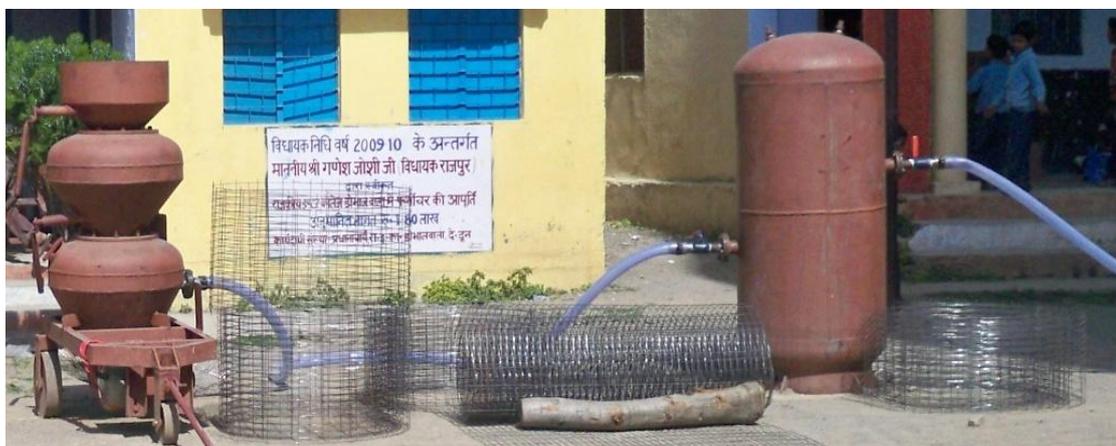
Fig. 49: Dry mix holder (left) and compression chamber (right).

The wire mesh is subsequently covered with micro-concrete. Micro concrete guniting has been used for this purpose. Guniting is the process of conveying desired mixture of dry cement, sand and aggregate under air pressure at high velocity with just sufficient quantity of water for hydration. Guniting machine consists of a twin chamber gun and twin water tanks and is powered by compressor (Fig. 49).

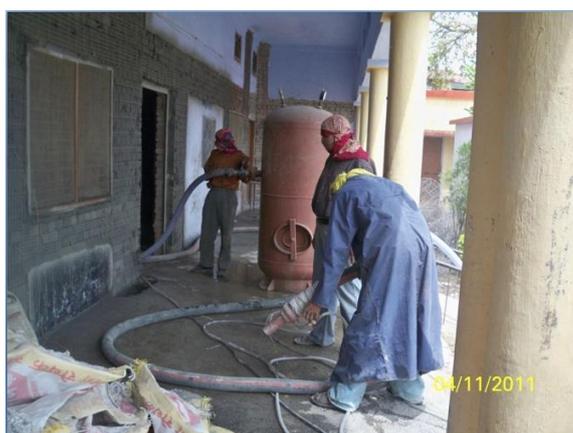
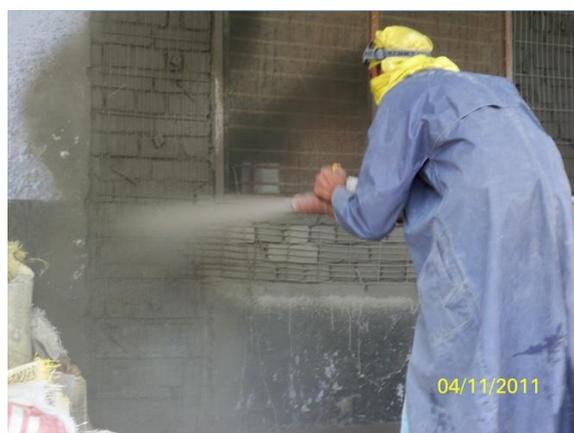
Fig. 50: Nozzle of machine in hand of the mason.

Fig. 51: Micro-concrete coming out at high velocity from the nozzle.

The material is carried under pressure through a pipe and deposited on the desired surface through the nozzle (Figs. 50 and 51). Besides saving time and labour use of guniting machine for concreting ensures proper compaction.

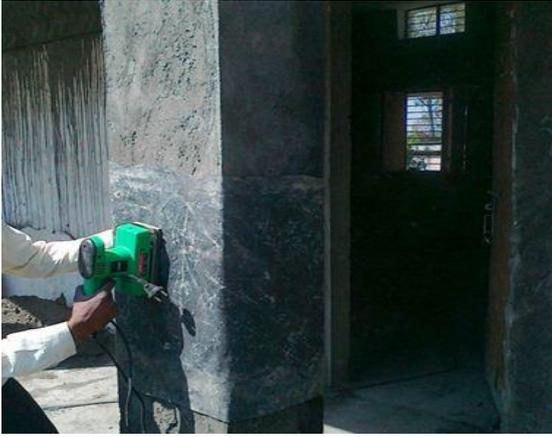
Fig. 52: Compaction using hand vibrator.

In case guniting machine is not available then compaction of micro-concrete can be done with the help of hand held vibrator as well (Fig. 52). View of the finished school building is given in Figure 53.

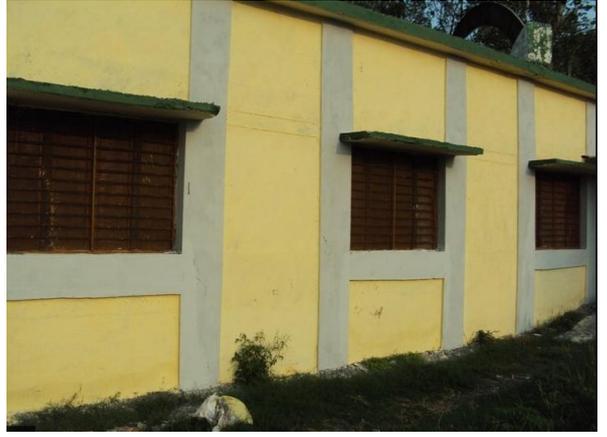
Fig. 53: The final finished look of School building block.
