**Investigations in the areas around Okhimath in  
Rudraprayag district on the aftermath of  
landslide incidences of September, 2012**

**A report**

**Disaster Mitigation and Management Centre  
Department of Disaster Management  
Uttarakhand Secretariat  
Dehradun 0 248 001**

**October, 2012**

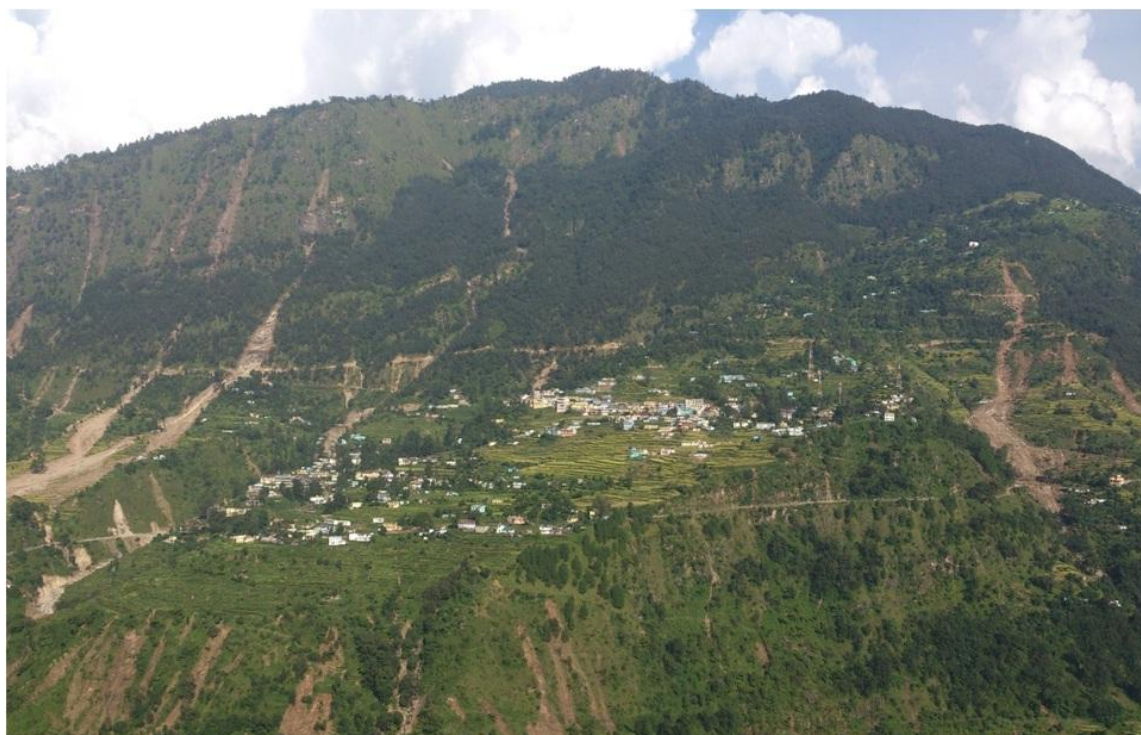
**Fig. 2. Panoramic view of Okhimath town showing scars made by the debris descending down the steep slope.**

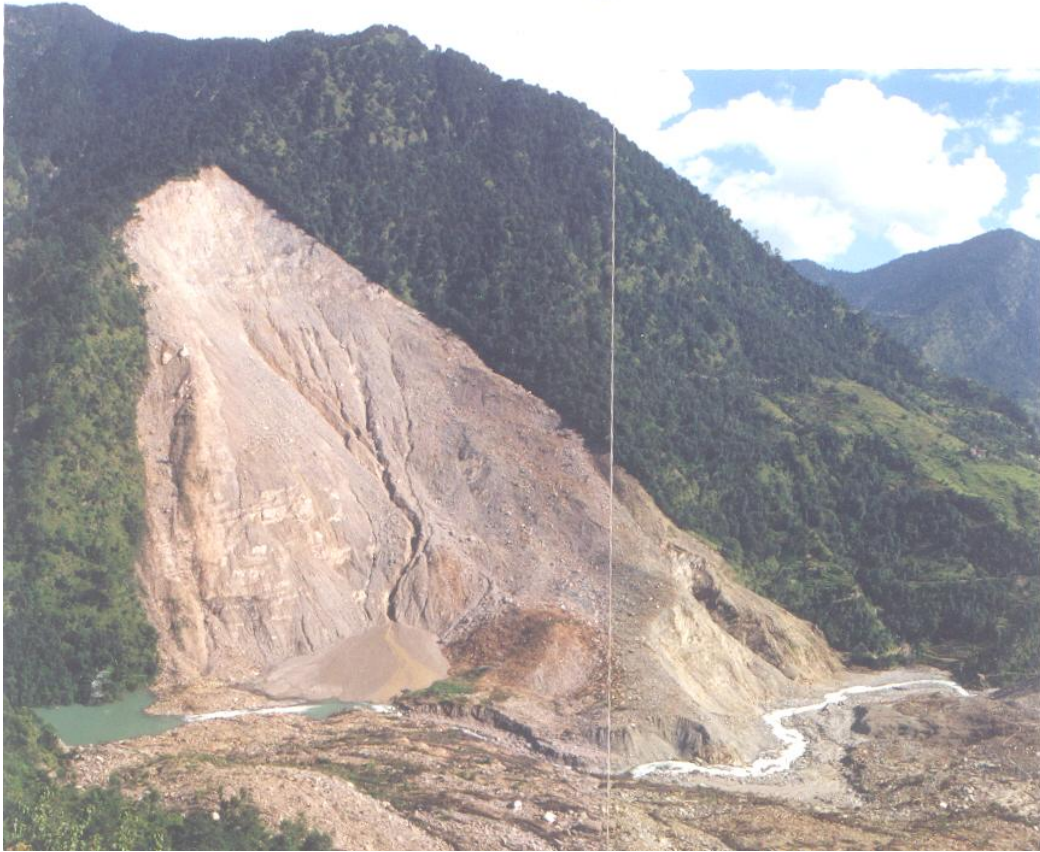
**Fig. 4. View of Bheti – Paundar landslide of August 1998.**

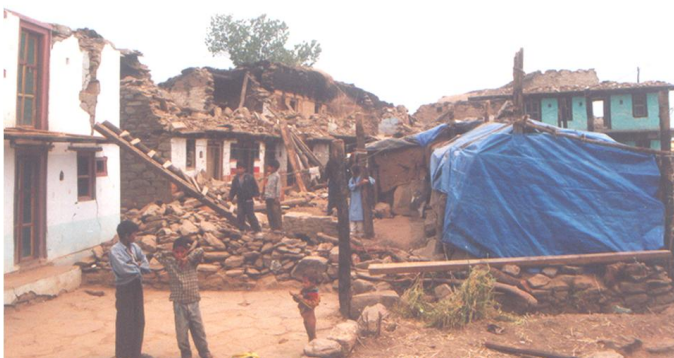
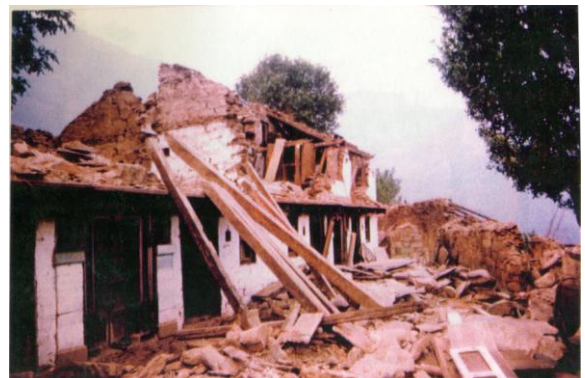
**Figs. 5 and 6. View of the devastation at Akhori (left) and Oring (right) villages of Rudraprayag district due to 1999 Chamoli Earthquake.**

Chamoli Earthquake of 1991 caused significant loss of human lives and property in Rudraprayag district (Figs. 5 and 6). Population of 11,500 in 34 villages was affected by the quake that caused loss of 36 human lives. 176 persons were injured in this incidence that took toll of 140 cattle.

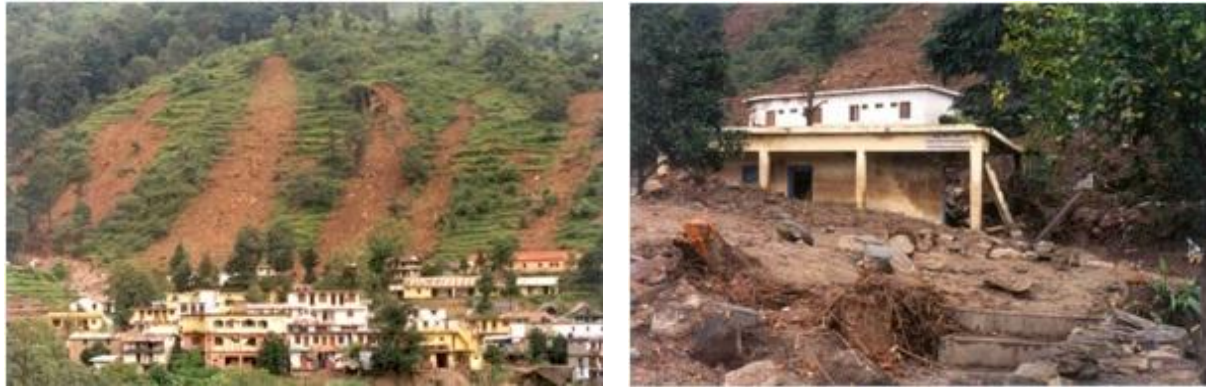
**Figs. 7 and 8. View of the Phata landslide of July, 2001.**

Landslides amid abnormally heavy precipitation on 15<sup>th</sup> and 16<sup>th</sup> July, 2001 in Phata area of Okhimath tehsil caused death of 28 persons (Figs. 7 and 8). Population of 3,924 in 15 villages of the area was affected by this incidence. 52 houses were damaged / destroyed in the incidence that took toll of 62 cattle and 43 hectare agricultural land.

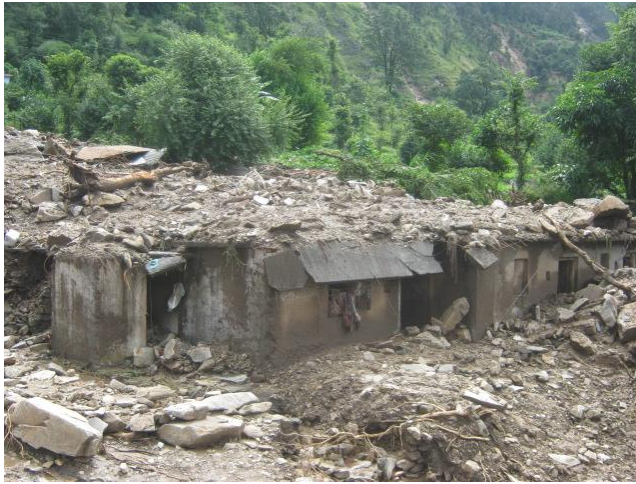
**Fig. 10. Damaged houses in Mangoli village.**

These incidences caused loss of 69 human lives and serious injuries were caused to 15 persons. More than 70 residential houses were reported to be destroyed in these incidences that caused heavy loss of other infrastructure and facilities (Figs. 10 and 11).

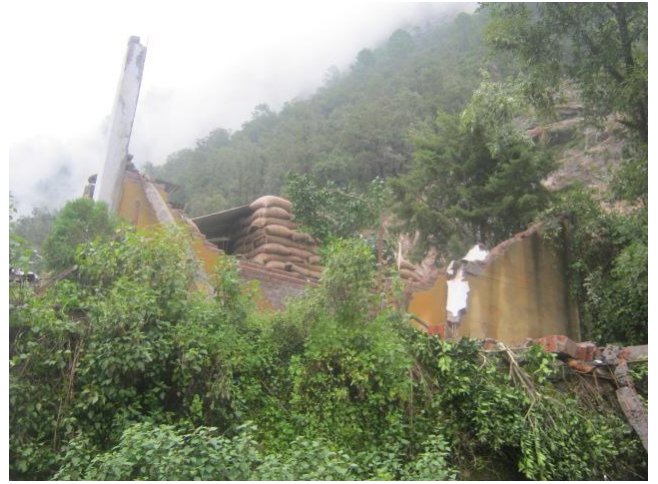
**Fig. 11. Damaged food grain storage facility at Bamankholi.**

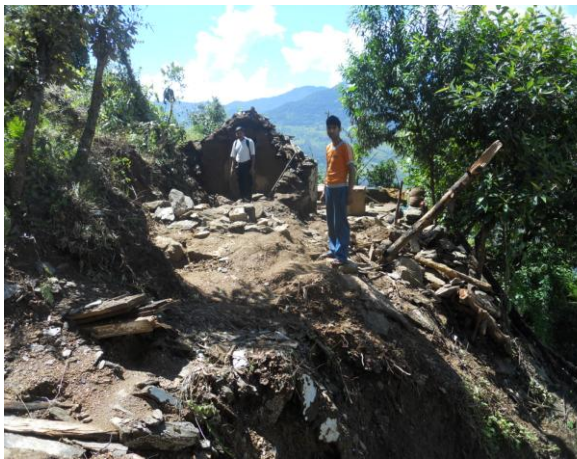
The slope failure was observed to have occurred on the northern slope of Pangran tok. The area was observed to be prone to instability due to foliation plane dips being parallel to the surface slope.

The width of the failure surface around the crown was observed to be about 12 meters while the height of the crown was about 8 meters from the houses destroyed by the mass movement. The inclination of failure slope was observed to be 35°.

The water laden down slope moving mass was observed to have overrun the houses and cultivated lands in the western side of Pangran tok (Figs. 24 and 25).

**Fig. 24. View of the house ravaged by landslide.**

Saturation by rainwater would have led to increased pore water pressure in the overburden mass on the hill slope and would have significantly reduced the shear resistance of the slope forming materials. This seems the most probable reason for triggering the destructive landslide.

**Mitigation measures:** Debris accumulated in the back slope of the houses needs to be cleared. After the debris has been removed concrete breast wall with adequate provision of weep holes or perforated pipes for draining out excess water is recommended. This has to be accompanied by provision for safe disposal of rain water through a

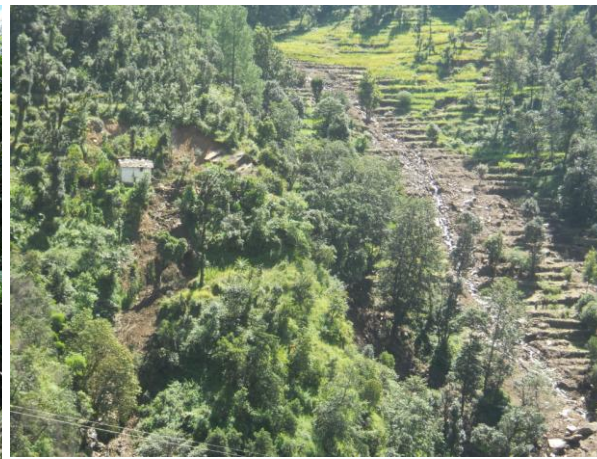
**Fig. 25. View of the agricultural land overrun by landslide debris.**

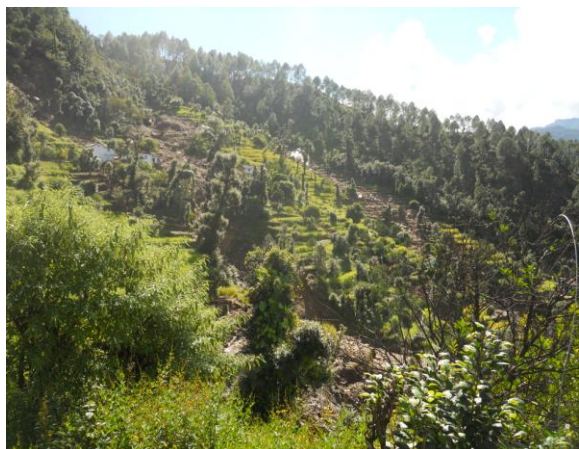
A number of agricultural fields around the village were observed to be damaged due to shallow water saturated debris flows (Figs. 26 and 27). Water is deduced to be the main driving force of these debris flows.

**Fig. 26. Photograph showing slope failure and ensuing damage to a number of agricultural fields around Salami village.**

Debris accumulated around the houses needs to be cleared. After this oblique concrete retaining structures of appropriate height would have to be constructed upslope of affected site. Particular caution is required to ensure that these structures are founded on compact rocks and compact soil materials. This would help in protecting the remaining houses.

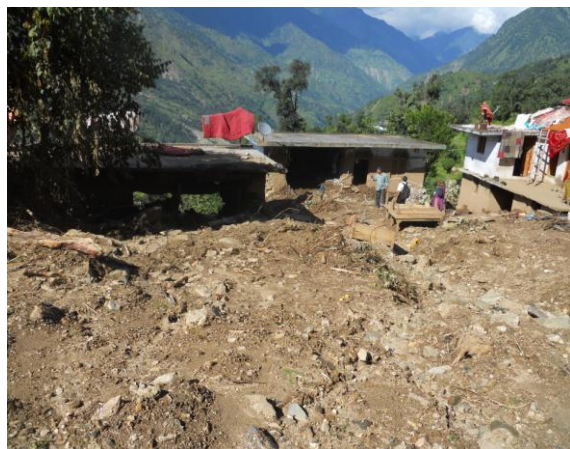
**Fig. 27. View of the houses damaged by water saturated debris in Salami village.**

The debris flows were observed to have overrun five residential houses of the village. Amongst these, one house was severely damaged while the others were partially damaged.

***Mitigation measures:*** In this area there exist a number of severely damaged structures that are located on highly vulnerable area falling in close proximity of the course of seasonal drainage channel. These are therefore endangered by bank erosion during coming monsoons. These are required to be removed immediately.

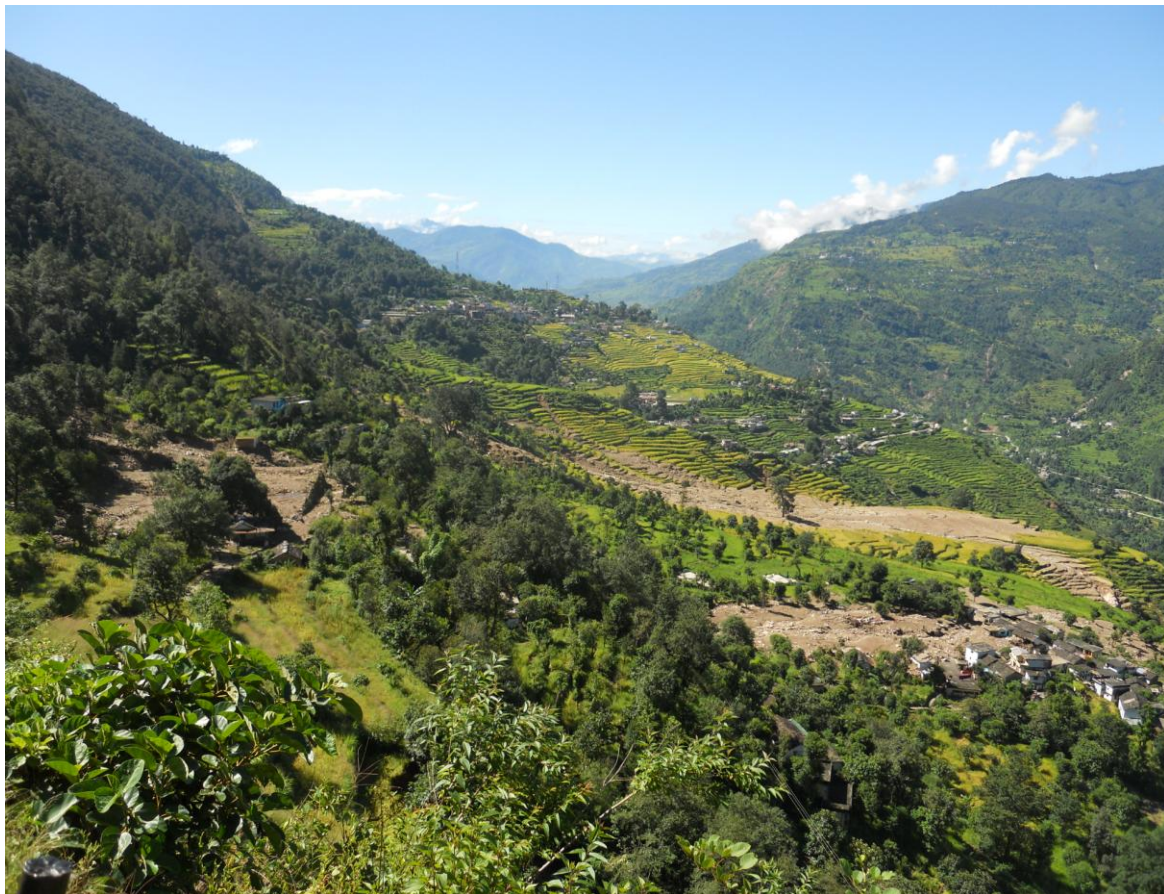
***Reconnaissance geological-geotechnical assessment:*** The landslide debris that descended down from the area upslope of the villages was observed to have overrun both agricultural fields and houses (Fig. 28). The thickness of the debris accumulated in the houses was observed to be 1.5 to 2.0 meters. This overburden material is observed to comprise of hill wash and debris consisting of gray to grayish brown, fine grained silty matrix with rare boulders and fragments of metabasics and gneisses.

**Fig. 28. View of debris flows around Mangoli, Bamankholi, Premnagar and Dangwari villages.**

***Mitigation measures:*** Removal the transported material which is come from the upslope through local streams/gulley's into agricultural lands. After removing the materials local community will be further utilize the agricultural lands.

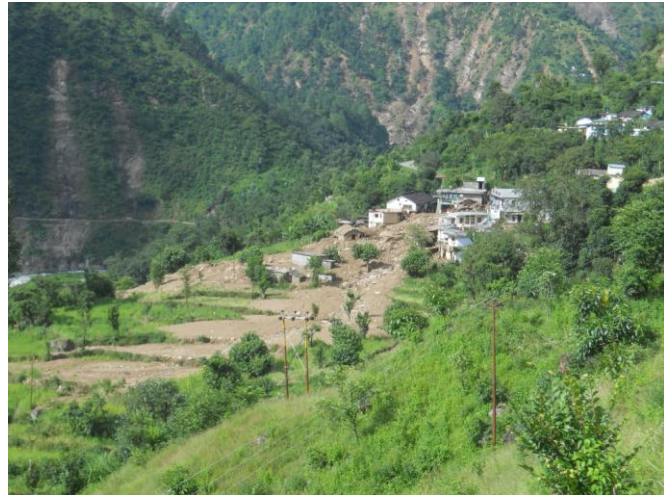
**Fig. 30. Photograph showing debris flow around Chunni village.**

Number of agricultural fields and houses were damaged due to shallow debris flows in the area (Fig. 29, 30 and 31). Rapidly running water and gravity driven movement induced by lubricating action of ground water were largely responsible for driving the debris down slope at fast pace.

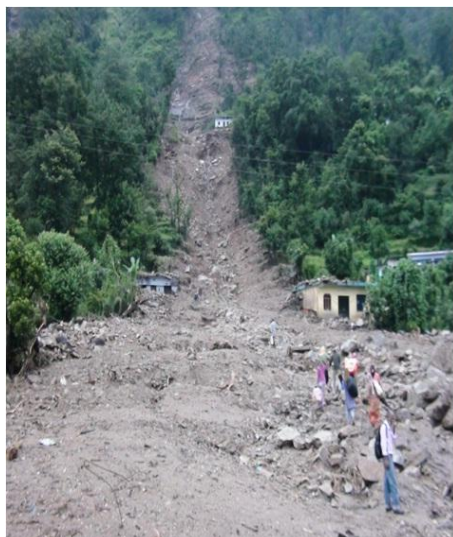
**Fig. 31. Photograph showing devastation caused by debris flow around Mangoli.**

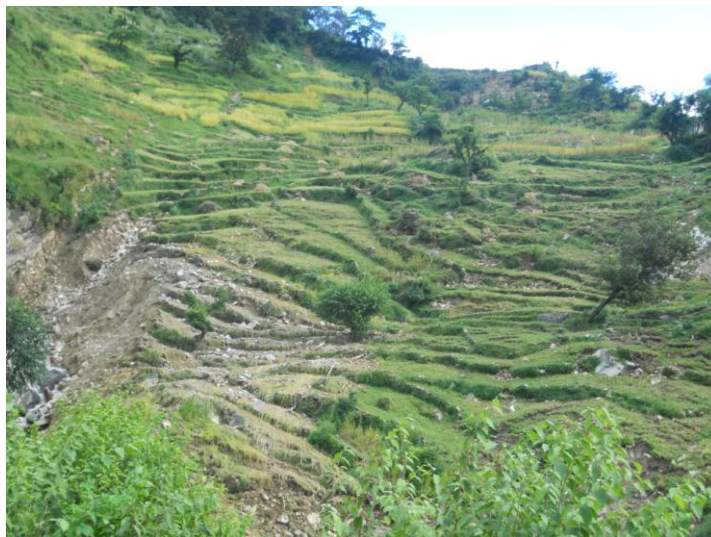
A seasonal stream was observed to flows through Sansari village. The agricultural fields in the vicinity of this stream were observed to show signs of ground subsidence on its left flank. Ground fissures as wide as 1.5 m were also observed around this location (Fig. 32).

**Fig. 32. Photograph depicting subsidence in agricultural lands due to bank erosion by seasonal nala around Sansari.**

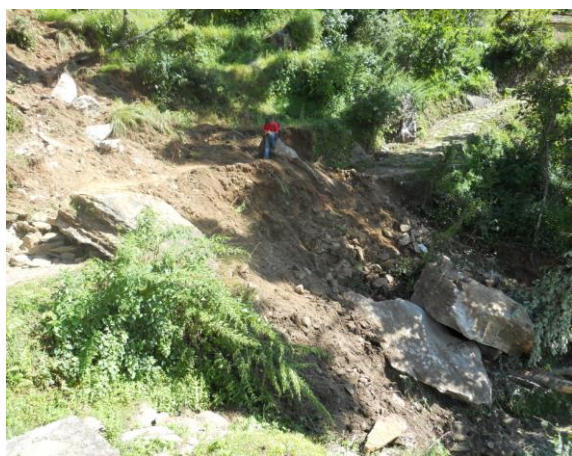
The spatial disposition of joint sets was observed to result in the formation of wedges that facilitated detachment of the rock mass (Fig. 33). The same was observed to slide down and overrun the agricultural fields near the Panchayat Ghar (Fig. 34).

**Fig. 33. Photograph depicting rocks detached due to wedging.**

***Mitigation measures:*** Devastation caused by the down slope moving mass is a direct function of the rock mass and fragmentation of large detached blocks is sure to reduce the impact. It is therefore recommended that the large detached rock mass be broken into small pieces so that the area situated on the down slope direction is safe.

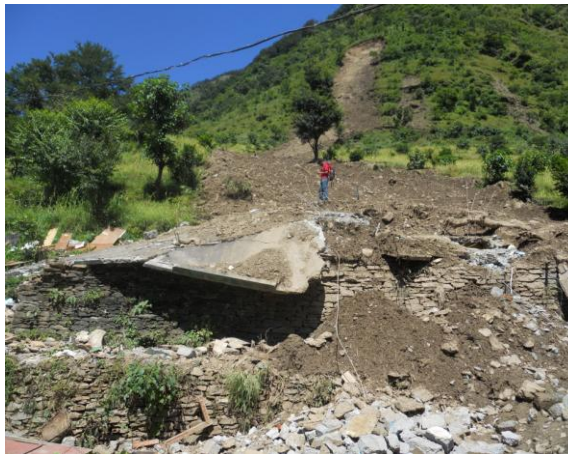
the destructive landslide that inflicted widespread damages in Semla village (Figs. 35 and 36).

**Fig. 35. Photograph showing damaged agricultural fields and houses due to rock cum debris slide.**

**Mitigation measures:** The slope is required to be modified at different level in the area affected by debris slide at Semla village by benching and erection of appropriately designed buttress / retaining walls with suitable provision of weep hole.

Well anchored concrete wall has to be constructed at the toe of the landslide where maximum damage has been inflicted to the houses. It would help in protecting the rest of the houses in case of future instances of slope instability.

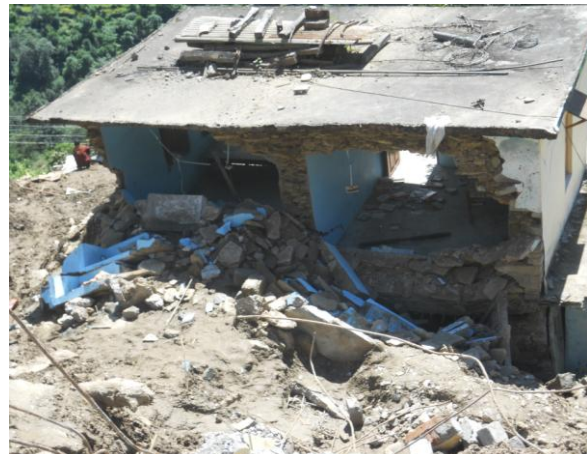
**Fig. 36. View of the damaged house.**

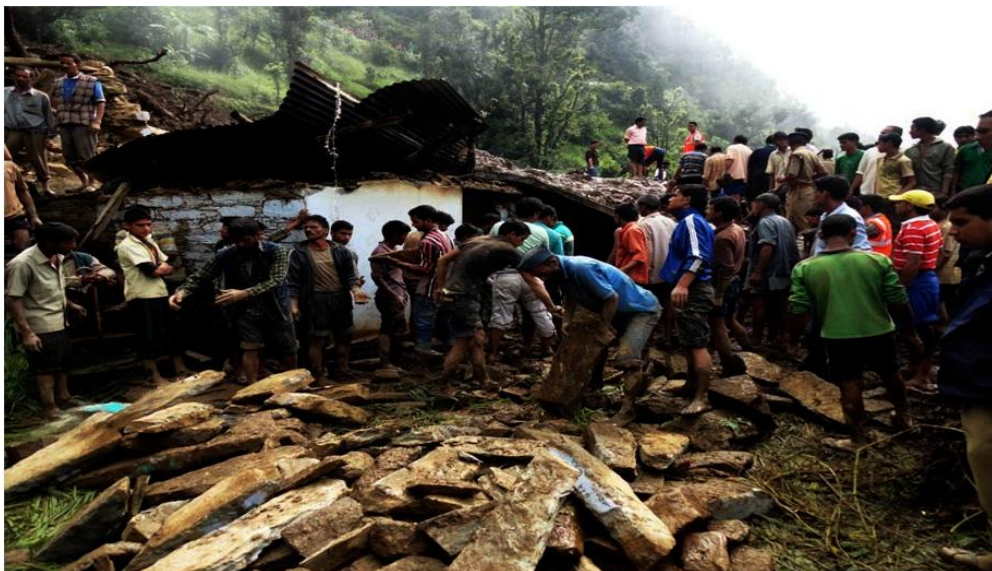
A disastrous landslide occurred on 16<sup>th</sup> September, 2012 at Kirora Malla village in Jakoli tehsil that is located at a distance of 22 km from Augustmuni on Mayali link road (Fig. 38).

**Fig. 38. Photograph showing devastation due to landslide in Kirora Malla.**

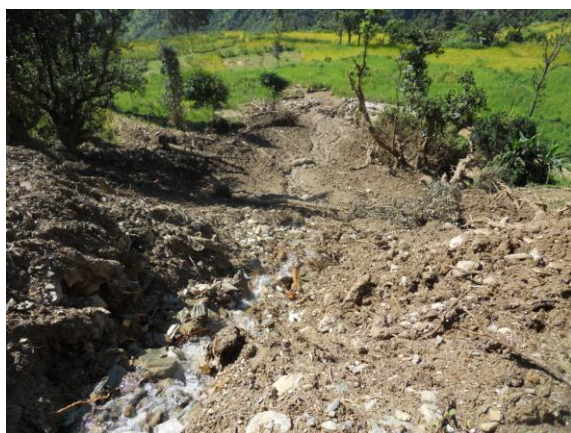
**Fig. 39. Photograph showing debris flow at Kirora Malla.**

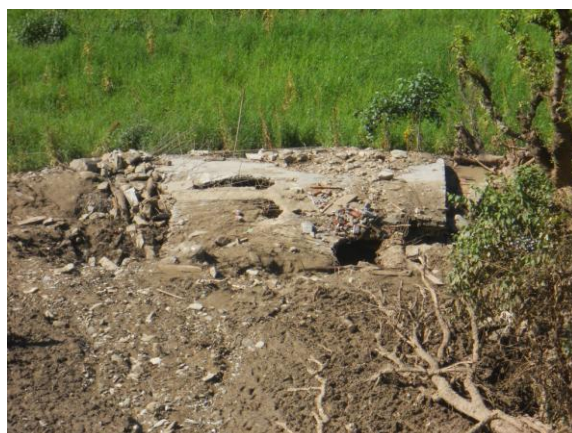
**Fig. 40. View of completely damaged house at Kirora Malla.**

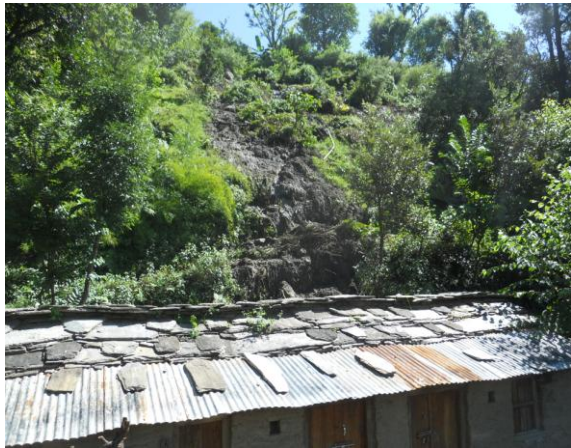
Another landslide was observed to be mass of water saturated debris that descended down the steep slope through the nala and ravaged a house that came in its way at Bengar tok (Figs. 41 and 42). Fortunately the flow of water was diverted upslope of the house towards western side and this limited the magnitude of damage.

**Fig. 41. Photograph showing slight debris flow at backslope of the house.**

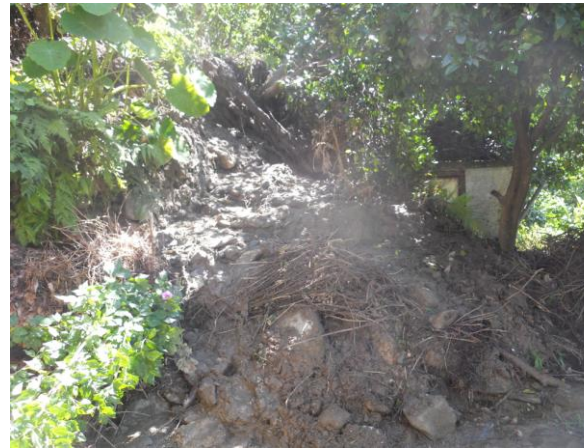
**Fig. 42. View of debris overrunning a toilet at Bengar tok.**
