**Earthquake Safe Koti Banal Architecture
of
Uttarakhand, India**

**Disaster Mitigation and Management Centre
Department of Disaster Management
Government of Uttarakhand, Uttarakhand Secretariat
Rajpur Road, Dehradun – 248 001
Uttarakhand (India)**

**Dr. Piyoosh Rautela
Girish Chandra Joshi**

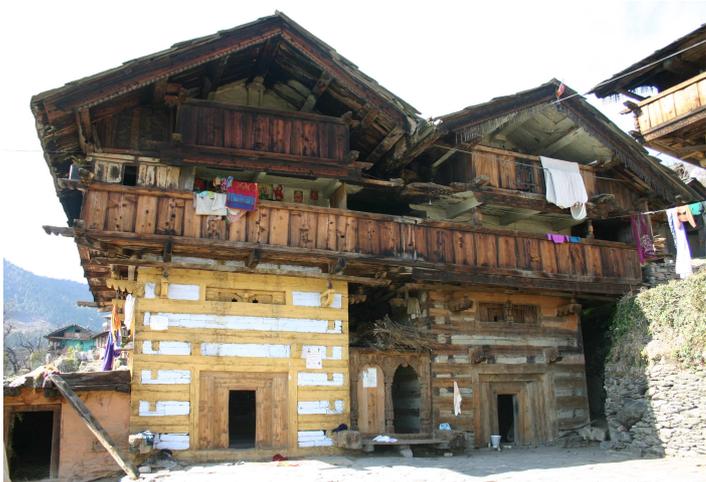
Rajgarhi area, to the north of Barkot across river Yamuna in Uttarkashi district of Uttarakhand (Fig. 4) has a large number of intact multistoried traditional structures (Fig. 5) in a number of villages in close proximity. This area was therefore selected for detailed investi

Fig. 5: Traditional multistoried structures in Rajgarhi.

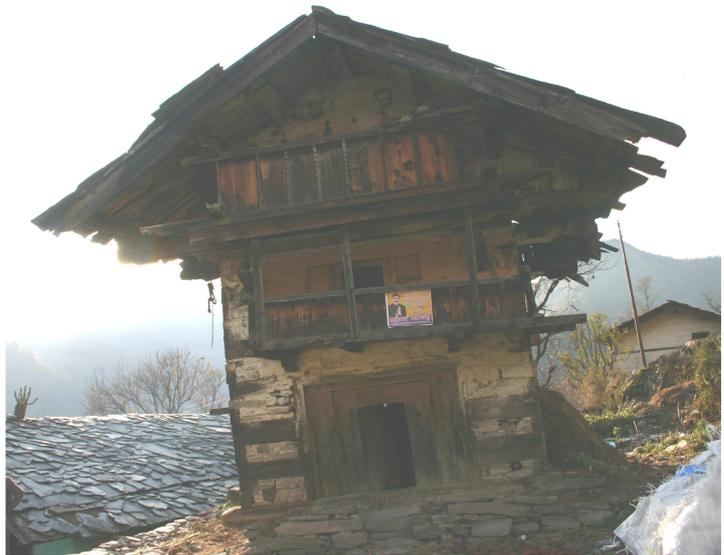
Most respondents (92%) maintained that these structures were constructed to provide safety from thieves while protection from heavy snowfall was also cited as a reason. Whatever be the considerations behind constructing these elaborate structures, these were certainly not designed to cater to the comfort of the inhabitants. This seems the prime reason for a large number of these multistoried structures being put to disuse presently. These abandoned houses are deteriorating fast due to the lack of maintenance (Fig. 6) and require interventions for preserving the rich heritage of the region.

Fig.6: Tradition in shambles: view of the abandoned multistoried structure at Koti Banal.

It is observed that many old structures of Koti Banal style are being put to disuse and are deteriorating fast due to the lack of maintenance (Fig. 6). People are even demolishing these old structures voluntarily so as to use the disassembled building material for the

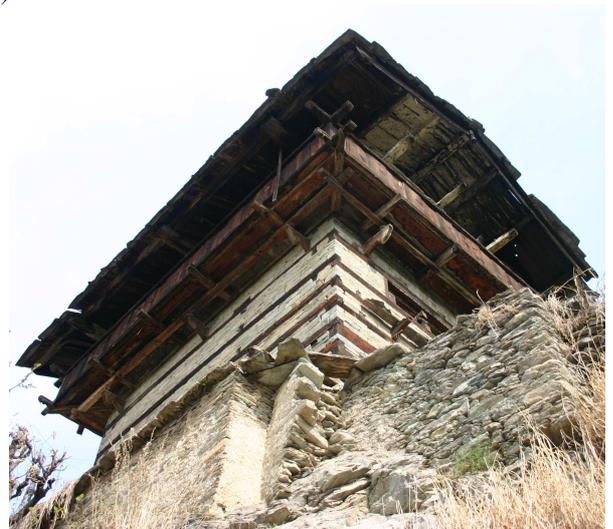
Raised platform: The multistoried traditional structures are observed to be constructed on raised and elaborate stone filled solid platform (Fig. 7) that is the continuation of the filled in foundation trench above the ground. In case of in situ rock being exposed the platform is observed to be raised directly over it. The height of the platform is observed to vary between 6 and 12 feet above the ground. Dry stone masonry is used for the construction of the platform. Massive solid platform at the base of the structure helps in keeping the centre of gravity and centre of mass in close proximity and near to the ground. This minimizes the overturning effect of the particularly tall structure during seismic loading.

Fig. 7: Raised platform erected over in situ rocks to support the multi-storied structure.

- viii) The raised pedestal on the foundation together with the wooden beams at plinth level restrict earthquake vibration effects on the superstructure. It is accepted that stiffer soils promotes effective isolation⁷. The elevated, solid stone platforms help in consolidation of the soil at the foundation level and thus help in promoting isolation.

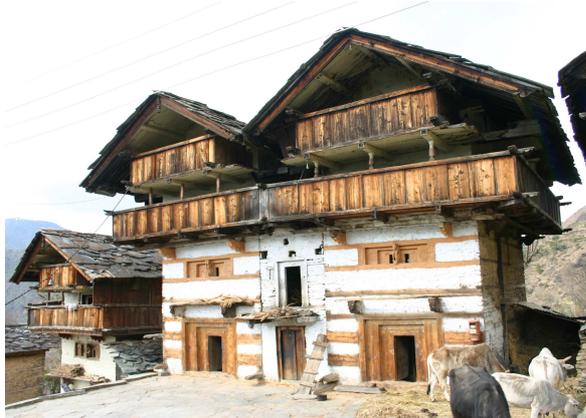
Simplicity: The structures are observed to be constructed on a simple rectangular plan (Fig. 8) with the length and width varying between 4 and 8 meters. The ratio of the two sides of the structures is observed to vary between 1.1 and 1.4.

Fig.8: Simple layout of the multi-storied structures.

This is in keeping with the provisions of the building codes⁵ that suggest that the building should have a simple rectangular plan and should be symmetrical both with respect to mass and rigidity so as to minimize torsion and stress concentration.

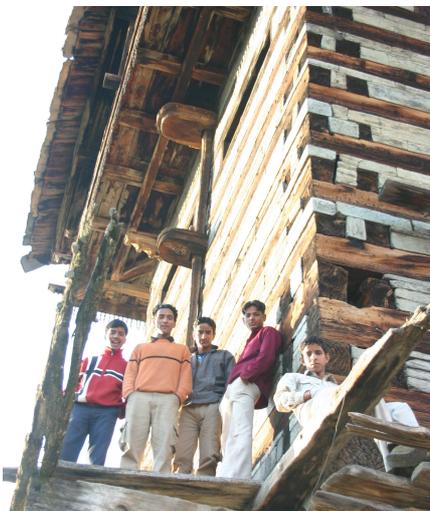
The four walls of the structure are thus raised using the wooden logs and dressed up flat stones alternately (Fig. 9). The structure is further reinforced with the help of wooden beams fixed alternately that run from the middle of the walls of one side to the other, intersecting at the center. This arrangement divides the structure into four parts and provides for joists supporting the floorboards in each floor of the building.

Fig.9: Wood – stone architecture of the walls of the traditional multi-storied structures.

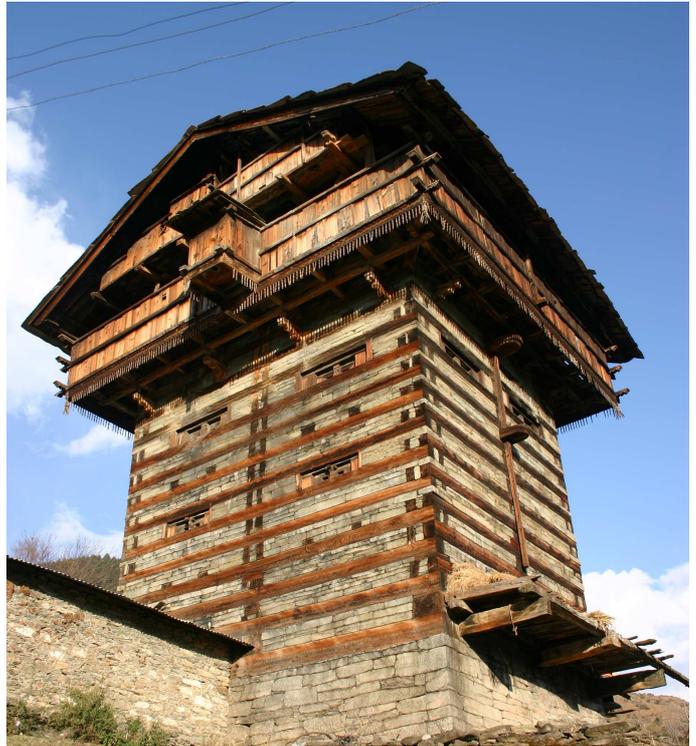
Fig.10: The vertical wooden beam on the side walls is considered to be a seismic safety related provision.

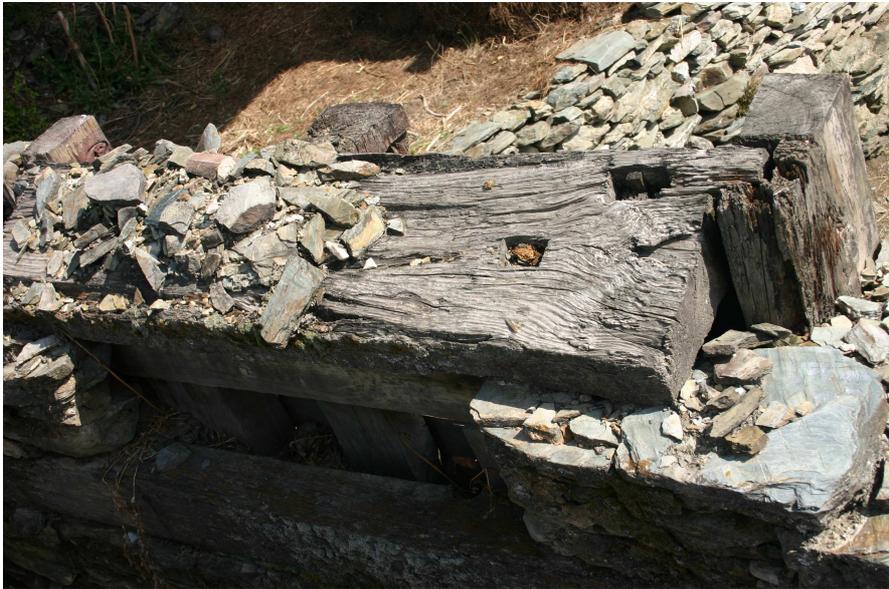
- Wood is a elasto-plastic material with ability to absorb power of earthquake. Both housing and nailing techniques are resorted to for joining the wooden components incorporated in these structures (Fig. 11). This allows for minimal angular displacement. This kind of joint in the wooden beams incorporates advantages of both pin joint and the rigid joint and acts as a semi-rigid joint which is an additional advantage for shock resistance.

Fig.11: Housed and nailed joints used for fixing the wooden components of Koti Banal architecture.

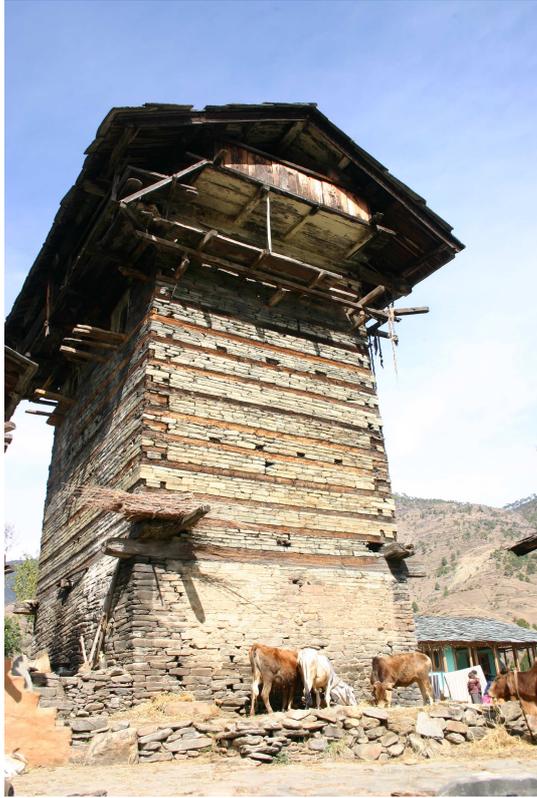
Fig.15: View of the multistoried traditional structure at Gona.

Equally impressive structure is observed in Gona village (Fig. 15). Detailed examination of the structure reveals that the principles of Koti Banal architecture are not strictly adhered to in this structure. The roofs of this structure are observed to be comfortably high while internal layout of the walls varied in every floor (Fig. 16). Detailed observations reveal that the basic elements of seismic safety have been compromised with in this structure.

It is observed that the middle portion of the Gona structure has bulged out which might be due to violation of Koti Banal guidelines. Collapse of the structure might jeopardize human lives.

It was interesting to note that the multistoried structure at Gona though built using similar architectural style is more occupant friendly with the roofs being sufficiently high. Radiocarbon dates reveal this structure to be younger than the one observed in Koti Banal. This structure digresses from seismic safety norms and does not provide for shear walls. This is thus a later digression rather than an earlier experimentation leading to architectural refinement.

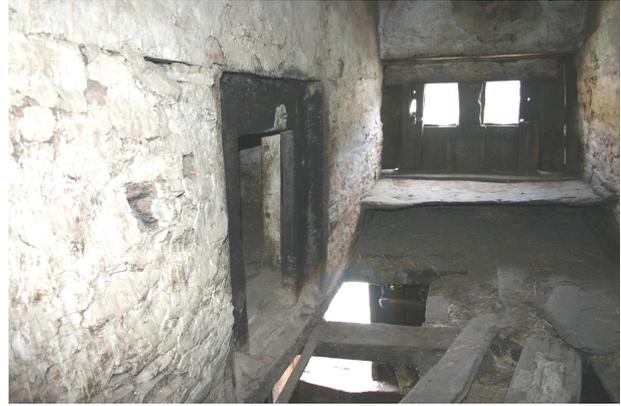
Fig.16: Internal wall with a door on the first floor. This wall lacks continuity from the ground floor.
