RIGHT AND AUTHENTIC INFORMATION: A MUST FOR THE CORRECTIVE ACTION

Piyoosh Rautela

Disaster Mitigation and Management Centre,
Department of Disaster Management, Deharadun-248001

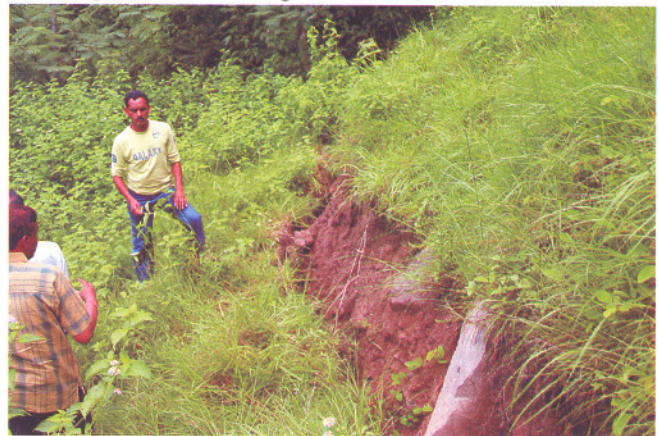
Figure 2. Ground fissures in Panjan village. These secondary fissures have developed due to the toe erosion by landslide debris.

Figure 3. View of the house devastated by differential ground movement along fissures shown in fig. 2.

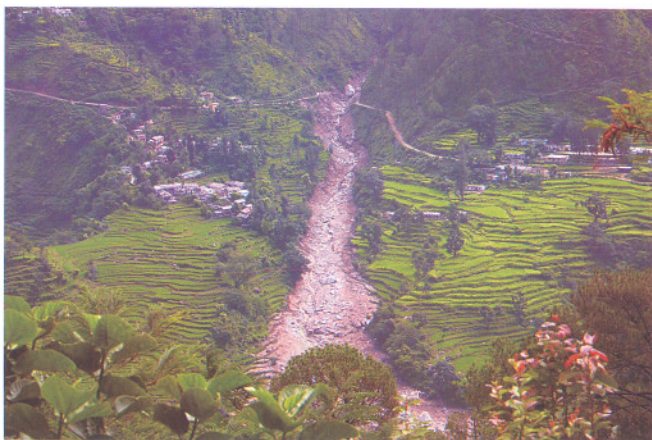
Figure 1. View of the Agricultural fields of Panjan village (district Rudraprayag) devastated by flow along Kagwa Gadhera.

human lives. There is similar story to be narrated at Panjana and Devpuri though at both these places the slide initiated at a much higher elevation. (Figure 1,2,3&4)

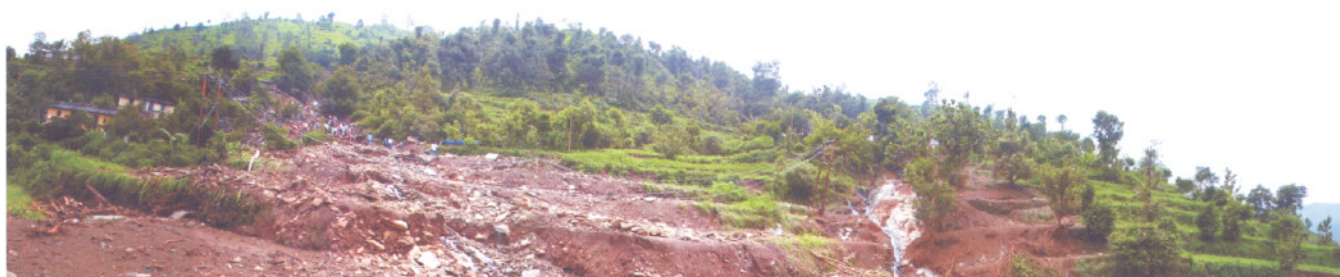
Figure 4. View of the Devpuri slide in Chamoli district that took toll of 08 lives.
