## FLASH FLOODS IN HIMALAYA WITH SPECIAL REFERENCE TO MORI TEHSIL OF UTTARAKHAND, INDIA

SUSHIL KHANDURI<sup>1</sup>, K. S. SAJWAN<sup>2</sup>

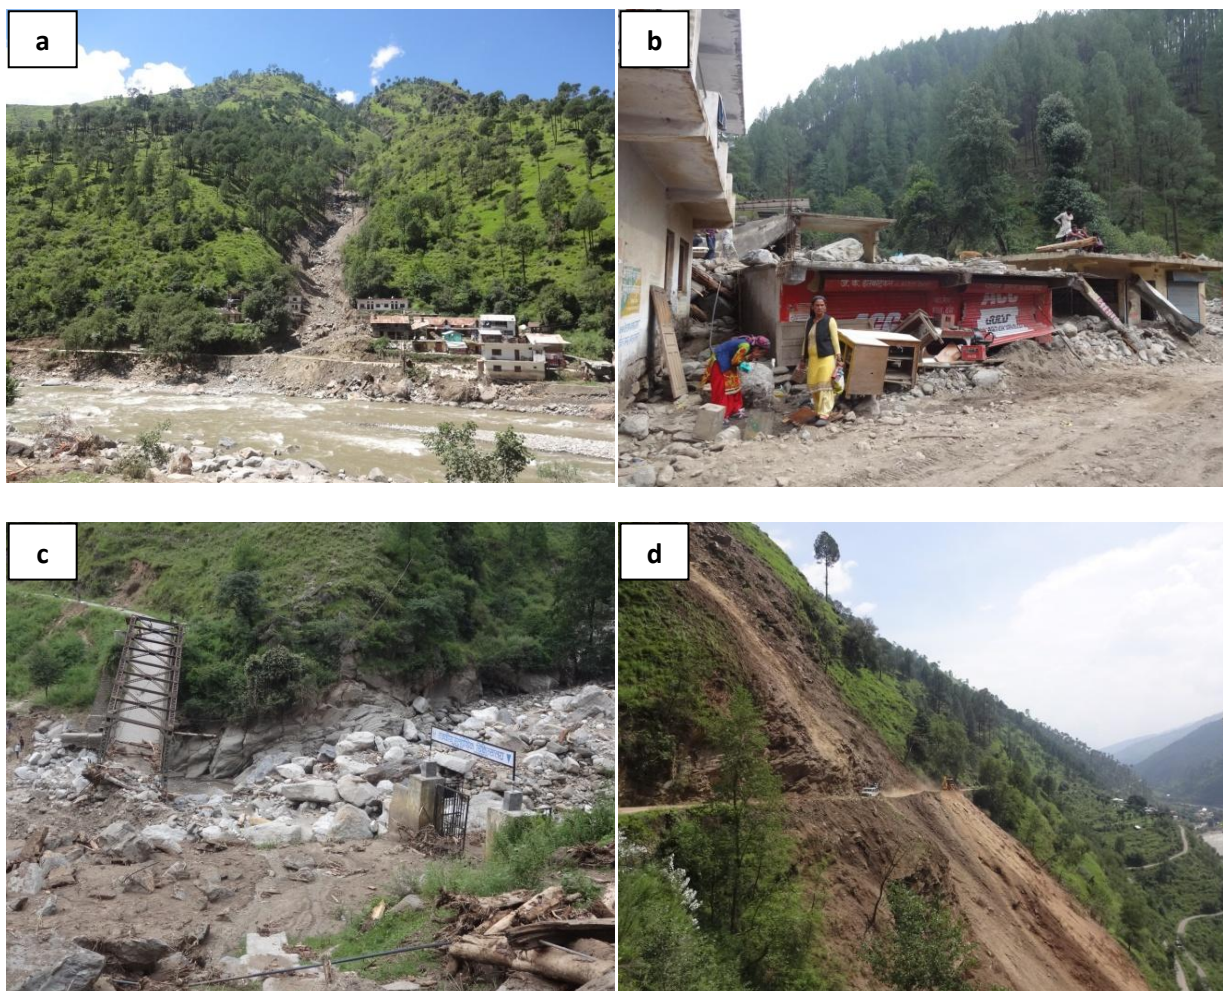
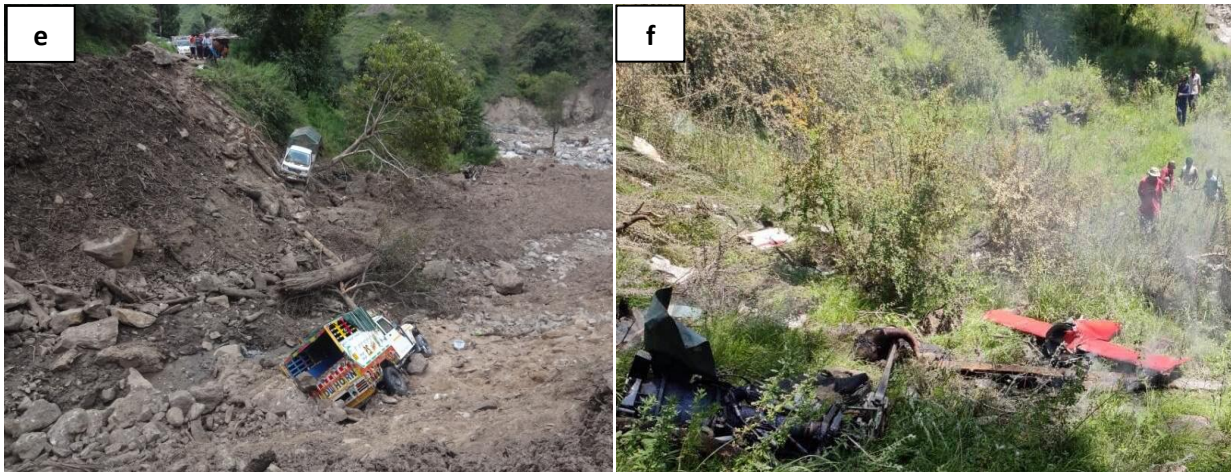
According to eyewitness accounts cloudburst incidence took place around Arakot along with Khaneda Gad valley after heavy rainfall in the morning hours (around 0445 hr) in which Arakot, Mauldi, Makuri, Tikochi-Nagwara, Snail, Duchanu etc. villages were severely affected and devastated. Heavy rainfall/Cloudburst like incidences took place in two phases, in first phase at 4.45 AM on 18<sup>th</sup> August, 2019 Khaneda Gad valley devastated by heavy downpour and associated flash floods afterwards in second phase on the same day at 6.00 AM extreme weather events occurred at Arakot and Snail area. Unprecedented damage and destruction occurred in the Khaneda Gad valley. It has been observed during field investigation that Khaneda Gad a tributary of Pabbar River has changed its course and shifted at several locations, due to heavy discharge. These caused loss of human life, property and infrastructure in the area. High sediments laden discharge through steep gradient streams in the area around Arakot washed away road which lead to Himachal Pradesh and damaged many structures which was exist its flanks (Figure 2a).

Continuous localised precipitation in the catchment of Khaneda valley caused spate in its course that has considerably changed the original topography of the area. Major destruction and damages have been occurred in Tikochi village (Figures 2b and 2c). Besides, Chiwan, Gokul, Jhotadi, Balawat, Moldi, Jagta, Dhara, Dagali, Duchanu, Monda, Kalich, Makuri and Barnali villages are adversely affected. The landslides and toe erosion by the streams caused breaching of the road and overran the vehicles in the area (Figures 2d and 2e).

One helicopter of Heritage Aviation crashed in the affected area while engaged in relief and rescue operations (Figure 2f). 3 persons onboard the ill fated chopper including Pilot and Co-Pilot died in the incidence. Detail of the losses is given in Table 3.

Figure 2: On 18<sup>th</sup> August, 2019 hydro-meteorological disaster induced losses; (a) high velocity discharge through local streams damaged road and other structures in Arakot; (b) damaged shops due to debris flows in Tikochi village; (c) damage to bridge and washed away Allopathic Hospital due to flash floods at Tikochi village; (d) road leading to Arakot-Chiwan blocked due to landslide; (e) vehicles washed away due to breaching of road and debris flows; (f) crashed helicopter of Heritage Aviation in the affected area
