Implications of Rapid Land Use/Land Cover Changes upon the Environment of the Area Around Nainital in Uttarakhand, India

*Disaster Mitigation and Management Centre, Department of Disaster Management,
Government of Uttarakhand, Uttarakhand Secretariat, Rajpur Road, Dehradun – 248 001, Uttarakhand, India.*

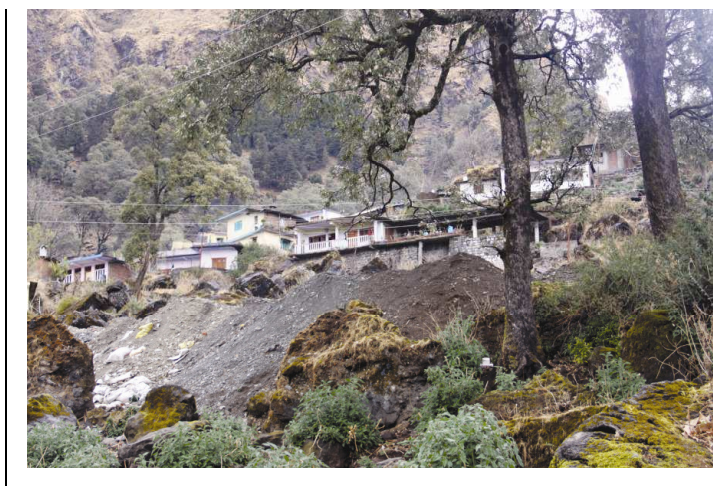
Figure 3 Disposal of excavated debris along the hill slope in Nainital. Obliteration of surface drains by site development works for construction.

It was observed during the field work in the area that steep slopes in many areas are presently being leveled for various construction related initiatives and excavated debris is being disposed off along the hill slopes as also along the surface drains (Figure. 3). At a number of places in the town the drainage network is observed to be encroached, blocked and obliterated (Figure. 4). Anthropogenic activities in the township have not spared even the recharge zones of the lake (Figure. 5) and these are sure to have irreversible adverse impact upon the very existence of the Naini lake.

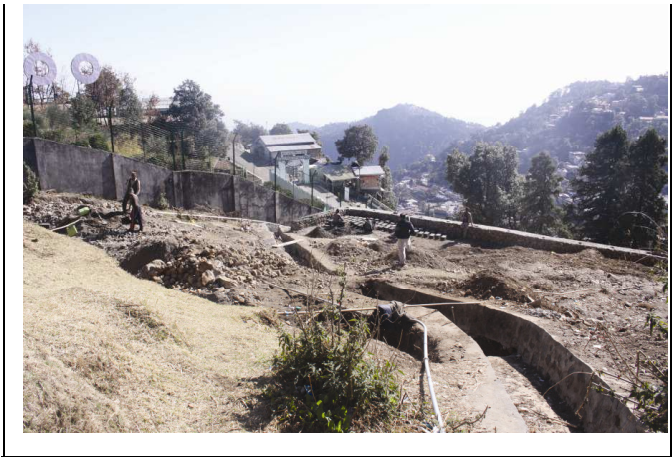
Figure 4 Disposal of excavated debris along the hill slope in Nainital. Obliteration of surface drains by site development works for construction.
