# Implications of Chakrata Road Widening Efforts

## A Report

*Road widening and enhanced building vulnerability*

**March, 2012**

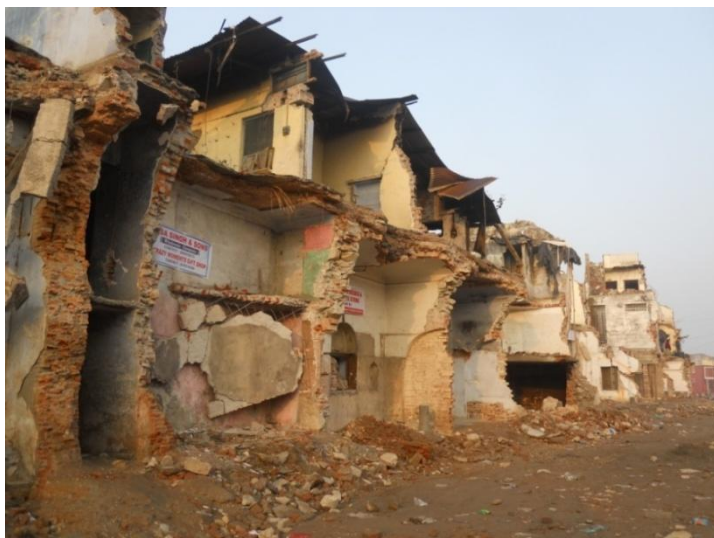
**5.1.1 Old construction:** The majority of the structures on the southern side of the Chakrata Road are observed to be load bearing masonry structures. There is not even a single framed structure on this stretch. This area constitutes old part of Dehradun city and a number of buildings in this portion are observed to be built with Lahori bricks. These bricks were largely used during the Mughal period and were put to disuse during the British rule. Use of these bricks is thus indicative of antiquity of these buildings and this construction can safely be said to be at least 100 years old.

*Fig. 6. The old structures on the southern side of the Chakrata Road made mostly of Lahori bricks.*

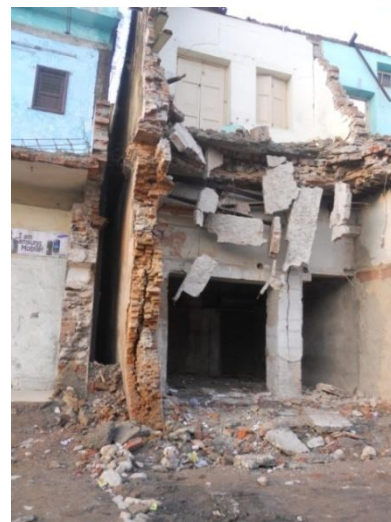
*Fig. 7. Partial demolition of the houses.*

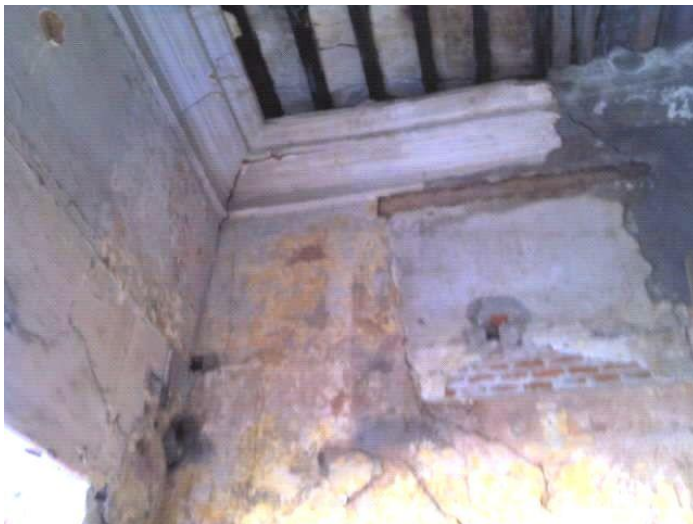
*Fig. 8. The cracks developed on inner walls of the building.*

The partially demolished structures in this area were observed to have developed cracks on internal walls as also on the roofs and these are attributed to the technique used for demolition that mainly consisted of persistent hammering. These cracks would ultimately render these buildings unstable and ultimate sudden collapse of some of these cannot be ruled out during extreme natural events related to seismic shaking and precipitation.

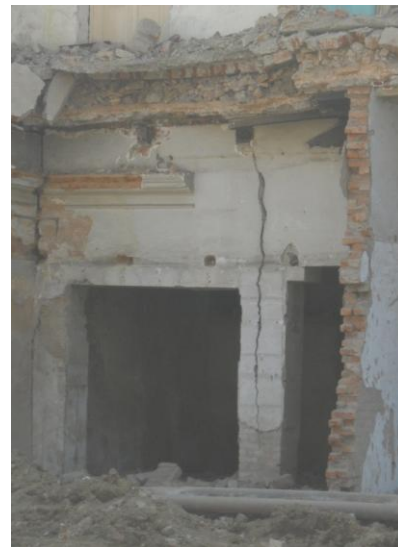
*Fig. 9. Highly vulnerable structures with multiple weaknesses must be fully demolished to avoid the risk.*

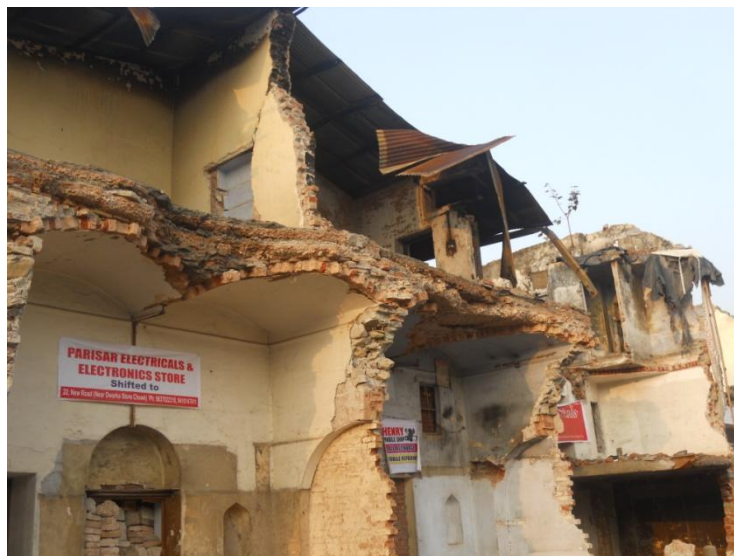
The arches used in the construction along this stretch of the Chakrata Road were observed to have been damaged badly. In a number of cases iron girders supporting the arches were observed to have been displaced from their original position and any attempt to restore these structures without appropriate technical support is bound to invite a major devastation in future.

*Fig. 10. The damaged segmental arches of the buildings at chakrata road.*

The arches were observed to have been used in a group of two or three segments joined together with the help of girders inserted in between these segments to provide support to load of the roof placed above it. The demolition of this important feature of the structures was observed to have resulted in the development of tension cracks within the remaining portions of the arches that would adversely affect the structural strength of the building.

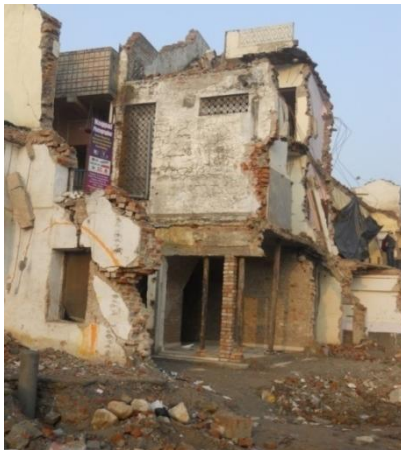
The reinforced brick roofs of the partially demolished structures on this stretch of the Chakrata Road were observed to have been temporarily supported by wooden planks while building surgery was on. Attempts were mainly observed to have concentrated on ensuring restoration of the maximum covered area possible. It was observed that proper attention was not being paid to ensure proper bonds and the continuity; both at corners and wall junctions. In case of the arches no restoration effort was observed and people seemed unaware of the methodology to be deployed for restoration of the damaged arches or to repair the roof that was previously supported by iron girders.

*Fig. 11. The vertical columns being erected to support the hanging roof.*

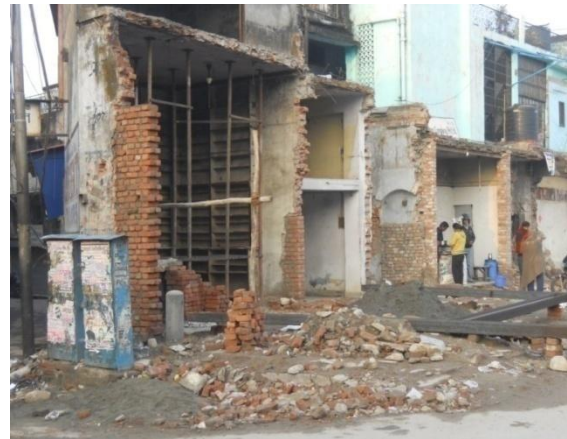
*Fig. 12. New construction practice observed at the site.*

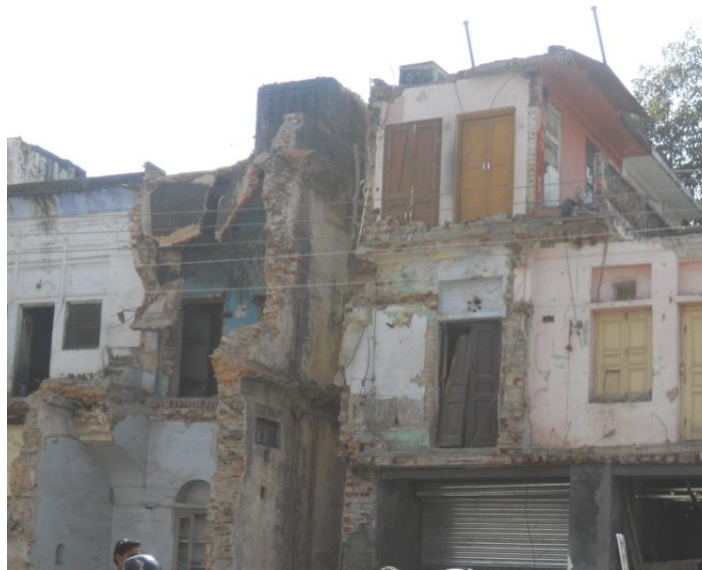
*Fig. 13. The new shops being constructed on the ground floor of the partially demolished structure while the upper floors still remain in dilapidated condition.*

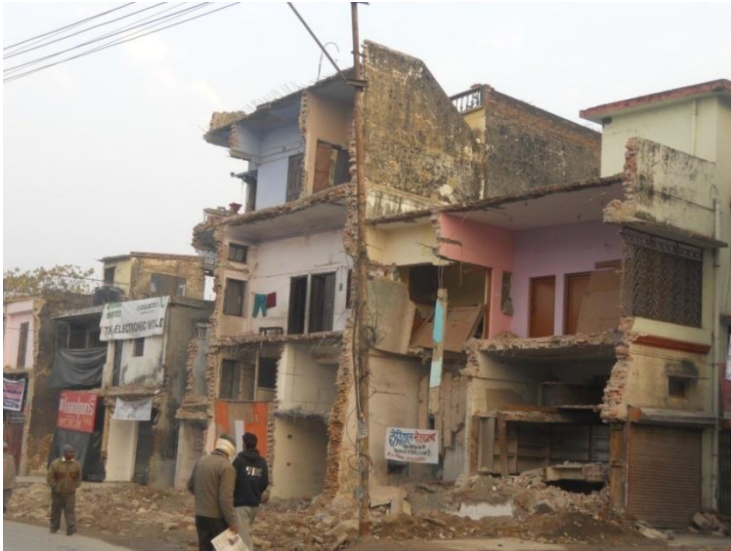
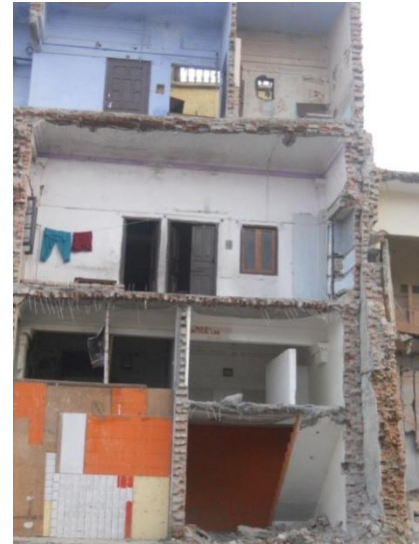
Majority of the buildings in this area were observed to have RB roofs while only a few (2 or 3) structures had RC roofs. Some 2 or 3 storey buildings were however observed to have RB floors and roofs of GI sheets. As in the previous stretch a few buildings (2 or 3) on this stretch were also observed to have specific architectural features related to arches. Girders were also observed to have been placed in between the segments to support the load of the roof in these structures.

*Figs. 14 and 15. The load bearing masonry construction with RB roofs to the north of the Chakrata Road.*

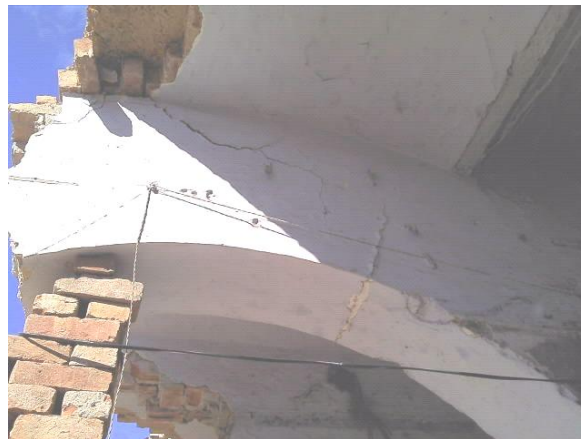
**5.2.2 Effects of the partial demolition on Construction:** Since the demolition was not carried out systematically partially demolished structures have been rendered more vulnerable. It is worth noting that cracks are the first signs of deterioration of any building and these have a direct bearing upon the serviceability and stability of the building. At many places the cracks have been identified in the buildings.

*Fig. 16. The cracks developed in the partially demolished building enhancing its structural vulnerability.*

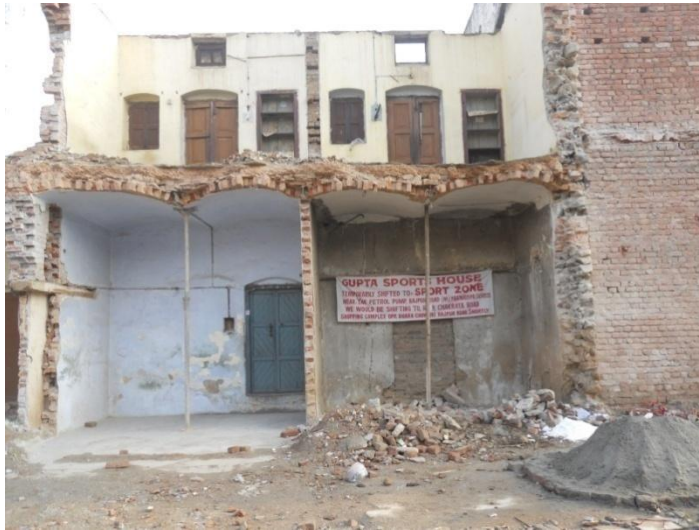
The arches were observed to have been damaged severely and the iron girders inserted in between two segmental arches for strength and support were observed to have been partially damaged or removed. This is sure to affect the load bearing capacity of the same and enhance structural vulnerability of these structures.

*Fig. 17. The damaged arches and the load of arches being supported by being planks.*

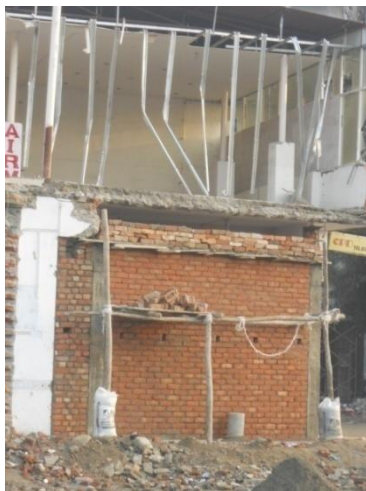
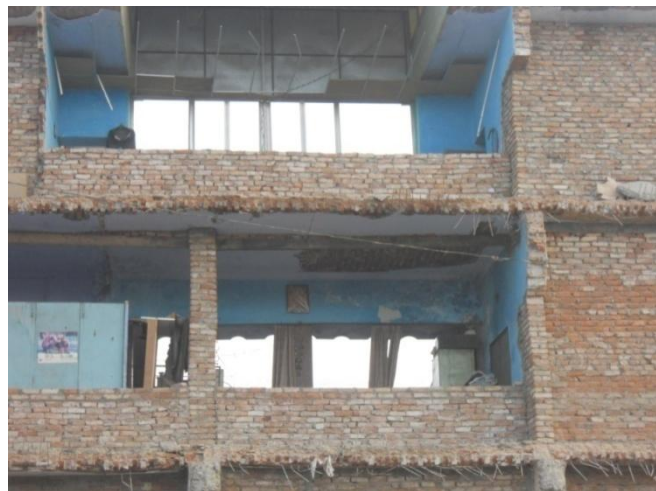
**5.2.3 New construction practices:** The restoration work was observed to be taking place in a haphazard and inappropriate manner; proper care was not being taken to erect the supporting walls and pillars on appropriately deep and firm foundation. At the same time proper connections were not being provided between different building elements. It was also observed that in some buildings no hierarchy was being followed while constructing new columns. Such construction faults can easily be observed in the area and these are bound to result in enhanced vulnerability of the building stock in this area.

*Figs. 18 and 19. The new construction practice at the site; irregular / tilted columns being constructed.*

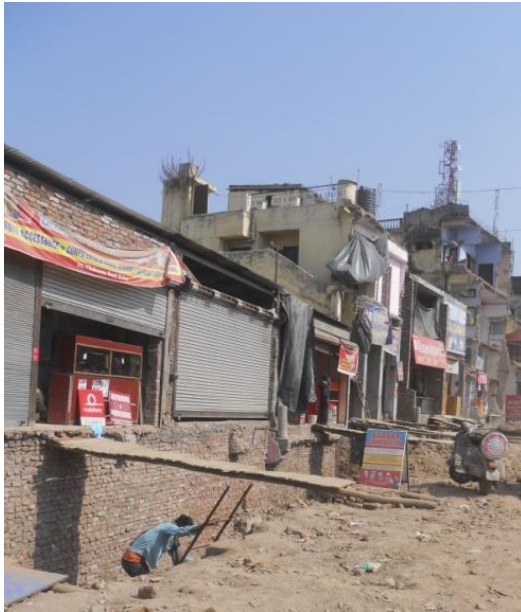
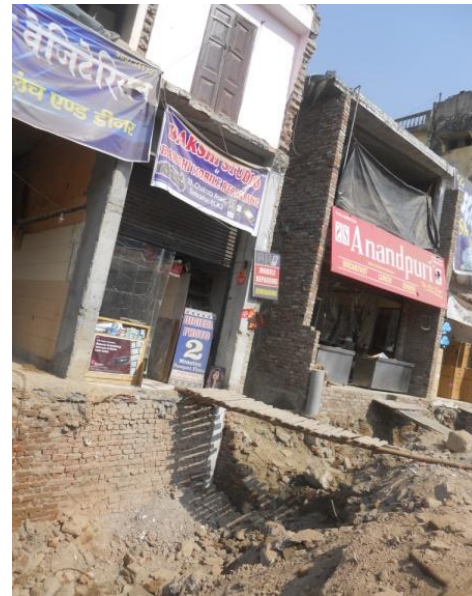
Drainage work was also observed to be in progress on this stretch of the Chakrata Road. While the work is still not completed and the shop owners were observed to run their commercial establishments even without proper and safe access. Though a temporary

arrangement, wooden planks being used to bridge the gap created by the drainage works are poorly placed and can cause mishaps.

***Figs. 20 and 21. Drainage work in progress along with the poorly placed wooded planks to ensure customer access.***

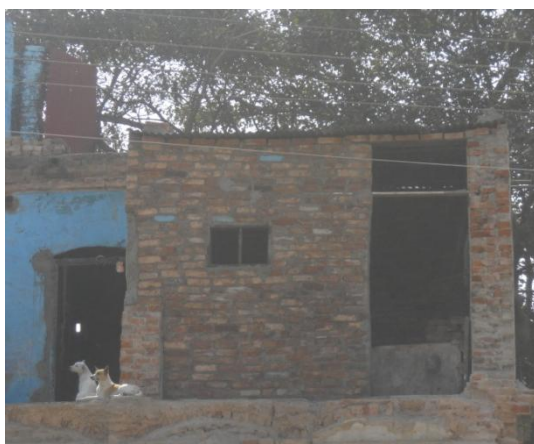
Despite confusion of different sorts at various levels, the construction work was observed to be going on. The quality of construction work is a major concern as building safety related aspects were observed to be blatantly ignored. Besides the safety haphazard construction is aesthetically unappealing. Overall vulnerability of the structures on this stretch of Chakrata Road is thus sure to increase.

***Fig. 22. poor construction quality of the new structures.***

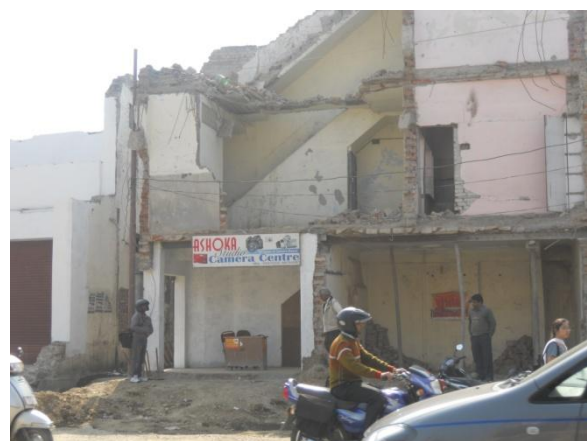
***Fig. 23. Ground floor construction with weak upper storeys can lead to a disastrous situation.***

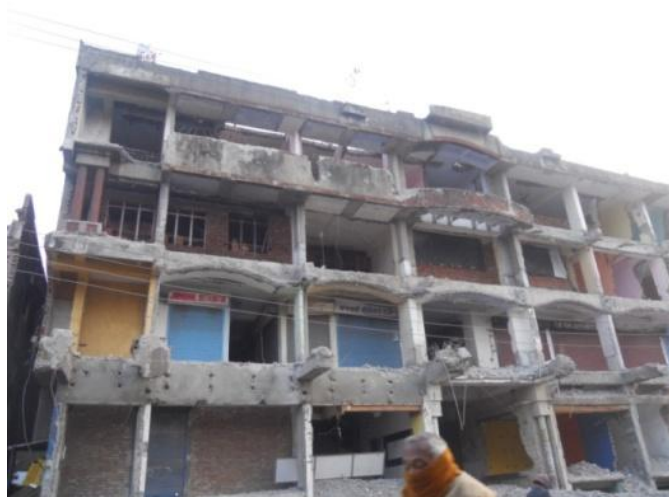
**5.3.1 Old construction:** The stretch of the Chakrata Road presently taken up for widening was observed to have only a few RCC structures that include RGM Plaza that was observed to be a well framed structure with raft foundation.

*Fig. 24. View of RGM plaza on the Chakrata Road.*

**5.3.2 Effects of the partial demolition on Construction:** It was observed that the demolition has resulted in a number of cracks in the undemolished portion of the building. Moreover removal of the columns in the front side of the building is sure to adversely affect its stability and performance

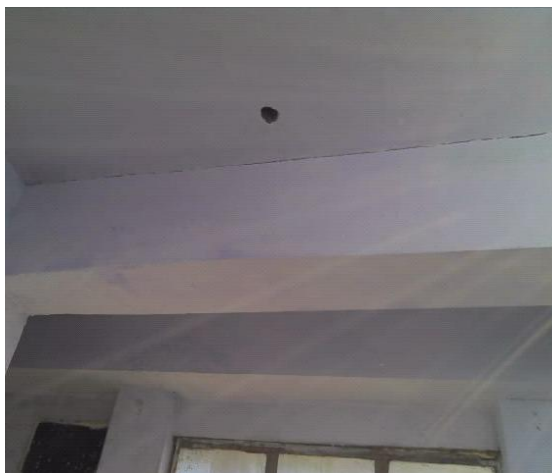
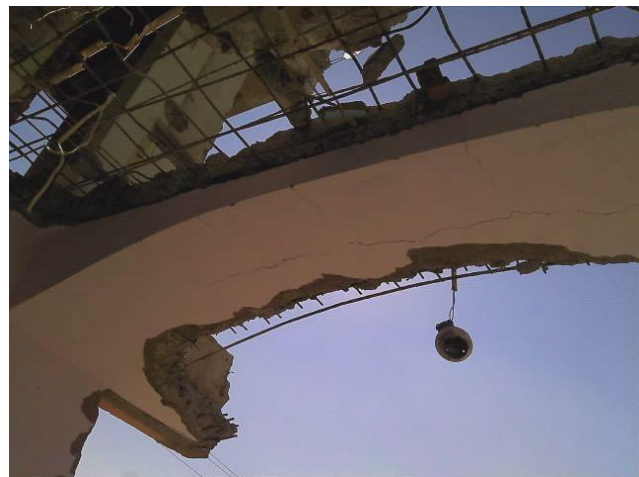
*Figs. 25 and 26. Cracks developed along beam and arches because of lack of systematic approach followed in demolition.*

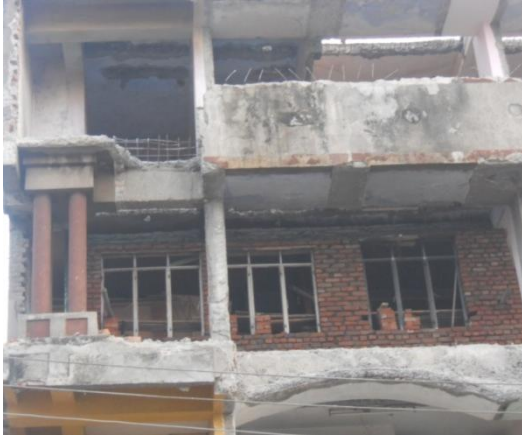
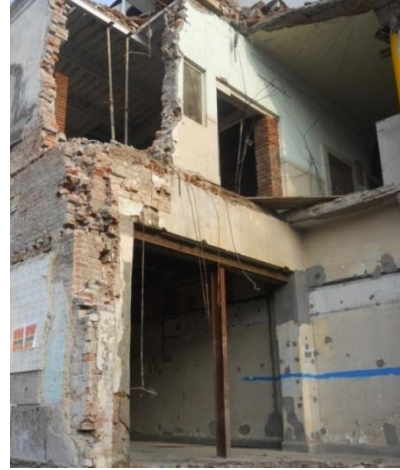
**5.3.3 New construction practice at site:** The foundation related aspects were observed to be ignored while undertaking restoration. The new columns in G+3 RCC buildings were not observed to follow the principles of regularity / hierarchy.

*Figs. 27 and 28. New construction practice at site.*

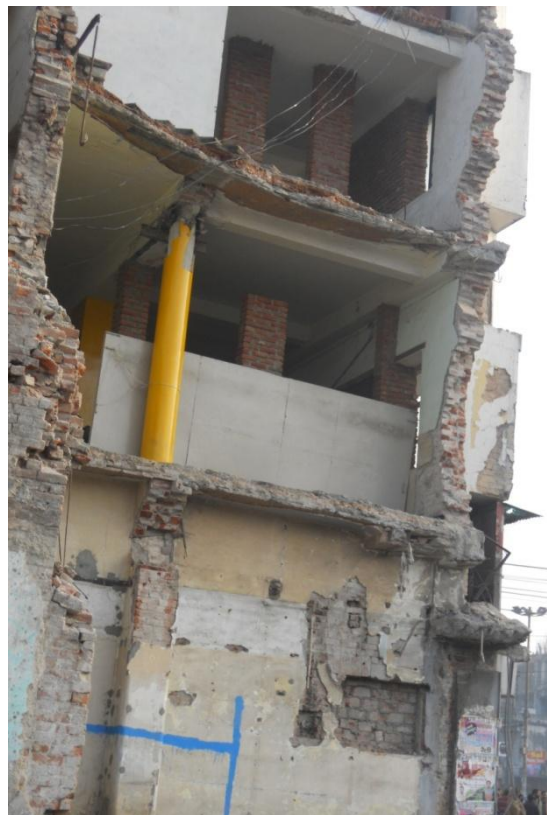
*Fig. 29. No proper hierarchy of columns being followed in construction which will lead to structural instability.*
