Science and Technology in Disaster Risk Reduction in Asia

Lessons learnt from June 16/17, 2013 disaster of Uttarakhand, India

Piyoosh Rautela

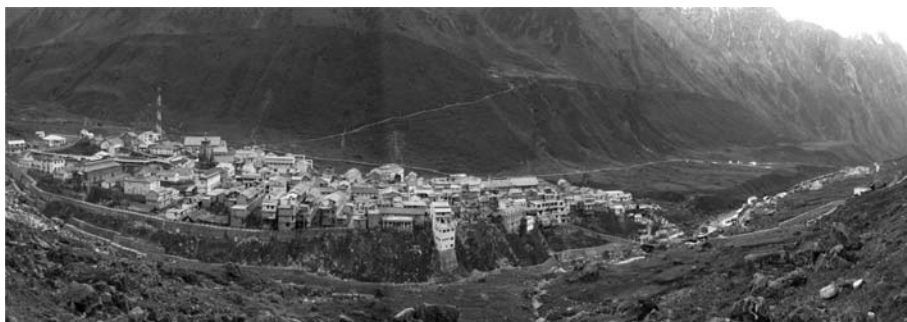
Mandakini valley of Rudraprayag district that was hit the hardest by the disaster of June 2013 houses sacred shrine of Kedarnath that is dedicated to lord Shiva, the God of death and destruction. The temple township (Fig. 17.2) is located on glacial outwash deposits at an altitude of 3581 m a.s.l. The main shrine is located on raised middle portion of the deposit that is 20–25 m above the level of Mandakini (3562 m a.s.l.). For reaching Kedarnath, one had to trek upstream along the course of Mandakini from Gaurikund for a distance of 14 km (Fig. 17.3).

Figure 17.2 View of the temple township of Kedarnath, with camera looking east.

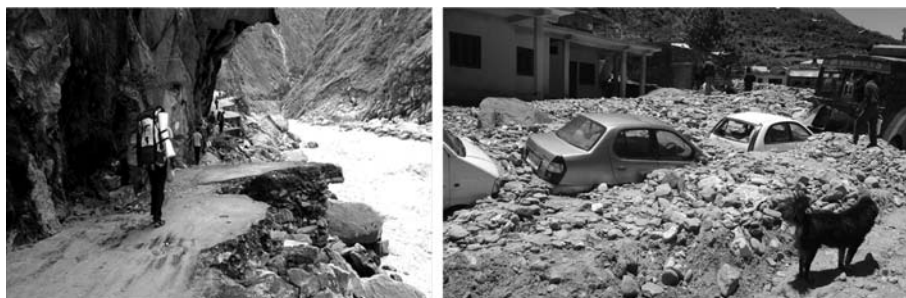
Figure 17.4 View of road disruption in June, 2013 due to bank erosion in the proximity of Tawaghat, Pithoragarh (*left*) and debris slide in Dharali, Uttarkashi (*right*).

Being associated with the abundance of water both landslide and flash flood are common in the region during the monsoon period, rainy season over the Indian sub-continent that extends between mid-June and mid-September. This period coincides with the ingress of both pilgrims and tourists in the area in large numbers. Road connectivity is often disrupted for long periods during this time due to landslides and toe erosion by the rivers (Fig. 17.4, Table 17.1). It is a cause of inconvenience,

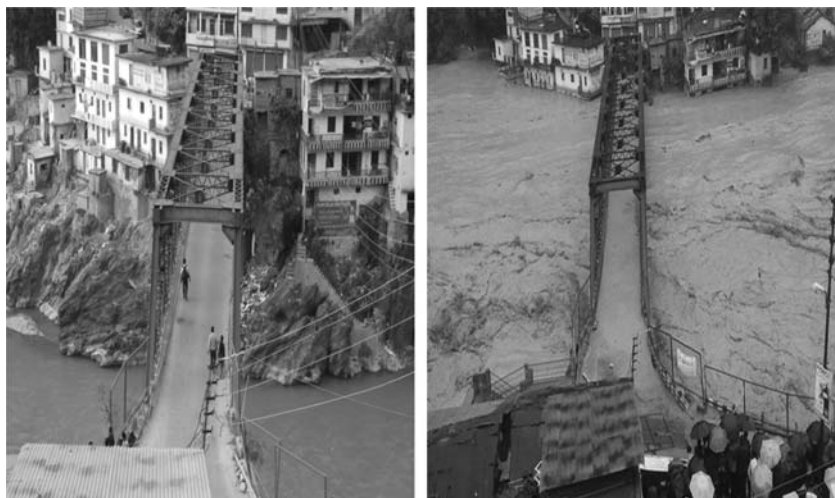
Figure 17.5 View of the motor bridge over Alaknanda at Rudraprayag in April, 2013 (*left*) and on June 17, 2013 (*right*) with camera looking NNW.

Fast melting of fresh snow due to rainfall impact added to the discharge of the streams and rivers that crossed the danger level. The level of Mandakini at Rudraprayag was 7.5 m above the danger level on June 18, 2013 and around this time most rivers in the region were flowing well above their normal levels (Fig. 17.5). Gushing debris laden water through the high-gradient mountain streams thus breached the banks and washed off roads, bridges, habitations, and other infrastructure on their way.

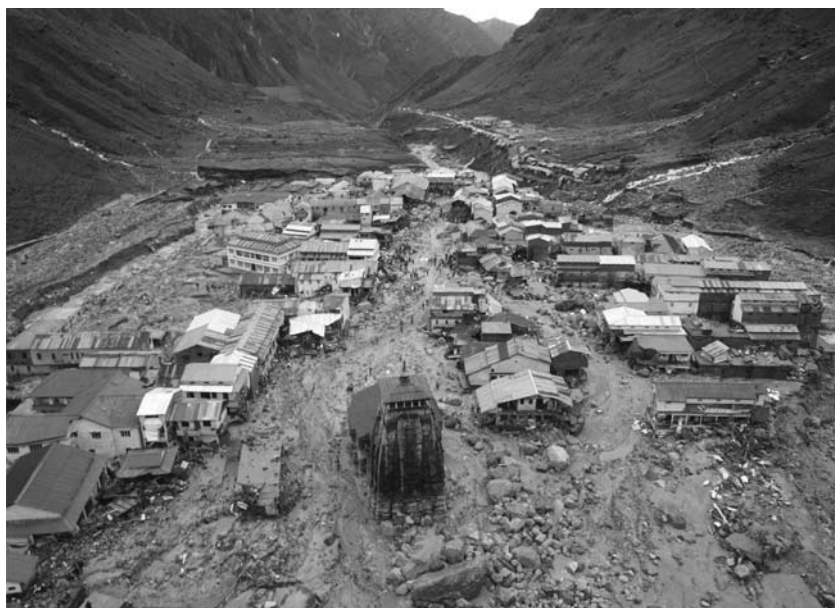
Figure 17.6 View of the Kedarnath township ravaged by the flood of June, 2013 with camera looking south.

Persistent heavy rains caused the level of water in Chorabari Tal to rise continuously. With the recession of the glacier, the lake had a weak moraine barrier that could not withstand mounting hydrostatic pressure. Stage was thus set for a major disaster in Kedarnath and the barrier ultimately gave way around 7 a.m. on June 17, 2013. The volume of water was enormous and it carried with it huge glacial boulders and outwash material that choked the course of Mandakini and the flow of water and debris got diverted toward the temple township that was thus ravaged (Fig. 17.6).
