Non – structural seismic
vulnerability assessment of
Mahant Indires h hospital,
Dehradun (Uttarakhand)

**Disaster Mitigation and
Management centre**

July 2012

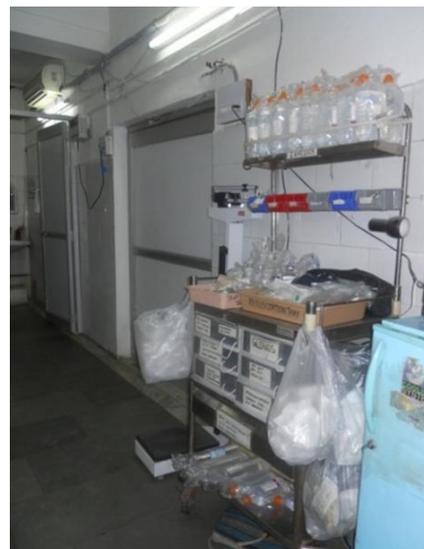
Storage of emergency drugs in cupboards and trolleys together with unanchored refrigerators and cupboards is observed to be a common problem in the hospital and the dialysis section is no exception to it (Figs. 22 and 23). The loss of these drugs in case of strong ground shaking might threaten life safety as also affect operational continuity of the hospital.

Fig. 23. View of the supplies in the trolley.

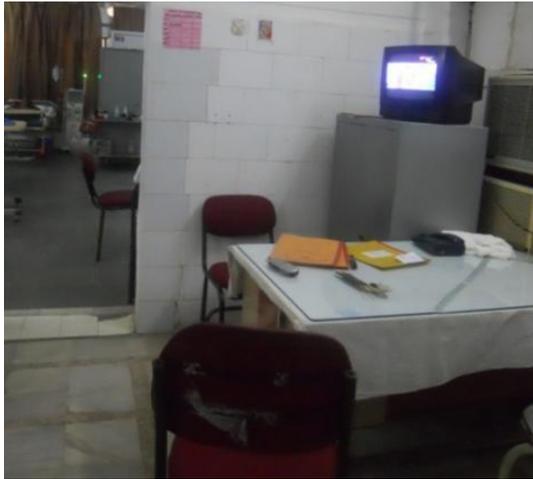
Fig. 24. View of the unanchored television and cupboard.

The location of fans and wall mounted ECG / multi monitors in the section is such that falling of these elements might threaten the life safety of the patients (Figs. 24 and 25). The placement of the non-structural elements thus makes the section highly vulnerable.

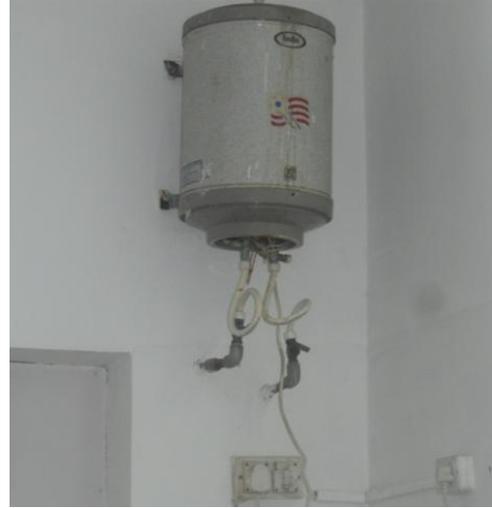
Fig. 59. View of the geysers in the hospital.

The problems relating to this important aspect were observed to be similar in the entire hospital premises. The major identified problems pertain to, i) open wiring, ii) improper fixing of conduits, and iii) missing covers. These can be easily fixed with the help of any electricians but ignoring this aspect could result in short circuit that could lead to a major disaster. The geyser fittings in the entire hospital are required to be checked (Fig. 59) and besides setting right electrical faults their anchorage with the walls is required to be checked and fixed, where necessary.

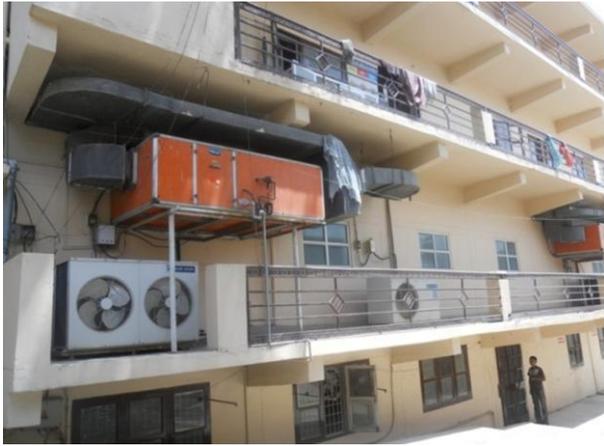
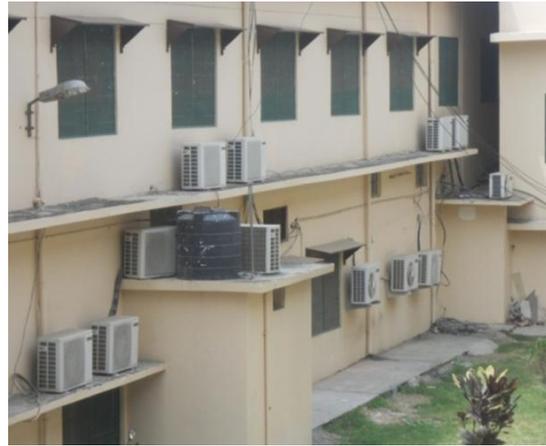
Figs. 63 and 64: View of the air conditioning provision in the hospital. To the left is that of the operation theatre complex.

Proper anchorage of the air conditioning units and shafts with dash fasteners is required as the major earthquake shaking would definitely hamper their functioning (Figs. 63 and 64). This at the same time has the potential of causing a major electrical hazard and therefore it needs to be addressed immediately.

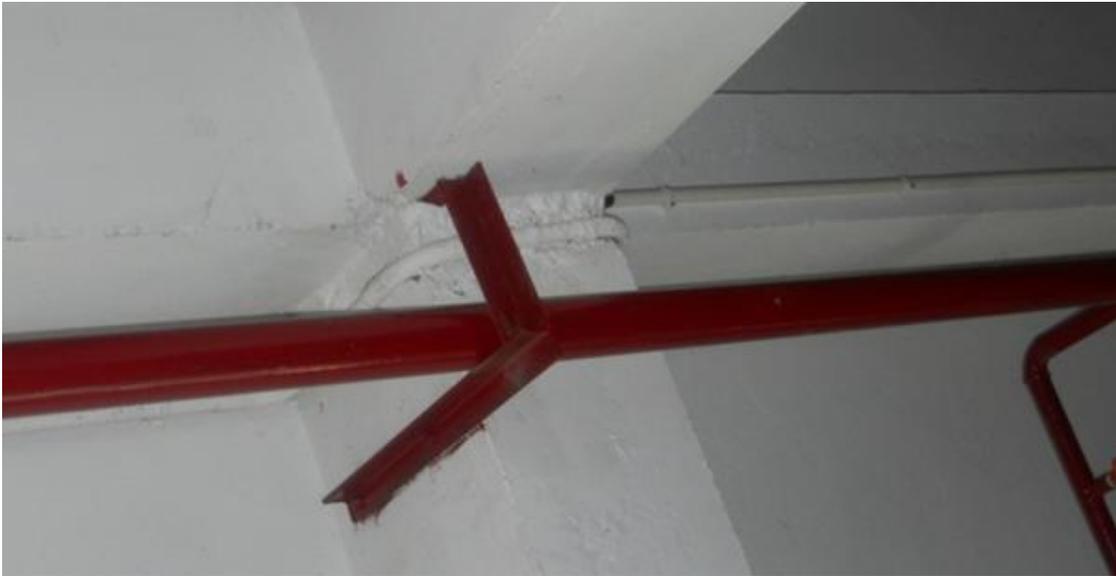
pipes being damaged, especially at joints. Since the new building of the hospital is equipped with fire alarm system and all fittings have been done this point needs to be checked because at many places the water pipes catering to fire fighting requirements were observed to be not properly braced (Fig. 69).

Fig. 69. View of fire water supply line at the junctions in the new building block of hospital meant for catering to the fire fighting requirements.

However the water supply lines feeding the fire extinguishers should also be properly braced so as to avoid any breakage during earthquake shaking. There exists risk of

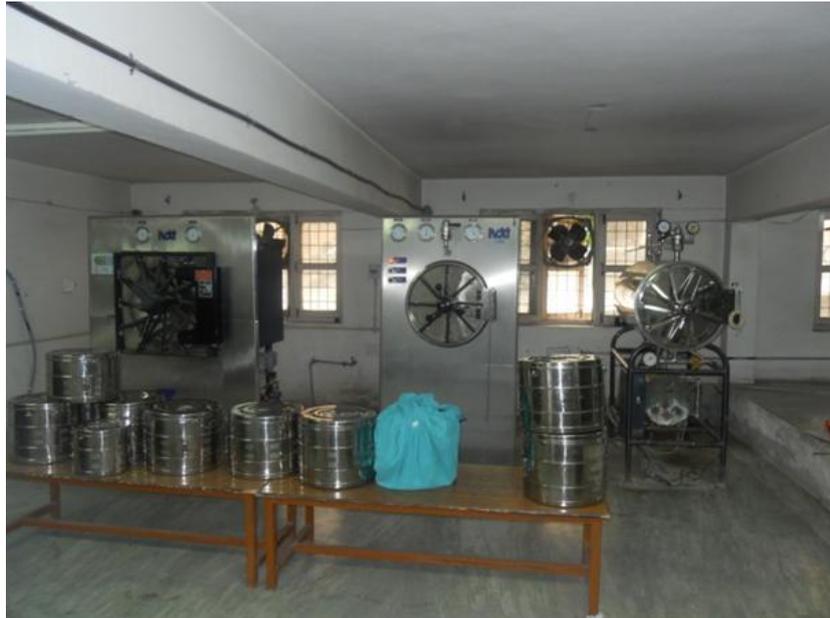
5.3.3 Tanks and clinical gases: The clinical gas storage area is one of the most vulnerable areas in any hospital premises. This section deals with compressed gas cylinders, bulk clinical gas storage, as well as roof top water tanks. Heavy machinery was observed to be placed in the Central Sterile Supply Department (CSSD). The autoclaves machines and sterilizers placed in this section are required to be anchored to the ground. The legs of autoclave machines are required to be concreted with the ground as it is not a movable item (Fig. 70).

Besides causing a major threat to the life safety disruption of this facility is sure to hamper operational and functional continuity of the hospital in case of a disaster. Supply lines providing water to the autoclave machines are likely to be disrupted during strong ground motion and therefore special attention is required to be given towards this important aspect.

Fig. 70. View of autoclave room.

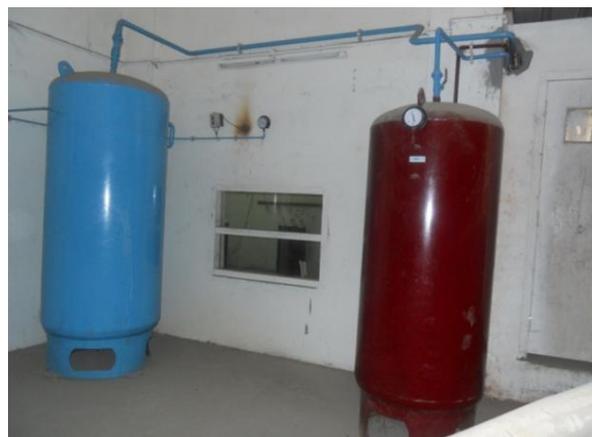
Fig. 72. View of the clinical gas tanks.

The clinical gas tanks were observed to be fixed to the ground. Engineering check is however required to be reassured of the strength of the anchor bolts that are fixed to the ground so as to ensure that these could hold the heavy tanks during ground shaking (Fig. 72). In case of any suspicion concreting at base might be resorted to.
