# **Investigations in the Asi Ganga valley on the aftermath of flash flood / landslide incidences in August, 2012**

## **A report**

**Disaster Mitigation and Management Centre  
Department of Disaster Management  
Uttarakhand Secretariat  
Dehradun - 248 001**

**October, 2012**

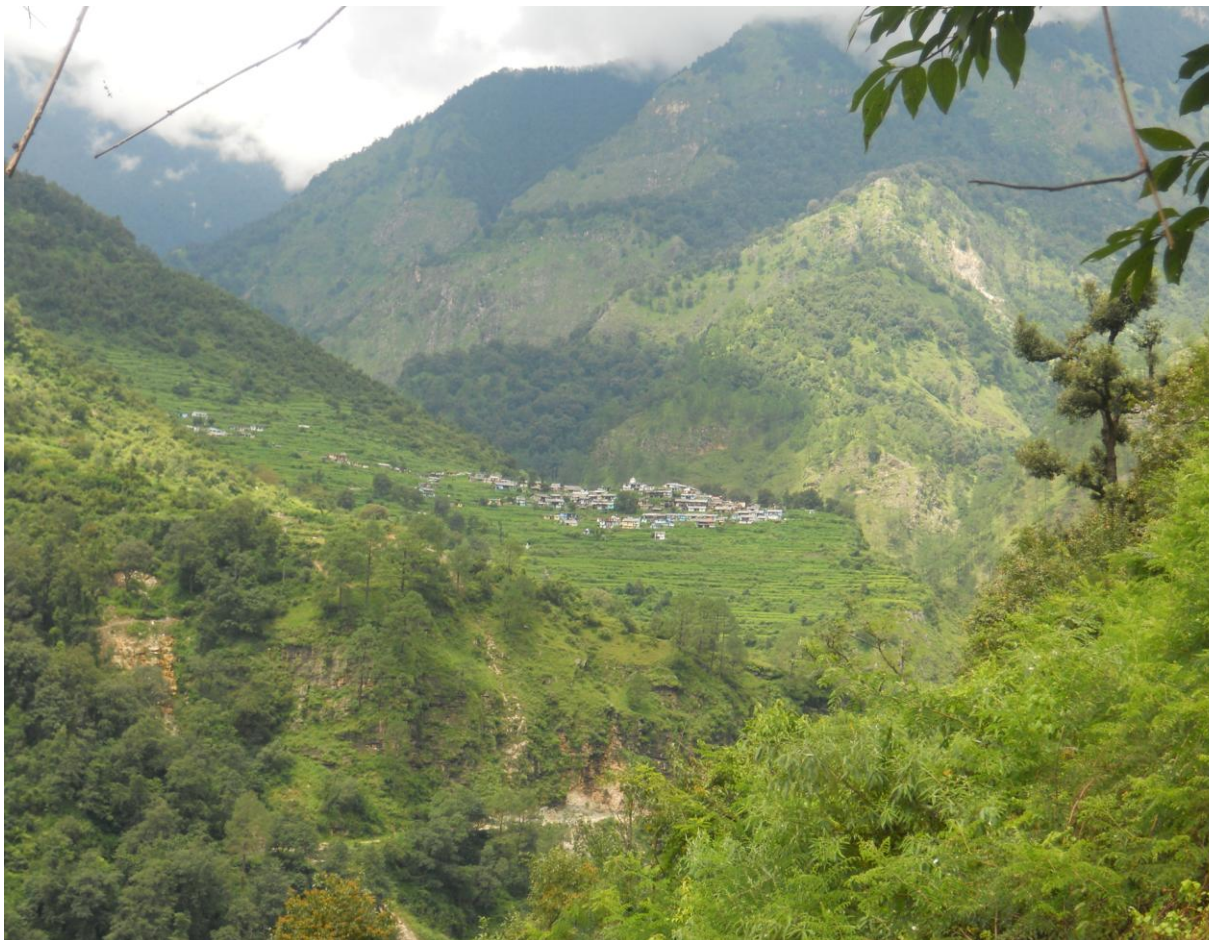
**Fig 22. Panoramic view of Gajoli village in Asi Ganga valley.**

The area around the village Gajoli is observed to be located amid agricultural lands and occupied by outcrops as well as overburden (Fig. 22). In the road section below the village Lesser Himalayan quartzites are observed to be exposed. These rocks are observed to be medium grained, white with staining, slightly weathered, moderately jointed and medium bedded. These dip towards northwest at moderate angles. The rocks in the area are traversed by numerous joints which are the important structural discontinuities affecting the strength of rock mass and stability of slopes. The rocks dip at angles varying from 25° to 30° towards northeast. The joint sets are observed to dip towards SSW, SSE and E (75° / 205°, 80° / 155° and 55° / 090°).

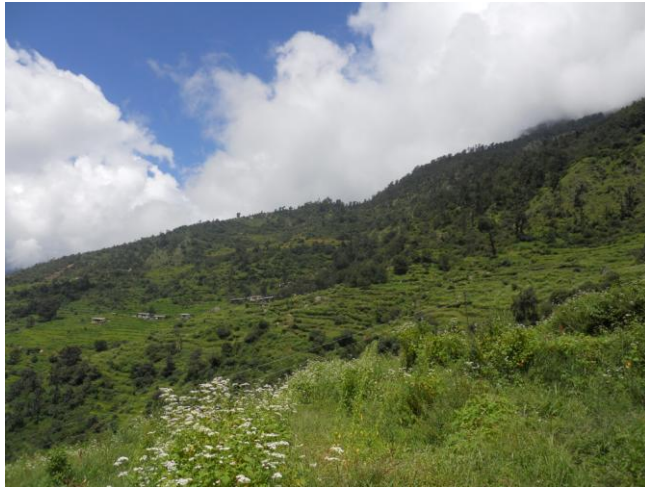
**Fig. 26. Panoramic view of Dasra village in Asi Ganga valley.**

The area around the village is located on agricultural lands and occupied by outcrops as well as overburden (Fig. 26). The Lesser Himalayan quartzites and metabasics are observed to be exposed in the area upslope of the village. The general trend of the rocks is NE-SW with moderate to steep dips towards NW. The rocks in the area are traversed by numerous joints which constitute important structural discontinuities affecting the strength of rock mass and stability of slopes.

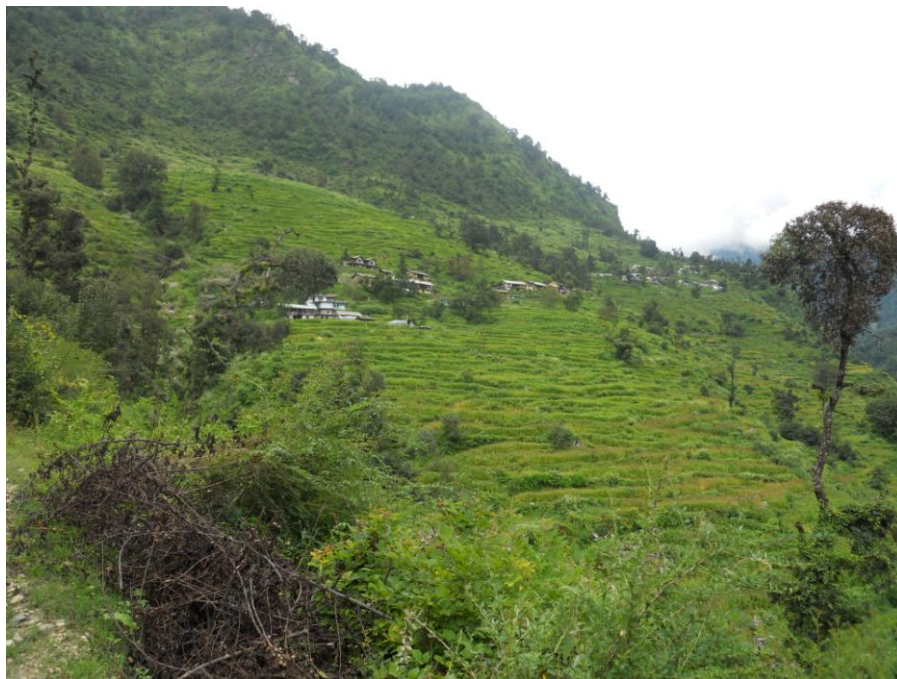
**Fig. 28. Panoramic view of Dhandnkala village in Asi Ganga valley.**

The area around the village is located on agricultural land and is occupied by outcrops as well as overburden (Fig. 28). Lesser Himalayan quartzites and metabasic are observed to be exposed near the village as also on the nala bed. Upslope of village area metabasics are encountered.

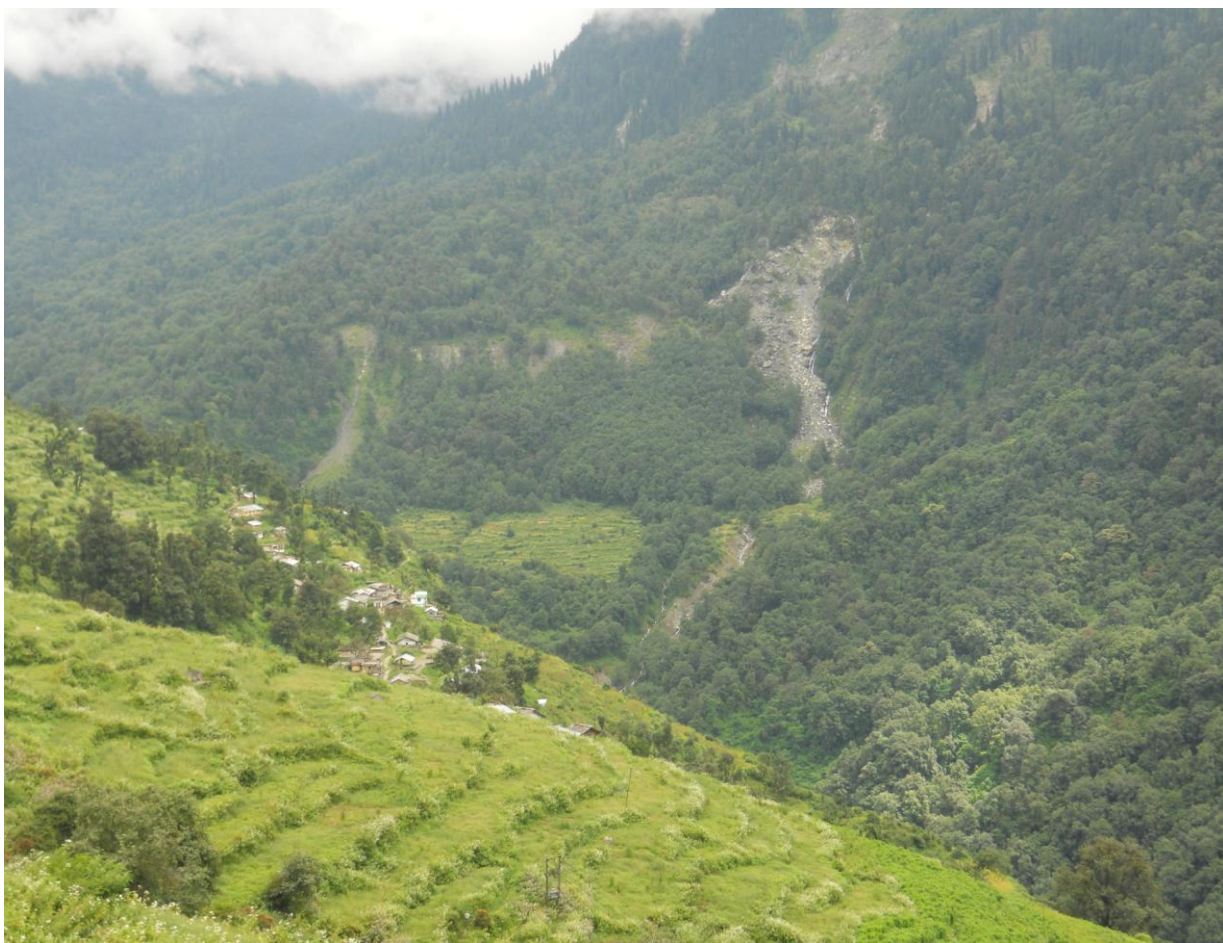
**Fig. 29. Panoramic view of Agora village in Asi Ganga valley.**

The area around the village is observed to be located on agricultural land and occupied by outcrops as well as overburden (Fig. 29). Exposures of metabasics are observed near the village on footpath section and in the area upslope of the village. The general trend of the rocks is NE-SW with gentle dips towards NW. The rocks in the area are traversed by numerous joints which constitute important structural discontinuities affecting the strength of rock mass and stability of slopes.

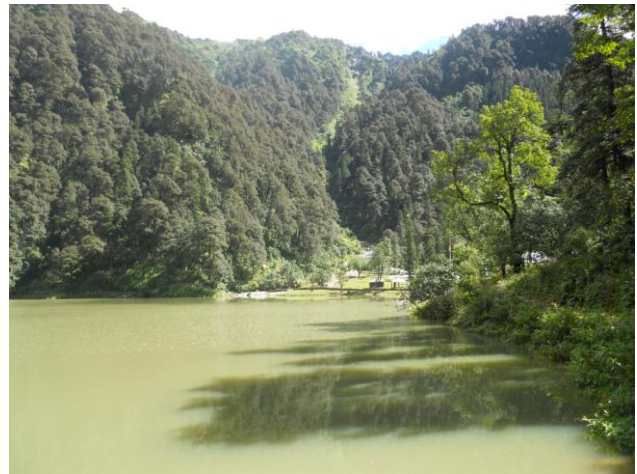
**Fig. 32. Photograph showing a seasonal stream towards the Forest Guest House side.**

***Reconnaissance geological - geotechnical assessment:*** High monsoonal discharge has resulted in accumulation of large volume of sediments at the northern end of the lake (Figs. 31 and 32). No major damage is however observed except for some instances of bank erosion along the Dodi Tal Gad.
