Economics of seismic safety for earthquake-prone Himalayan province of Uttarakhand in India

Piyooash Rautela

Abstract

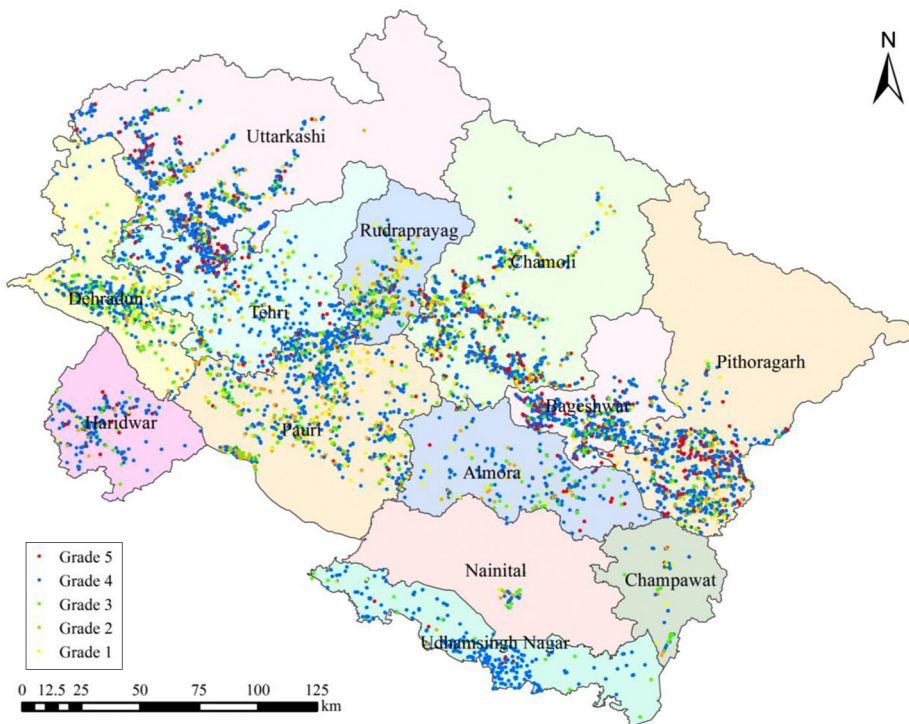
Figure 3.
Distribution of
different
damageability grade
buildings in the state
of Uttarakhand

overwhelmingly large proportion of the surveyed masonry buildings (64.1 per cent) fall in Grade 4 and are likely to sustain heavy structural damage and very heavy non-structural damage. Together with this significant proportion of masonry, buildings in Haridwar, Bageshwar and Pithoragarh districts fall in Grade 5, which is a cause of concern (Figure 3).

The state of RCC buildings is observed to be relatively better but not satisfactory (Table IX) as 50.9 per cent of the surveyed RCC buildings are assessed as being unsafe. In all 33.3 per cent of the surveyed RCC buildings fall in Grade 4 with significant proportion in Bageshwar and Pithoragarh districts falling in Grade 5, which is a cause of concern (Figure 3).
