**Geological note on landslide affected villages in
Kapkot tehsil of Bageshwar district in
Uttarakhand**

A report

**Disaster Mitigation and Management Centre
Department of Disaster Management
Uttarakhand Secretariat
Dehradun 0 248 001**

November, 2012

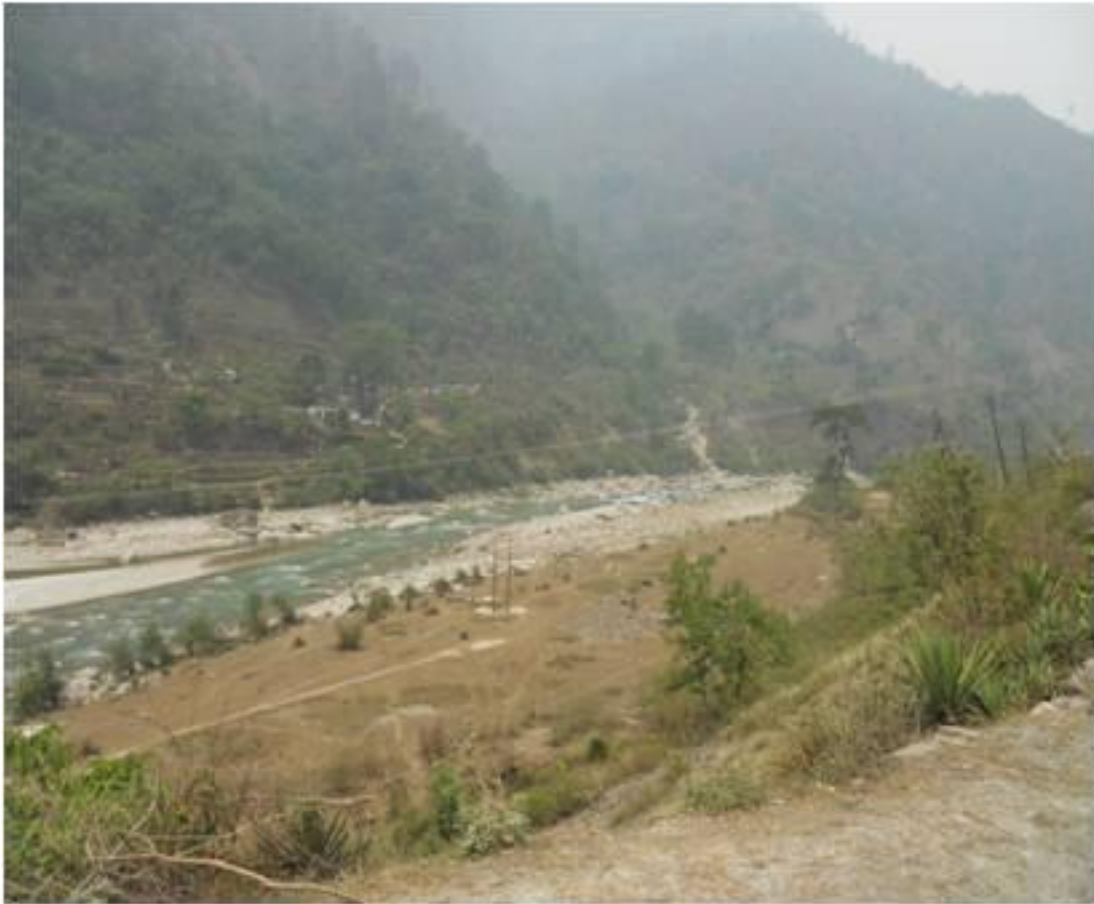
Fig. 9: Panoramic view of Tallabagar tok.

Another failure was observed along the northeast flowing Ghatta roli but the same is fairly far from the *tok* (Fig. 9).

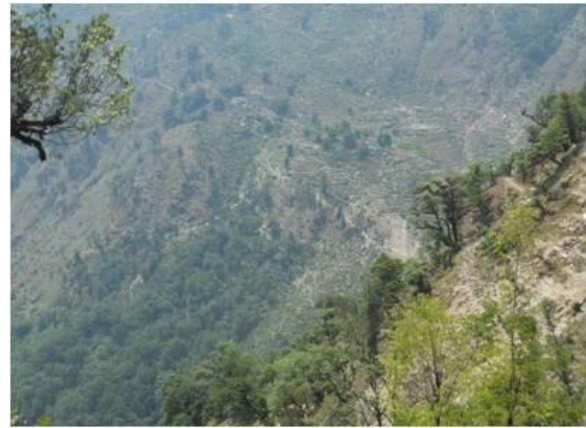
The slide was observed to have occurred on the southwestern slope of NE - SW trending ridge. Two houses were damaged in the southern side below the *tok* due to bank erosion by the local seasonal drainage on its right flank (Figs. 17 and 18).

Fig. 18: Panoramic view of Talla Wachham.

Mitigation measures: Appropriately designed masonry retaining walls are required to be constructed at specific intervals without disturbing the natural slope so as to protect the critical slope mass.

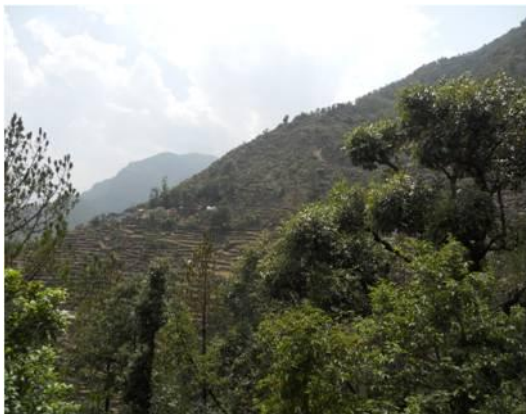
Dhurkot *tok* (Fig. 22) is located on the right bank of Sarju river and is at a distance of 17 kilometers from Kapkot. The area can be approached by Kapkot – Munar - Patiyasar motor road. The main village is located about 3.5 kilometers upslope of the road head. The area is drained by a southwest flowing stream.

Fig. 22: Panoramic view of Dhurkot *tok*.

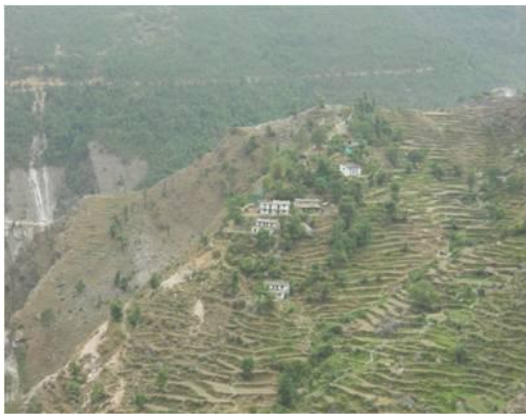
The failure was observed to have occurred on agricultural fields below the houses. A number of agricultural fields below the *tok* were completely damaged due to the slope failure. The quartzitic rocks were observed to be shattered by blasting undertaken during the road construction and this was deduced to have adversely affected the rock mass strength (Fig. 24).

Fig. 24: Panoramic view of Pass tok

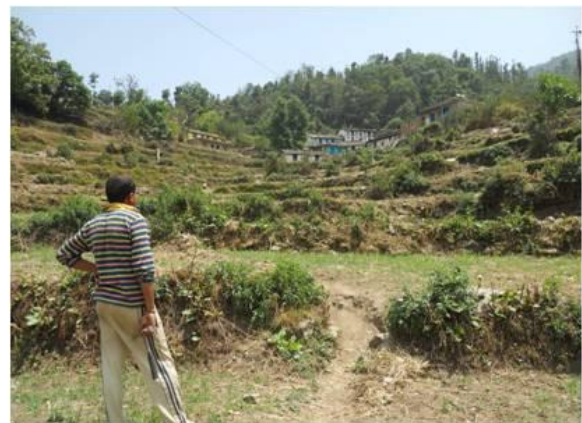
Fig. 29: Panoramic view of Gansi village.

The Gansi village was observed to be situated over in situ rocks and the failure slope was fairly far away from the village (Fig. 29). At the eastern end of the village a house was observed to be located on critical slope and waste / household water was observed to flow in close proximity of the house. This may be dangerous to the house during monsoons.

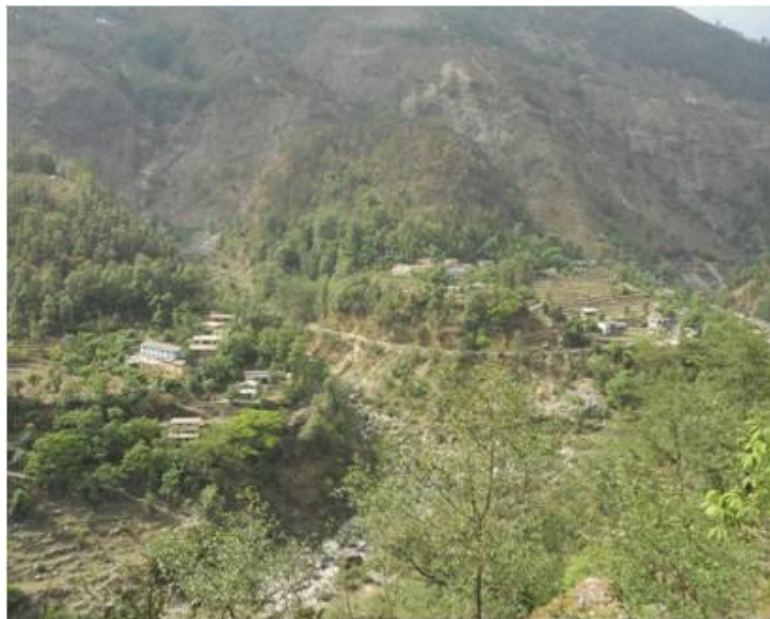
Reconnaissance geological-geotechnical assessment: Around the village general thickness of the overburden was observed to vary between 1 to 2 meters but at places its thickness including weathered rock zone was observed to be up to 3 meters. The overburden material comprised of hill wash and debris and consisted of grey to brown, fine grained silty - sandy matrix and fragments of quartzite (Fig. 34).

The general slope angle in the area was moderate and the direction of slope was towards northeast. Slope instability did not appear to affect the natural slopes in the area. Presently there were no indications of major slope instability around the village.

Fig. 34: Panoramic view of Munar village.

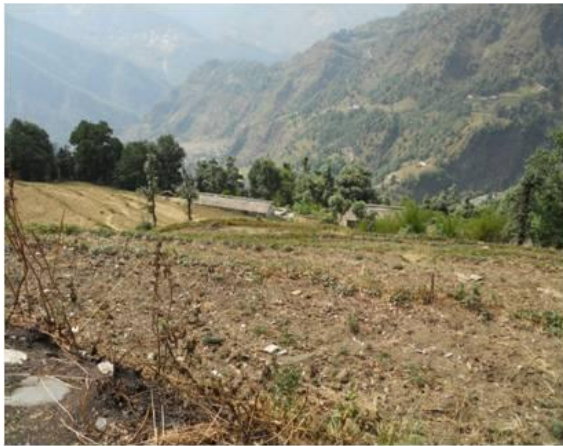
The relative relief around the *tok* was fairly high with sub-vertical to vertical rocky scarp towards eastern end. This was attributed to heterogeneity, jointing and fracturing of rocks. Flooding in local seasonal streams during excessive rainfall events during the monsoons were deduced to have caused erosion in the area leading to slope instability (Fig. 38).

Fig. 38: View of agricultural land uphill of *tok* area.

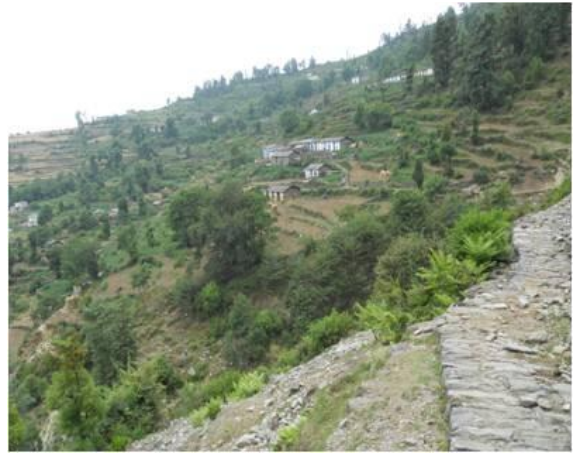
In the northern extremity of *tok* bank erosion by Gora gad was observed to have damaged a number of agricultural fields and affected many houses. About 12 houses were affected by both seasonal water course and perennial stream (Figs. 43, 44 and 45).

Fig. 44: Panoramic view of Gora tok.
