# **Sikkim Earthquake of 18<sup>th</sup> September, 2011**

## **A Report**

**Disaster Mitigation and Management Centre**

**January, 2012**

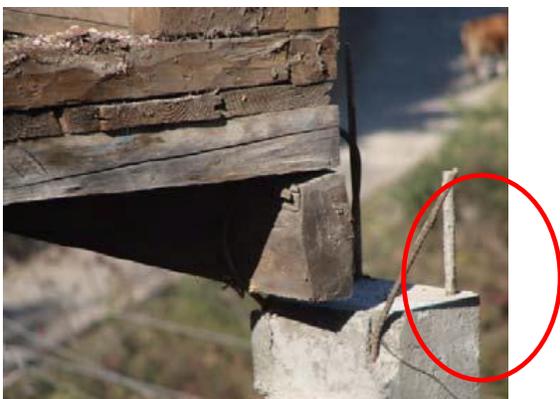
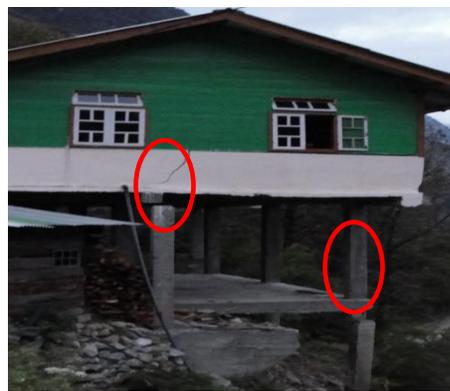
Damage is also observed in the foundation, mainly on hill slopes.

*Fig. 8 and 9. Type of foundations used in case of Ekra houses.*

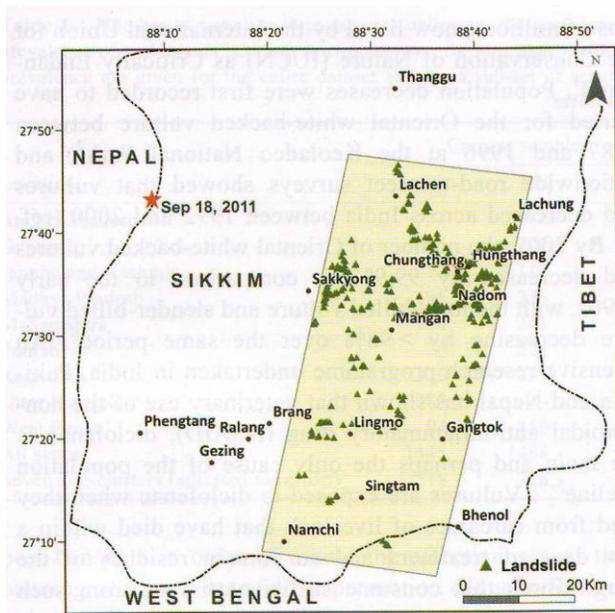
A few isolated instances of fissures and pavement failures were reported after the earthquake. The CARTOSAT 1 and CARTOSAT 2B satellite imageries of 29<sup>th</sup> and 30<sup>th</sup> September 2011 have revealed that 350 new landslides have occurred in the post-earthquake period. The spatial distribution of landslides from these satellite imageries can provide useful guidelines for vulnerability assessment, as also planning and formulation of mitigation strategies. Detailed analysis of the newly initiated landslides using imageries from adjoining areas would provide the state administration with complete inventory of landslides triggered by the earthquake.

The instability induced in the hill slopes due to the earthquake has certainly enhanced landslide vulnerability of the state and it is going to be a cause of major concern during the next monsoon. Disaster mitigation efforts need to be directed towards the identification of vulnerable regions, with emphasis on preventive steps as well as for planning relocation of settlements wherever necessary.

*Fig. 25. Distribution of co-seismically generated landslides (area:2000 km<sup>2</sup>)*
