Geological investigations in Rudraprayag district with special reference to mass instability

Disaster Mitigation and Management Centre

A Disaster Mitigation and Management Centre (DMMC) publication

2014

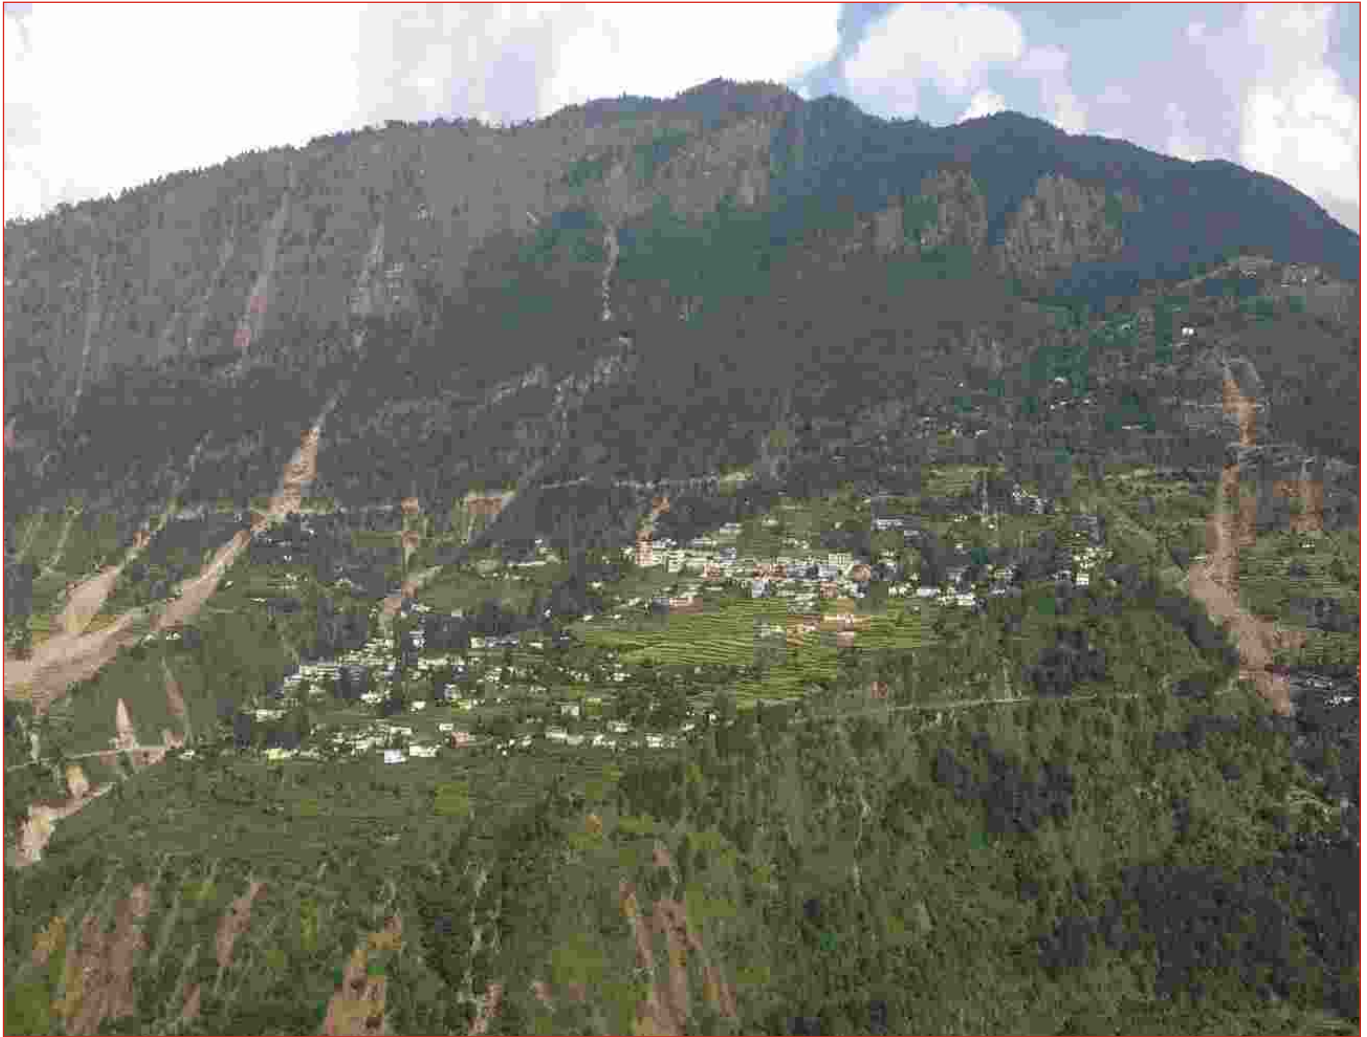
Fig. 3: View of the landslides around Okhimath in September, 2012.

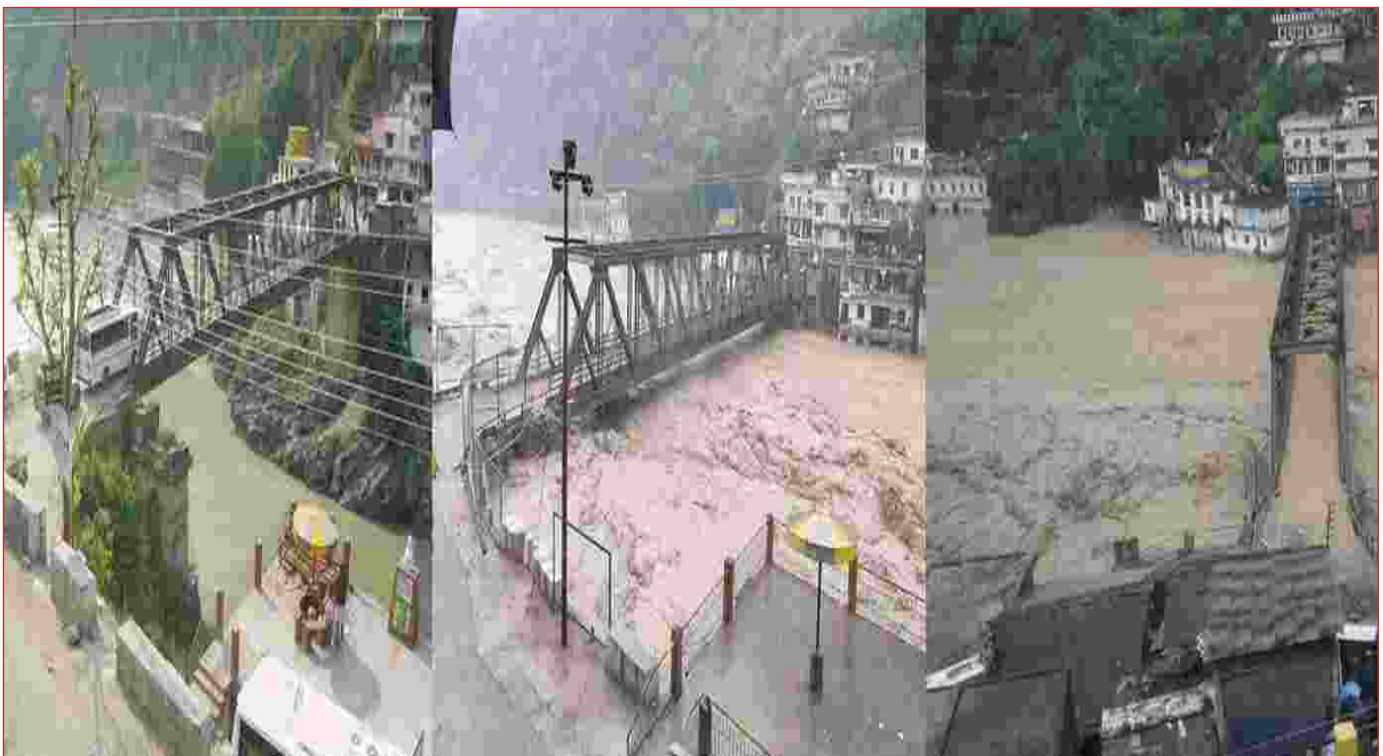
Fig. 4: Level of Alaknanda at Rudraprayag just before its confluence with Mandakini. On the left is normal water level while middle and right depict water levels on 16 and 17 June, 2013 respectively.

Heavy rainfall took place when there was still snow on the mountains and valleys. Abnormally fast melting of snow and ice due to heavy rains added to the discharge of hill torrents and streams and almost all the major rivers of the state crossed danger levels (Fig. 4). Recorded level of Mandakini on 17 June, 2013 at Rudraprayag was 633.5 meters as against the danger level of 626.0 meters (Table 2).

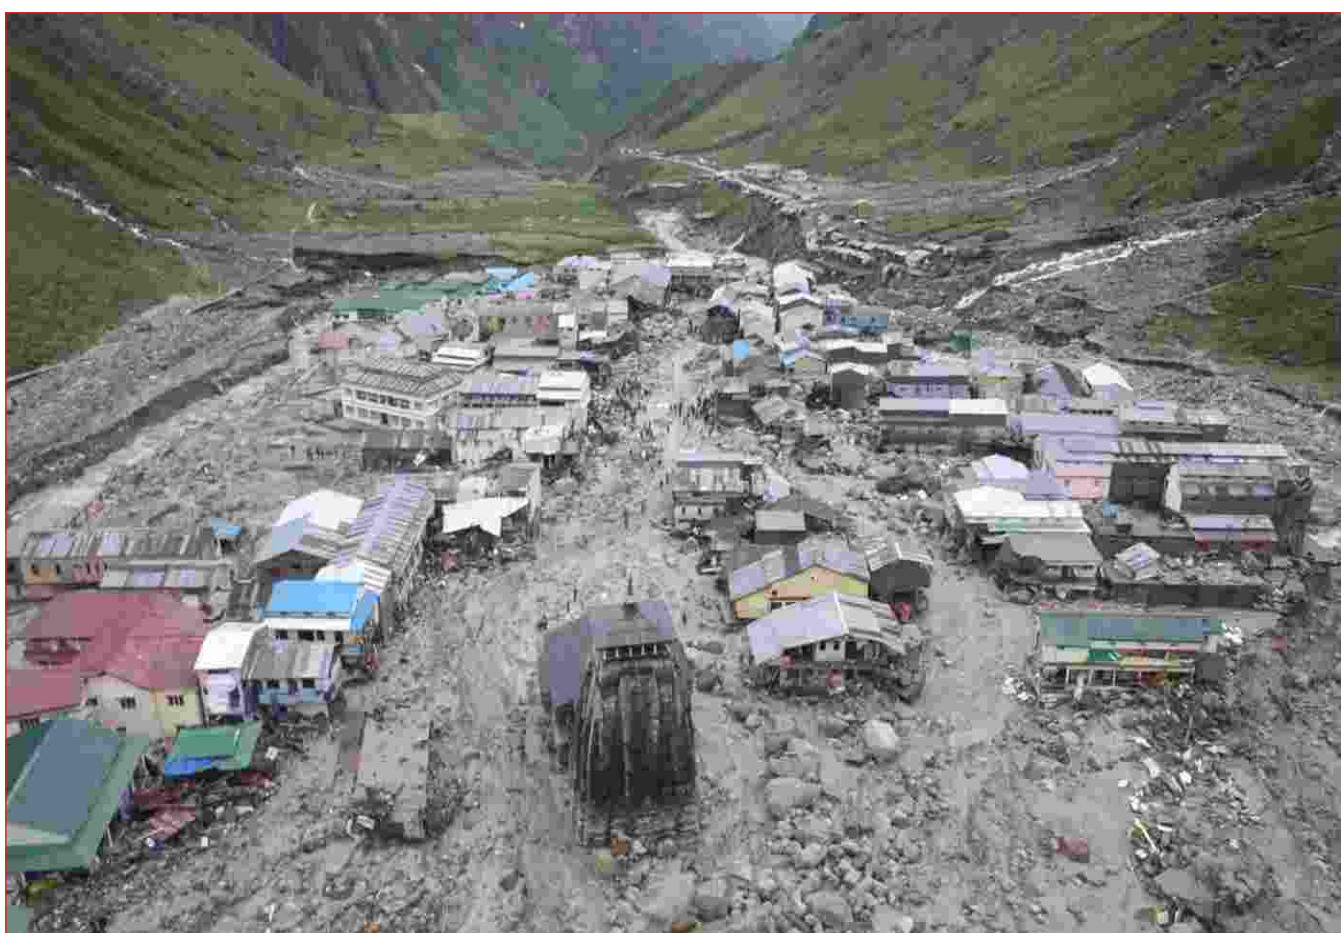
It was this blockade of Mandakini on 16 June, 2013 that led to impoundment of the channel to the west of Kedarnath. The embankment on the left bank of the channel soon gave way and the abandoned channel of Mandakini (Saraswati) to the east of Kedarnath became active. This event resulted in washing off of some

Fig. 5: View of Kedarnath after the disaster of 16 and 17 June, 2013. Activated course of Saraswati is seen to the east of the temple with camera looking south.

people in the late evening of 16 June, 2013 from Kedarnath, that thus became water locked. Rising hydrostatic pressure due to fast increasing volume of water forced the barrier to give way and the ensuing floods devastated Rambara and Gaurikund as also pedestrian bridge over Mandakini near Kedarnath. All connectivity with the area was thus snapped.

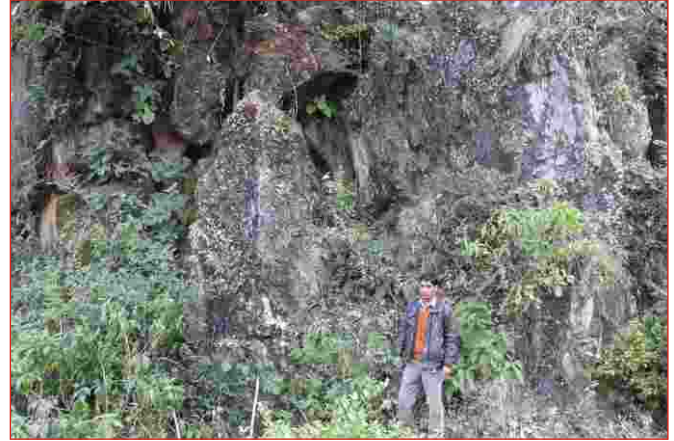
Garhwal Group of rocks in the area around Rudraprayag, in both Koteshwar and Tilni sections, are characterized by massive dolomitic limestone having dislodged blocks. This rock is observed to show shrinkage features and local folding (Figs. 14 and 15).

Fig. 15: View of dislodged limestone blocks at Tilni.

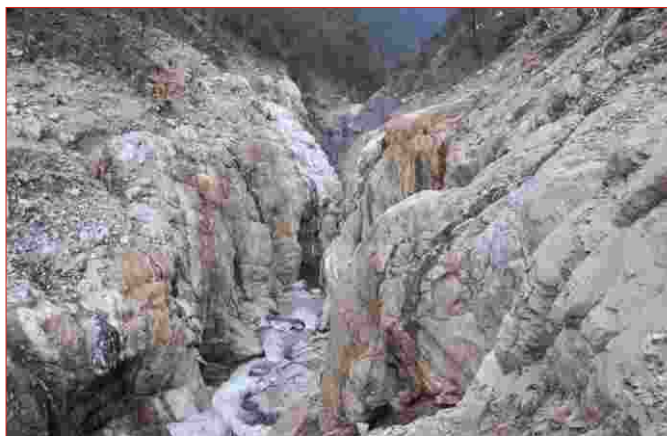
Fig. 26: Gorge downstream of the construction site where the bridge would have been constructed.

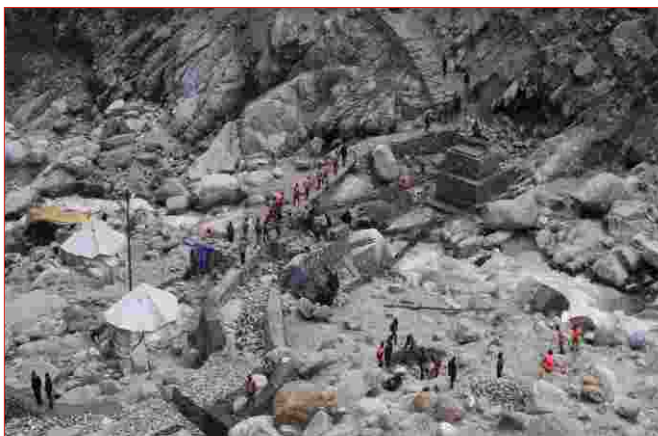
Unfortunately attempts are being made to place the bridge before this point and both the abutments of this bridge are on the loose sediments and boulders (Fig. 27). Moreover the approach trek on the right bank passes through vertical cut on the moraines and is vulnerable to falling boulders .

In case of heavy rains stability of this bridge constructed on the active river bed is likely to be compromised. It is worth noting that it is the only bridge for crossing Mandakini between Gaurikund and Kedarnath and damage to the same would result in persons in Kedarnath-Linchauli area getting stranded. Emergency evacuation arrangements have to be therefore put in place for avoiding panic of any sort.

Fig. 27: Bridge being constructed on the river bed downstream of Rambara.

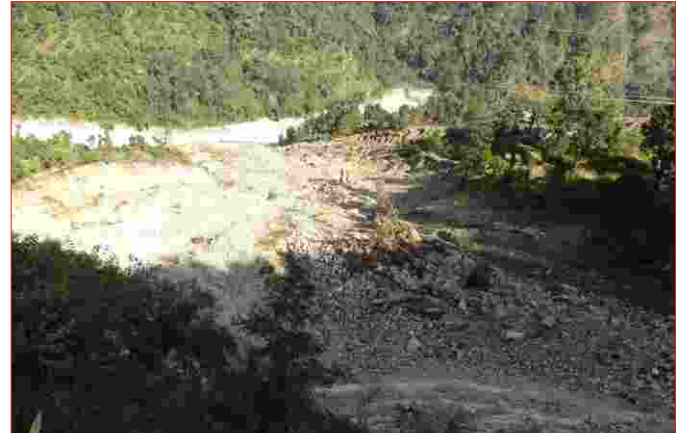
The inclination of failure slope is observed to be around 25° - 35° and the slope direction is towards northeast. The width of failure slope is about 200 meters and vertical height of the slide is about 150 meters (Figs. 33 and 34).

Fig. 34: Close view of Barasu landslide.

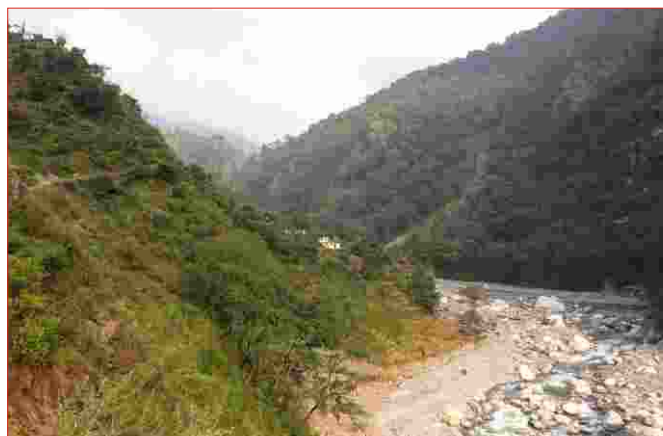
Abnormally high sediment laden discharge of Madhyameheshwar Ganga has eroded the terrace on its right bank and deposited around 3.0 meters thick pile of sediments (Fig. 39). Some agricultural fields adjacent to the river bed, both upstream and downstream of the village, are observed to be partially wash off (Fig. 40).

Fig. 40: View of agricultural lands washed off due to floods to the downstream of Gaundar.

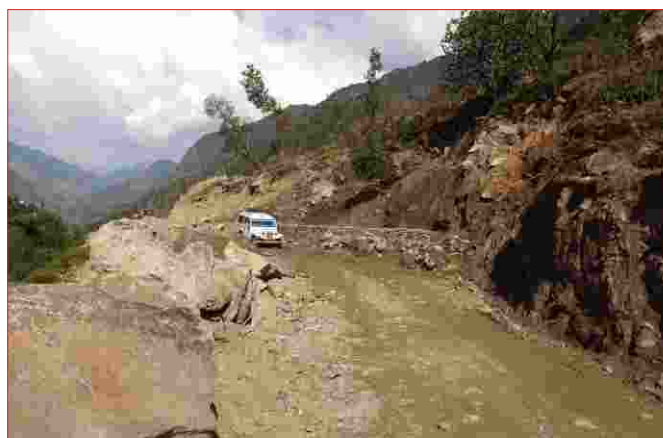
Undercutting of hill slope for reconstruction of the damaged road would remove the lateral support of the upslope material that might lead to slope failure and the same might pose a risk even for the village (Fig. 46).

Fig. 46: Cutting the hill slope for reconstruction of road.

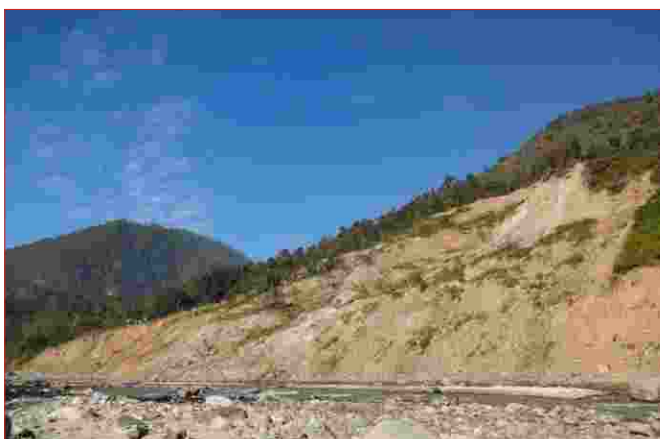
Flood induced landslide is observed on the opposite side of the Ramleela Ground (Fig. 61). It has damaged a number of houses at Patiyon, Chaka, and Tilli villages along with a number of agricultural fields. The inclination of failure slope is observed to be around 40° and the slope direction is towards southeast. The width of the failure slope is about 250 meters while the vertical height of the slide is about 45 meters.

Fig. 61: Photograph depicting flood induced landslide.

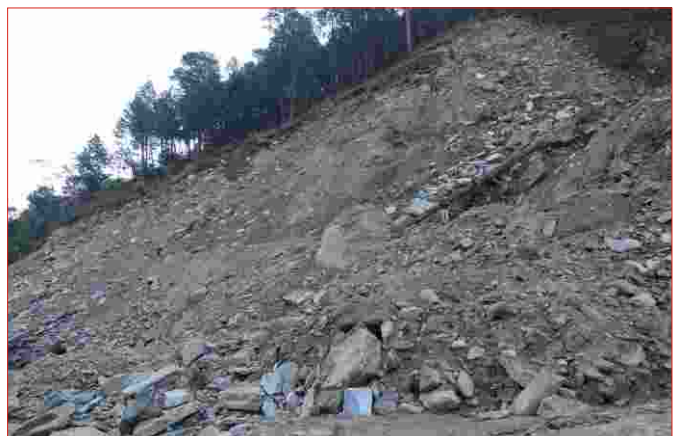
Gully erosion is observed to the downstream of the Chaka village on the right bank of river (Fig. 62). No damage has however occurred in the Chaka village area. Landslide is observed to the downstream side of the Silli village and the same has damaged around 200 meters stretch of the National Highway (NH 109) on the left bank of Mandakini river (Fig. 63).

Fig. 63: View of debris dumped on National Highway on the left bank of Mandakini.

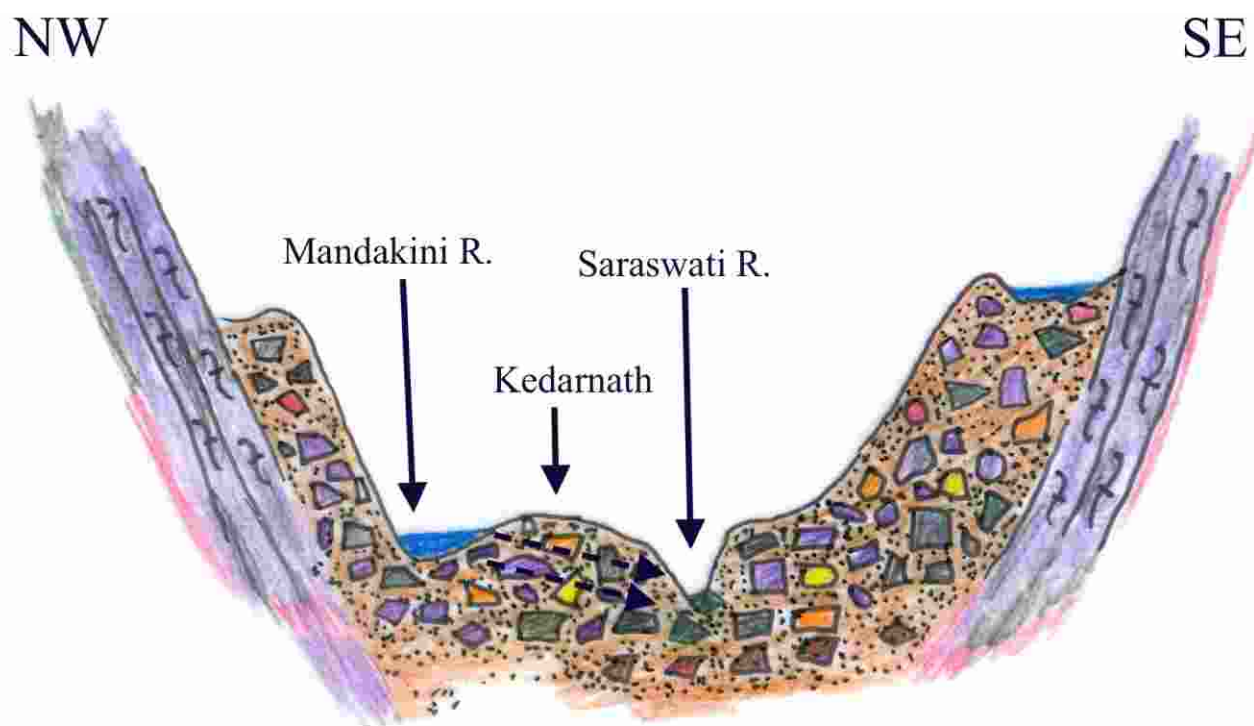
Attempts to divert water from this geomorphic low towards the old course of Mandakini by creating structural barriers is sure to initiate subsurface flow of water towards this geomorphic low (Fig. 76). This envisaged east - southeastward subsurface flow of water from Mandakini to Saraswati, in that situation, would result in piping action due to washing away of fines from the matrix of the glacial outwash deposits on which is located Kedarnath temple. It is to be kept in mind that removal of fines is likely to induce ground subsidence in the glacial outwash deposits and the same may jeopardise the safety of structures built over it, including the temple.

Fig. 76: Schematic diagram depicting subsurface flow of water towards the geomorphic low.

Similar piping action was responsible for severe ground subsidence in Chain village in Chamoli district where subsurface flow of water from Dharmangar nala towards Rauldhar nala resulted in major ground subsidence in 2007 (Nawani et al., 2007).

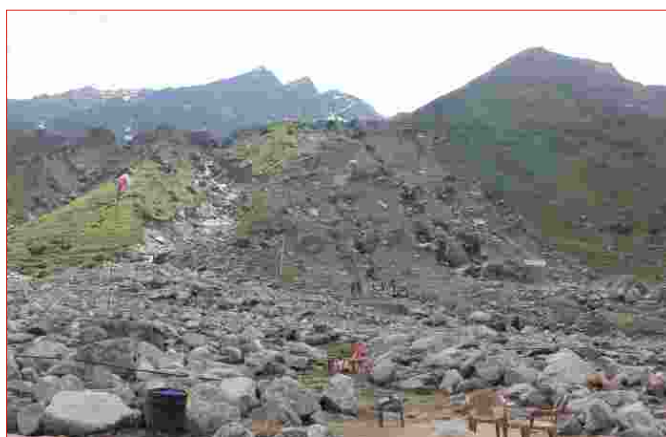
It needs to be noted that there exists a major elongated north south running depression between the morainic ridge and valley wall (Fig. 77). This depression is just to the east northeast of the helipad and GMVN facilities and there is usually significant impoundment of water in this depression, particularly during the monsoon period. Water from this depression is observed to flow down from as many as three places along the morainic ridge (Fig. 78).

Fig. 78: Water flowing down the left lateral morainic ridge on the left bank of Mandakini to the east of the helipad at Kedarnath.

Breach of this depression is likely to destabilise the morainic ridge and bring down huge volume of debris and boulders. This site is therefore deduced to be not that safe and therefore no permanent structures should be erected at this site. This site should also not be used for overnight stay of pilgrims and others.
