**DISASTER MITIGATION AND MANAGEMENT
CENTRE UTTARAKHAND SECRETARIAT
DEHRADUN**

**Geological note on road
subsidence on
Yamunotri NH 94 below
Wariya village in Barkot
tehsil of Uttarkashi
district in Uttarakhand
(India)**

**27th August
2012**

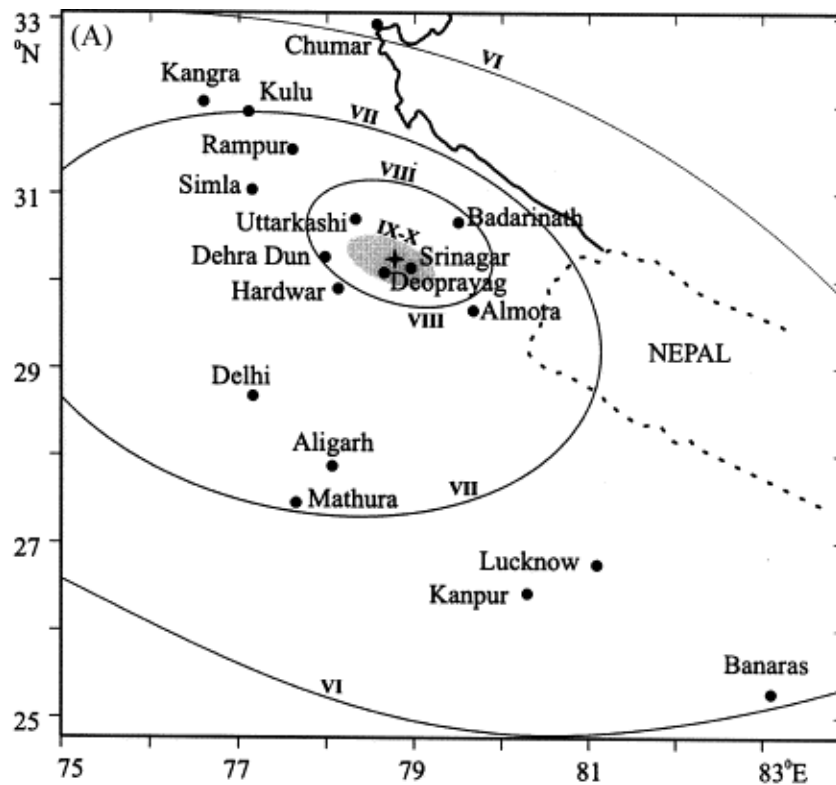
Fig. 3: Seismic Intensity Map of Uttarkashi Earthquake of 1991.

The epicentral tract of 1991 earthquake occupying an area of 20 sq km around Maneri in Bhagirathi valley recorded an intensity of IX – X on MSK - 64 Scale (Fig. 3). The main shock was followed by a series of over 2,000 aftershocks over a period of two months.
