# TRADITIONAL GENIUS AND EARTHQUAKES

*Traditional building techniques have always existed in regions vulnerable to earthquakes. Unfortunately, aspirations to modernity have tended to bury these norms, resulting in heavy casualties in recent times.*

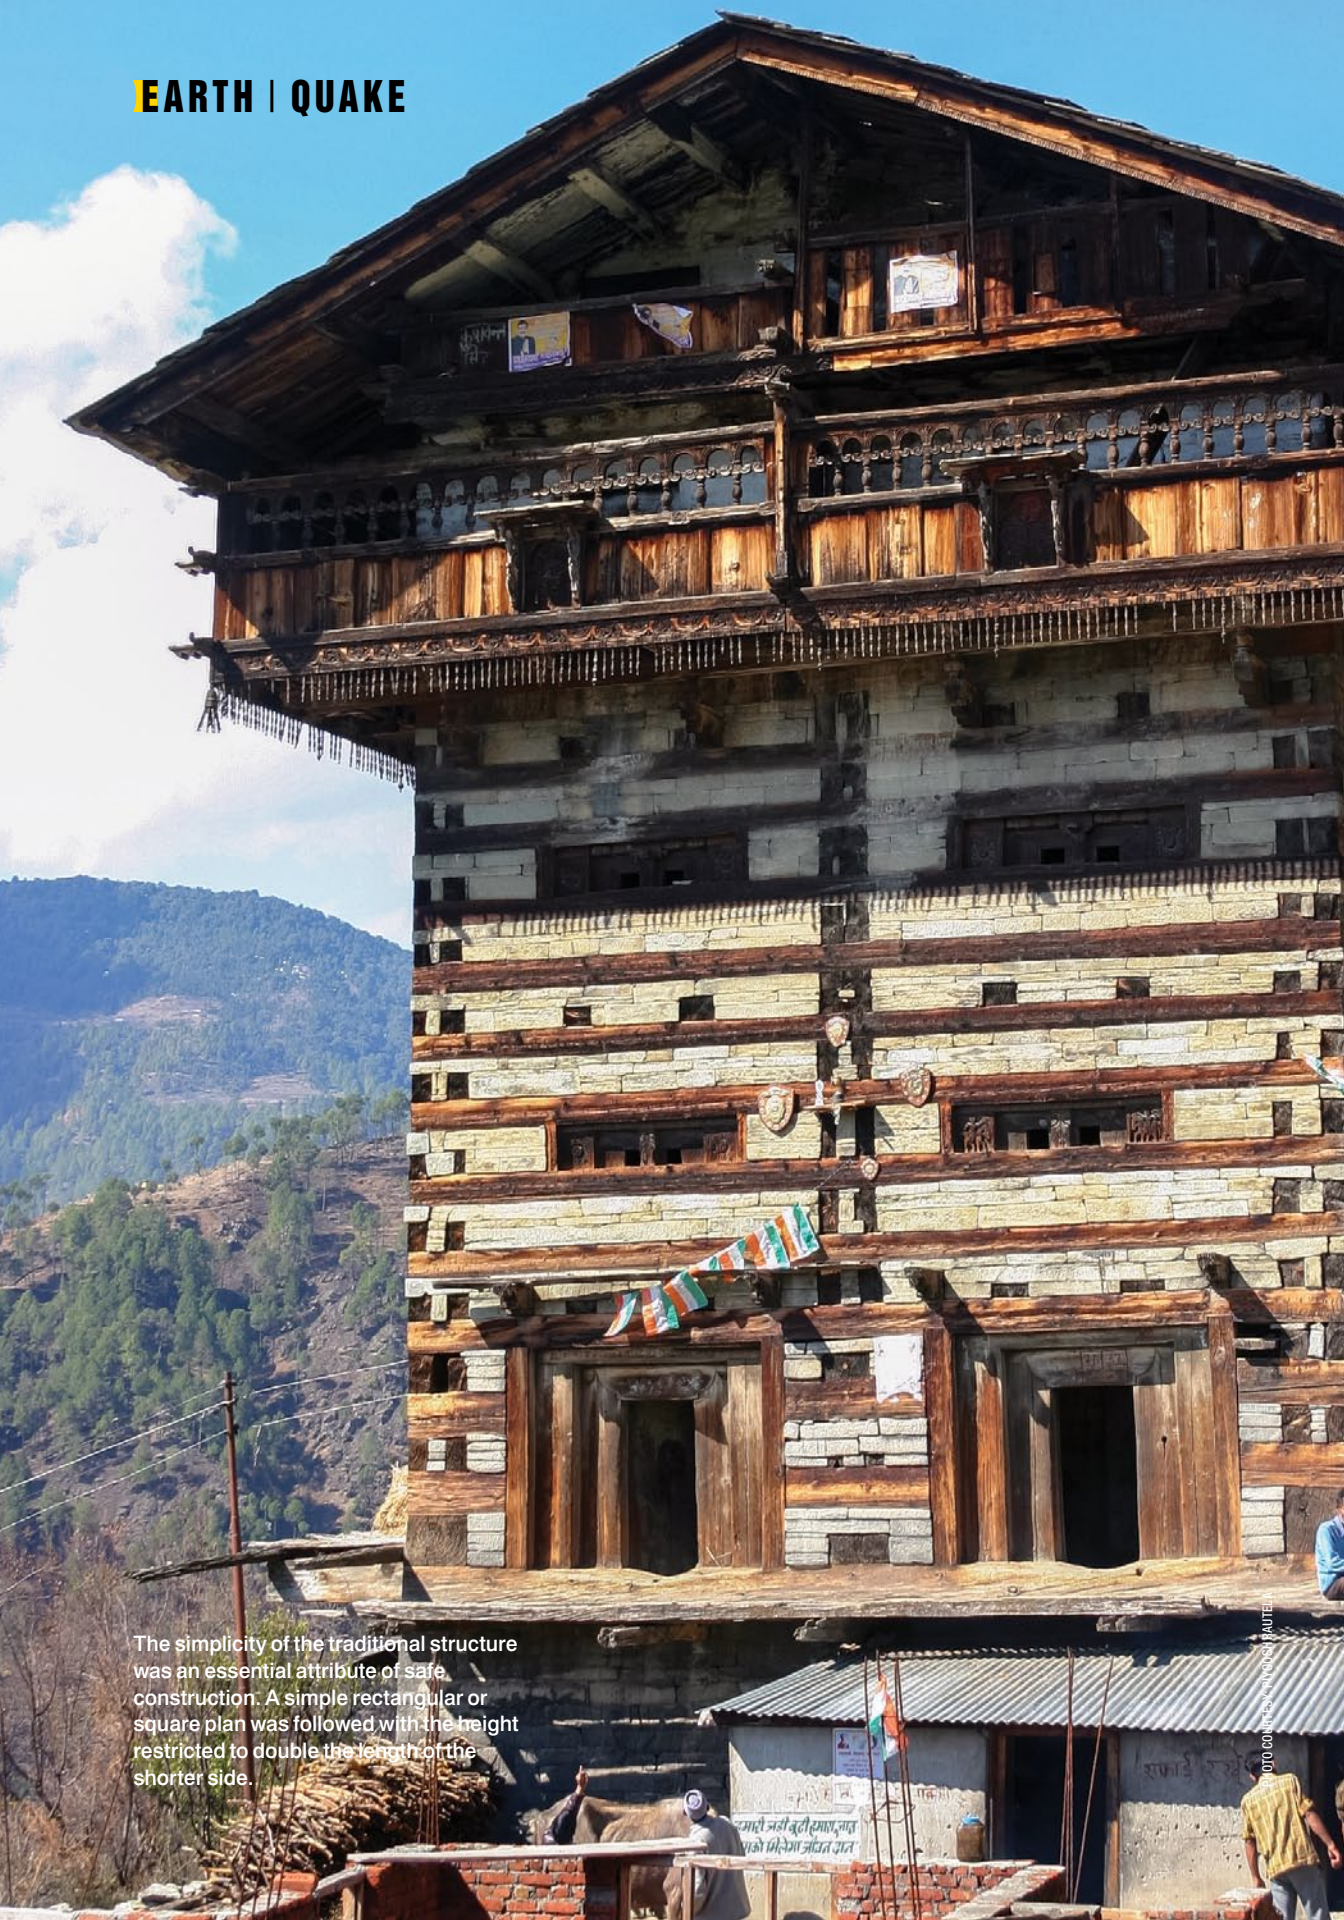
The simplicity of the traditional structure was an essential attribute of safe construction. A simple rectangular or square plan was followed with the height restricted to double the length of the shorter side.

**Simplicity:** The simplicity of the structure was an essential attribute of safe construction. A simple rectangular or square plan was followed with the length of the sides varying between 4 and 8 m. The ratio of the two sides of the structure varied between 1.1 and 1.4 and the height was restricted to double the length of the shorter side.

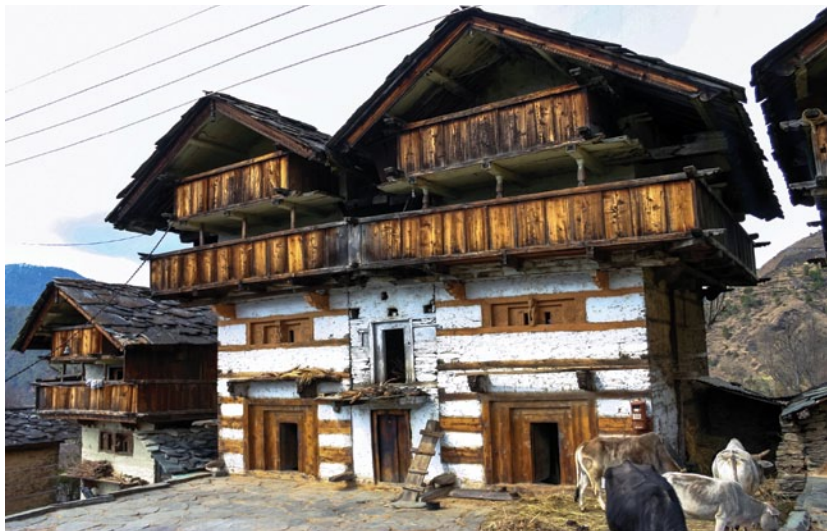
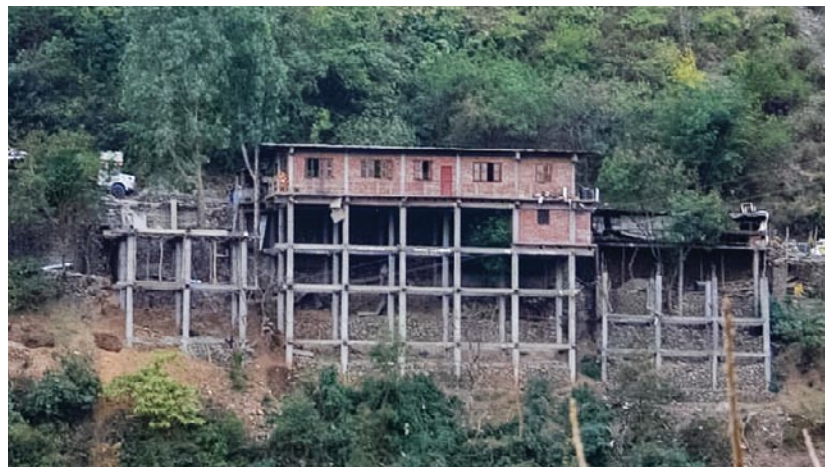
As opposed to traditional structures, a network of ill-reinforced and unplanned beams and columns that defy the slope of hills of Uttarakhand are in place today. Heavy structures on steep hill slopes are the bane of Devprayag, Karnaprayag, Almora, Rudraprayag and Bhatwari.

the region in recent times has found many locals keen to cash in on the business boom. This has, in turn, seen many put up guest houses and hotels to make the most of this opportunity. A network of ill-reinforced and unplanned beams and columns that defy the slope of hills of Uttarakhand are in place today. Even riverbeds have been encroached upon to make a neat profit out of tourism. Heavy structures sited over elongated columns and multiple storeys on steep hill slopes are the bane of Devprayag, Karnaprayag, Almora, Rudraprayag and Bhatwari. Except for a few urban areas, building codes are non-existent. Even where well-defined building codes are in place, enforcement is weak and defaulters get their constructions regularised by paying penalties if reprimanded.
